SUMMARY REPORT
230 ASPEN STREET (FORMERLY 385 ASPEN STREET)
LAUREL BAY MILITARY HOUSING AREA
MARINE CORPS AIR STATION BEAUFORT
BEAUFORT, SC

CDM - AECOM Multimedia Joint Venture
10560 Arrowhead Drive, Suite 500
Fairfax, Virginia 22030

Contract Number: N62470-14-D-9016
CTO WE52
JUNE 2021

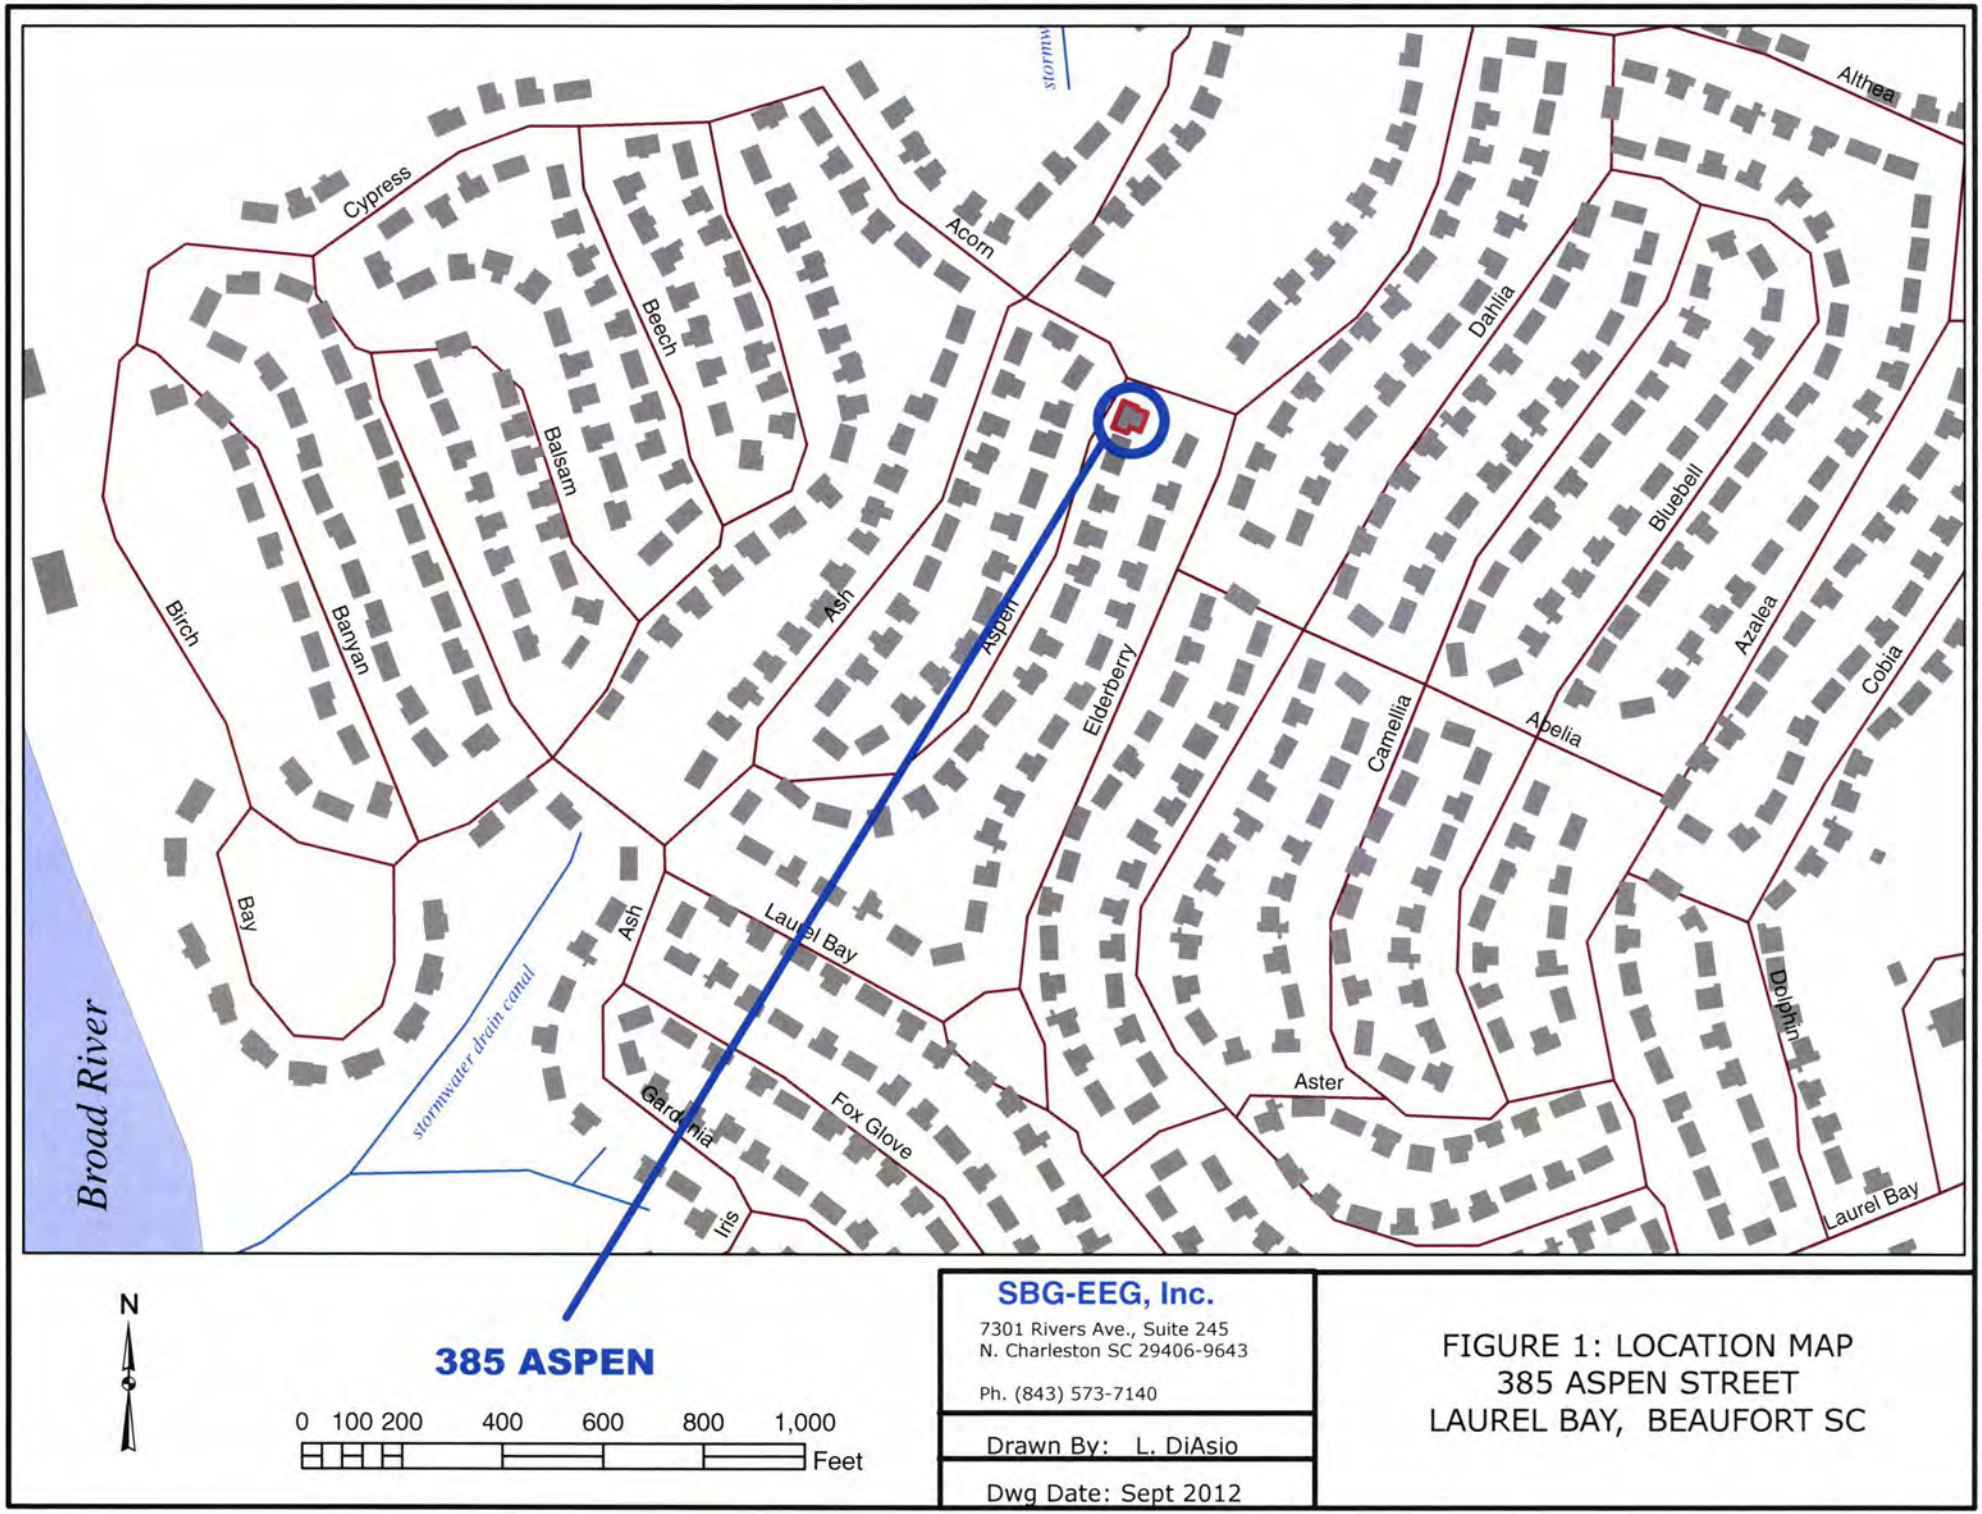
You must supply a scaled site map. It should include all buildings, road names, utilities, tank and dispenser island locations, labeled sample locations, extent of excavation, and any other pertinent information.

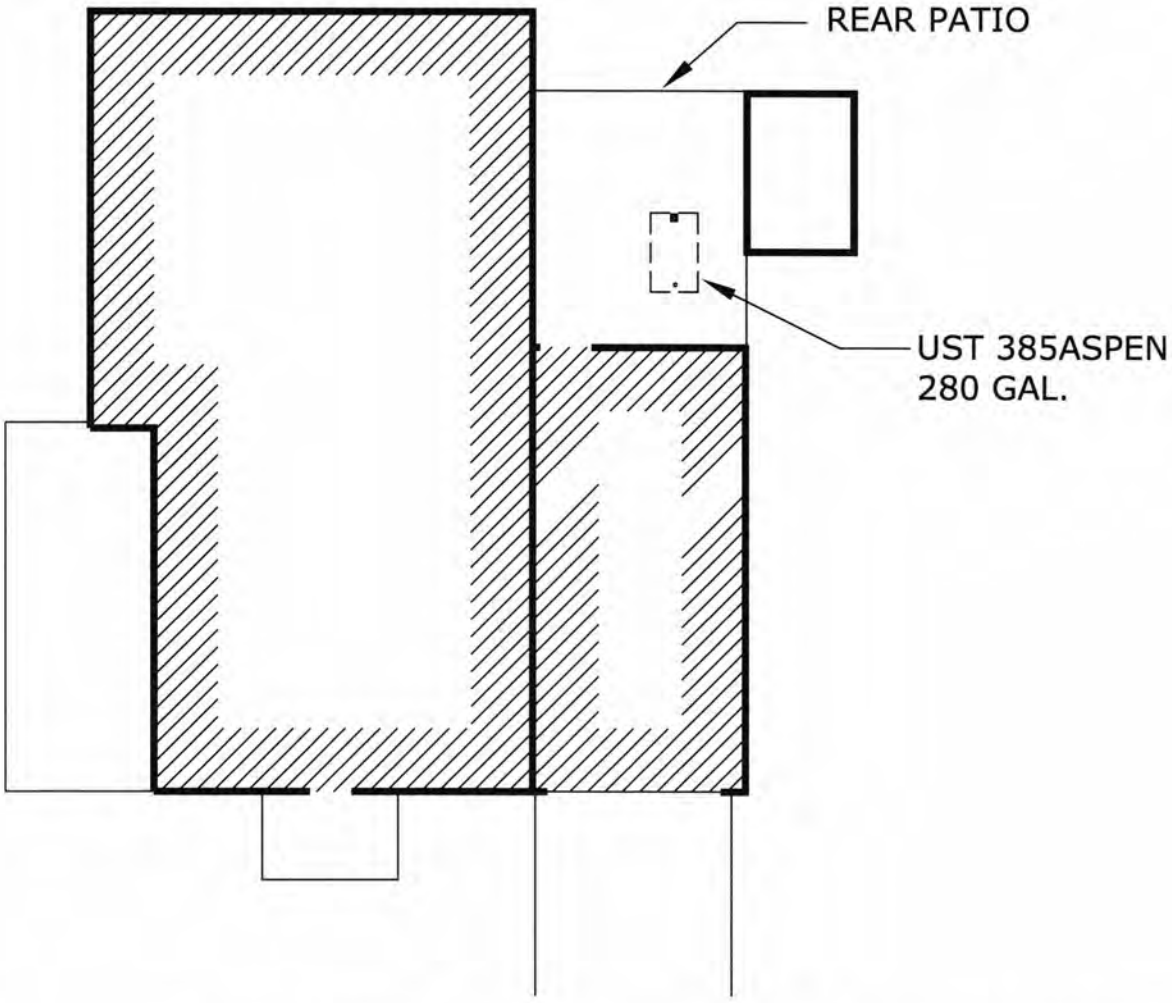
FIGURE 2 SITE MAP
385 ASPEN STREET, LAUREL BAY
MCAS BEAUFORT SC

TANK DEPTH BELOW GRADE
385ASPEN = 30"

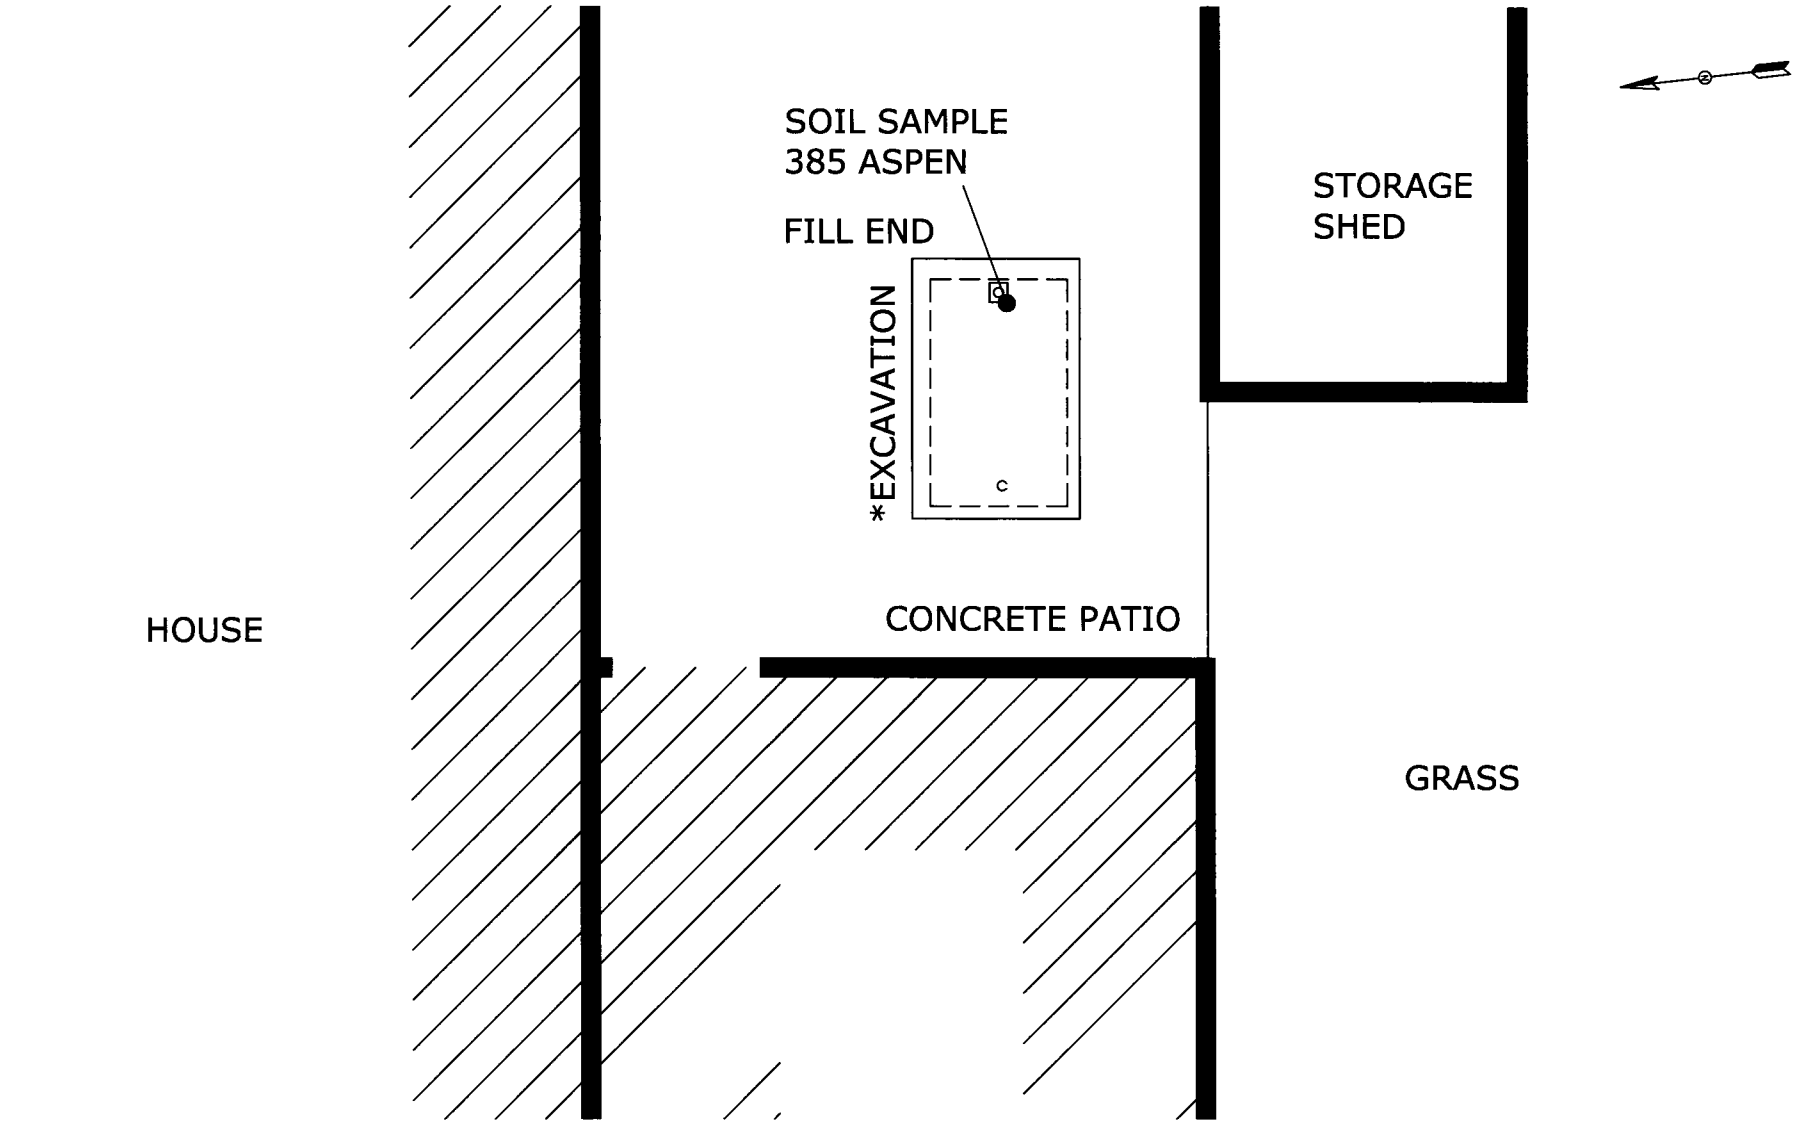
FIGURE 3 UST SAMPLE LOCATIONS
385 ASPEN STREET LAUREL BAY
MCAS BEAUFORT SC

*A PORTION OF THE PATIO WAS REMOVED TO FACILITATE EXTRACTING THE TANK.
