SUMMARY REPORT
125 ACORN DRIVE (FORMERLY 388 ACORN DRIVE)
LAUREL BAY MILITARY HOUSING AREA
MARINE CORPS AIR STATION BEAUFORT
BEAUFORT, SC

Contract Number: N62470-14-D-9016
CTO WE52
JUNE 2021

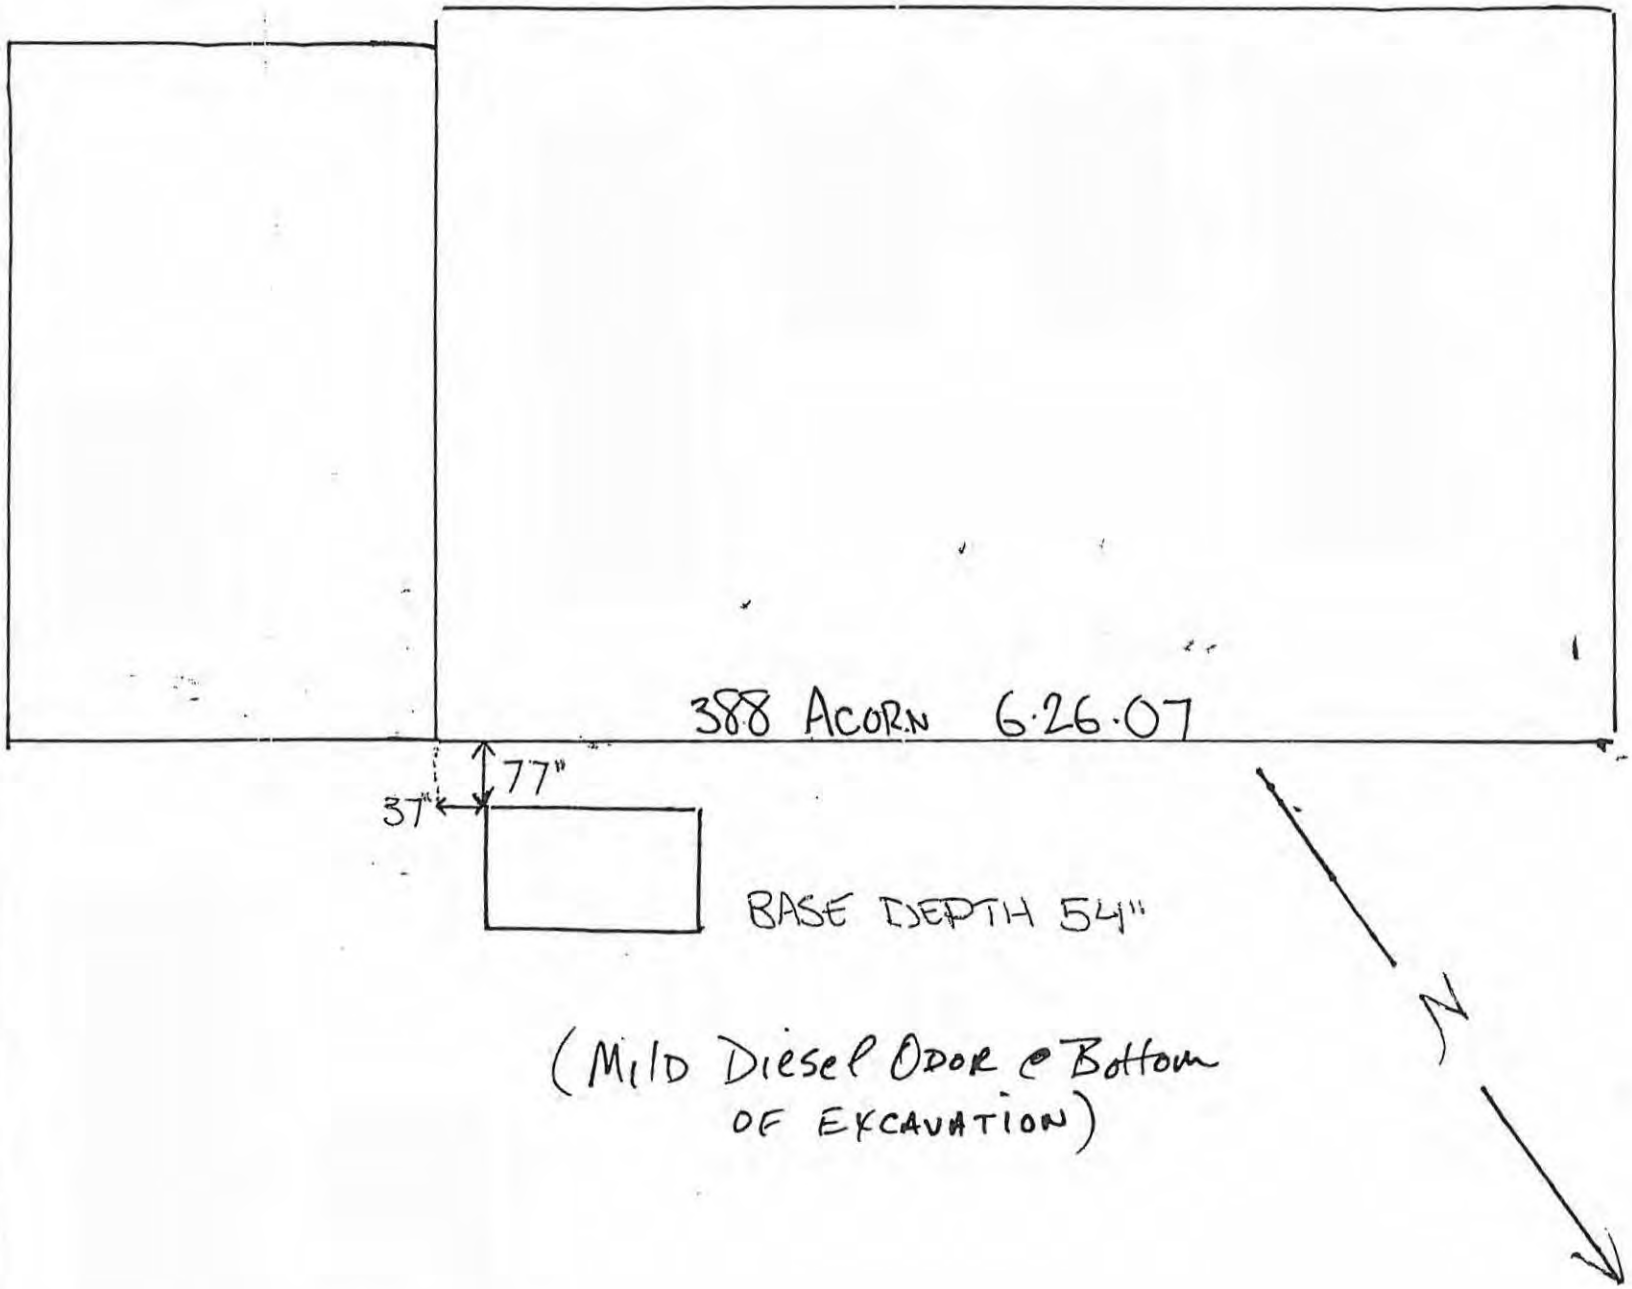
388 ACORN 6.26.07
77"
37"
BASE DEPTH 54"
(MILD DIESEL ODOR @ BOTTOM OF EXCAVATION)
N
