SUMMARY REPORT
169 ACORN DRIVE (FORMERLY 394 ACORN DRIVE)
LAUREL BAY MILITARY HOUSING AREA
MARINE CORPS AIR STATION BEAUFORT
BEAUFORT, SC

Contract Number: N62470-14-D-9016
CTO WE52
JUNE 2021

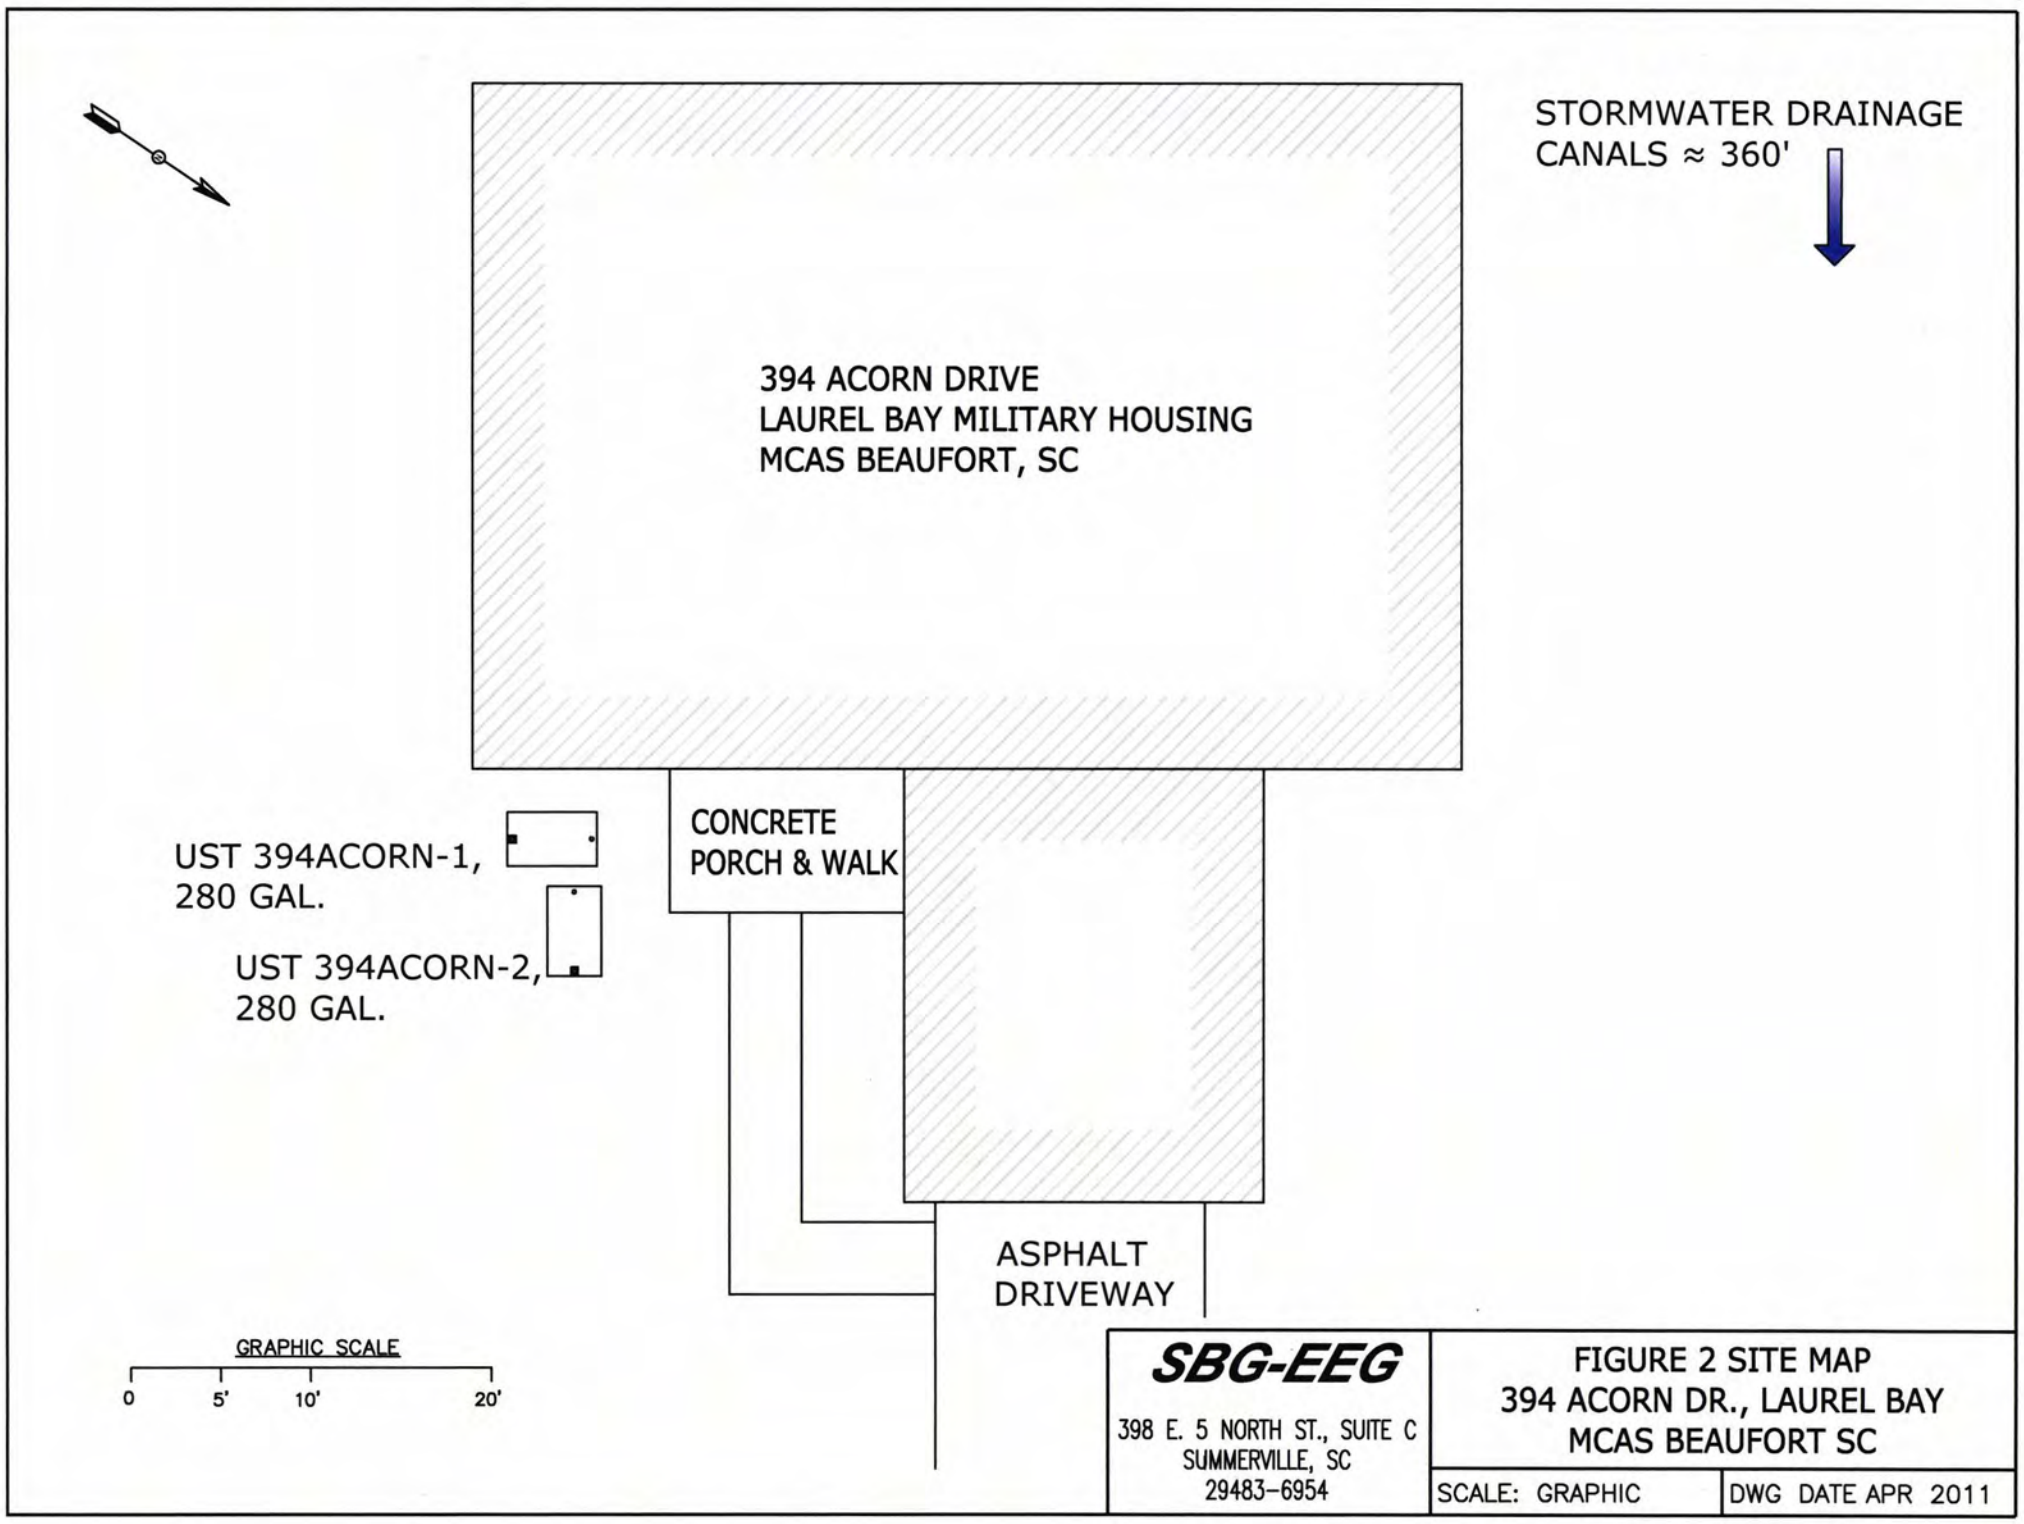
FIGURE 2 SITE MAP
394 ACORN DR., LAUREL BAY
MCAS BEAUFORT SC

On March 8, 2011, two 280 gallon heating oil USTs were removed at 169 Acorn Drive (Formerly 394 Acorn Drive). Tank 1 was removed from the landscaped bed area, adjacent to the front concrete porch. Tank 2 was removed from the grassed area, adjacent to Tank 1 and the front concrete walk. The former UST locations are indicated in Figures 2 and 3 of the UST

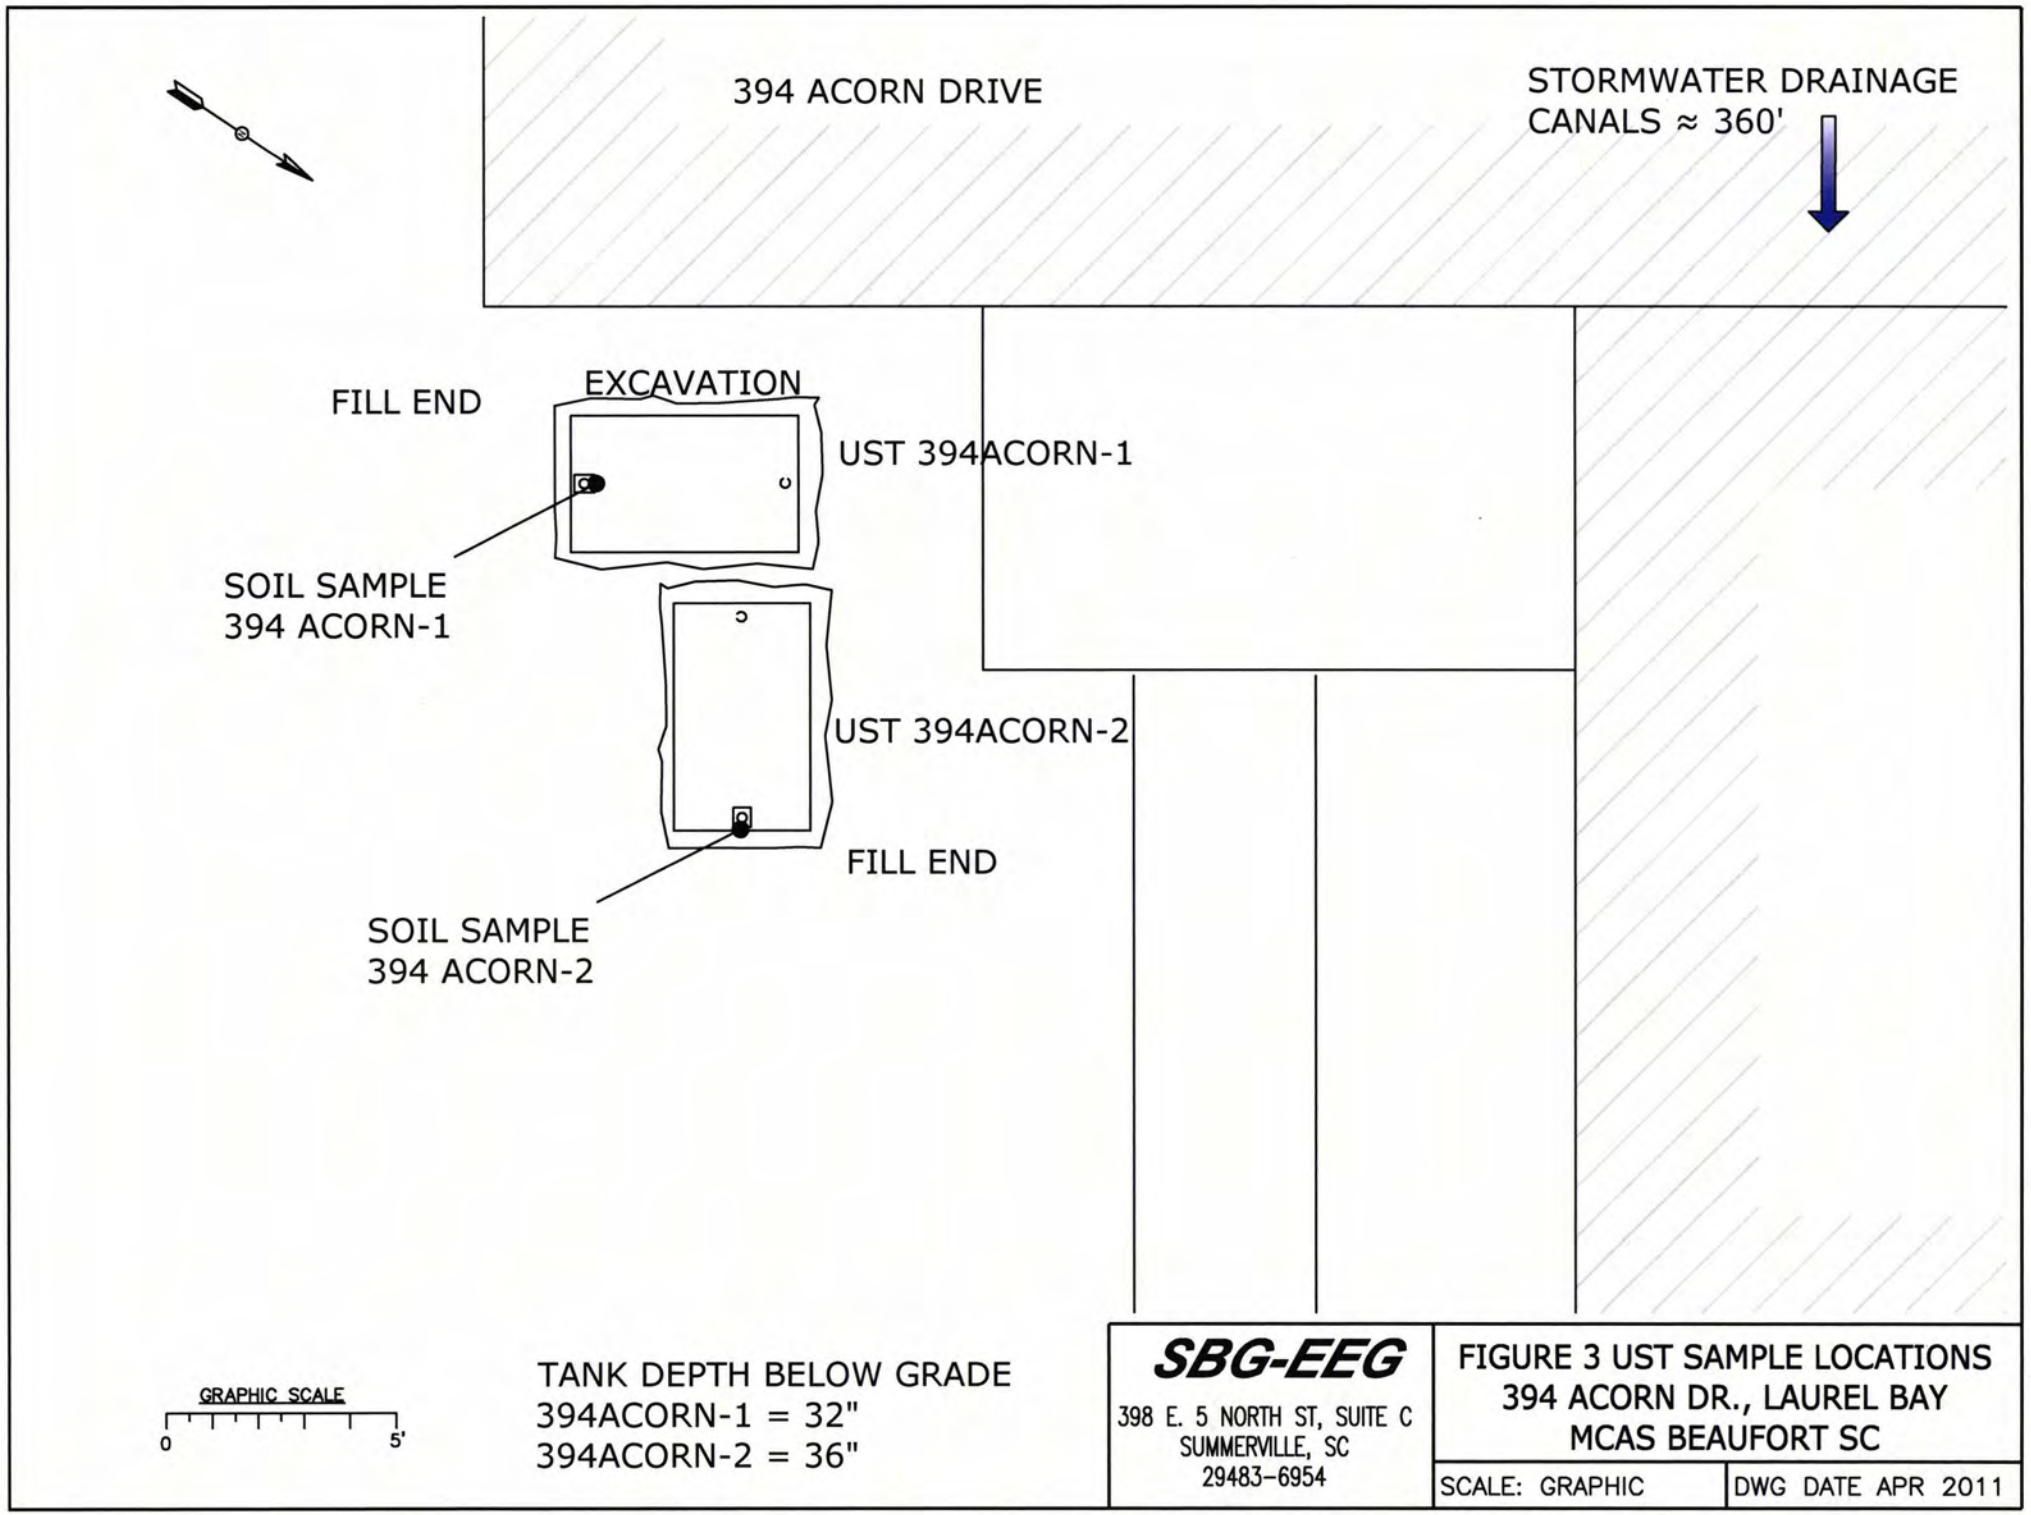
FIGURE 3 UST SAMPLE LOCATIONS
394 ACORN DR., LAUREL BAY
MCAS BEAUFORT SC

Following UST removal, a soil sample was collected from the base of each excavation and shipped to an offsite laboratory for analysis of the petroleum COPCs. Sampling was performed in accordance with applicable South Carolina regulation R.61-92, Part 280 (SCDHEC, 2017) and assessment guidelines.
