SUMMARY REPORT
20 ELDERBERRY DRIVE (FORMERLY 401 ELDERBERRY DRIVE)
LAUREL BAY MILITARY HOUSING AREA
MARINE CORPS AIR STATION BEAUFORT
BEAUFORT, SC

Contract Number: N62470-14-D-9016
CTO WE52
JUNE 2021

Underground Storage Tank (UST) Assessment Report

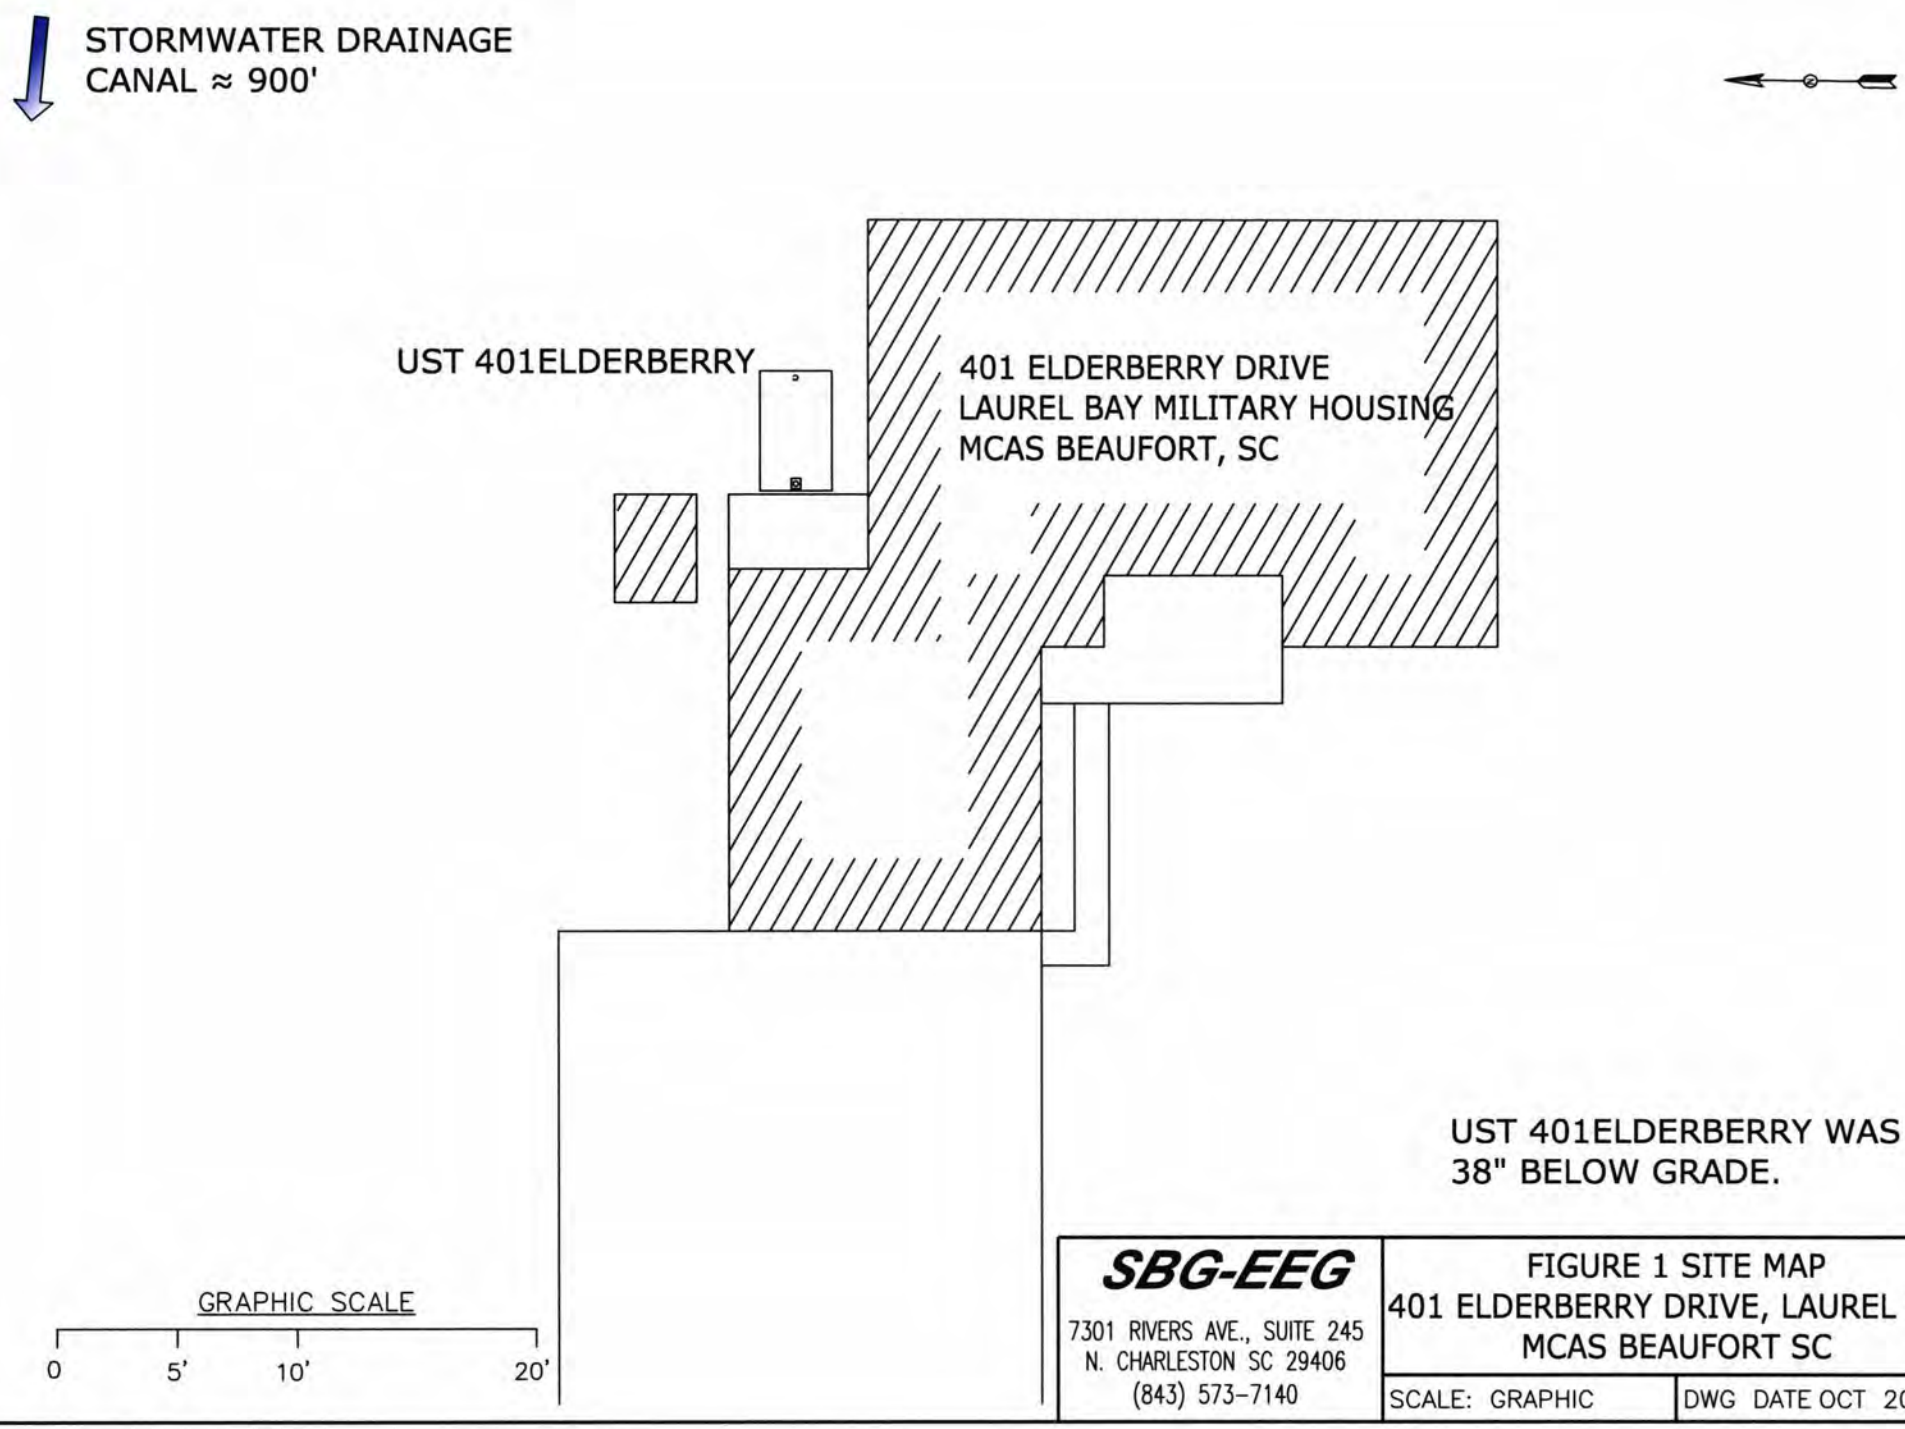
FIGURE 1 SITE MAP
401 ELDERBERRY DRIVE, LAUREL BAY
MCAS BEAUFORT SC

On September 25, 2014, a single 280 gallon heating oil UST was removed from the back yard adjacent to the rear patio area at 20 Elderberry Drive (Formerly 401 Elderberry Drive). The former UST location is indicated on Figures 1 and 2 of the UST Assessment Report (Appendix B). The UST was removed and properly disposed of (i.e., shipped offsite for recycling or transported to a landfill). There was no visual evidence (i.e., staining or sheen) of petroleum impact at the time of the UST removal. According to the UST Assessment Report (Appendix B), the depth to the base of the UST was 6’2” bgs and a single soil sample was collected from that

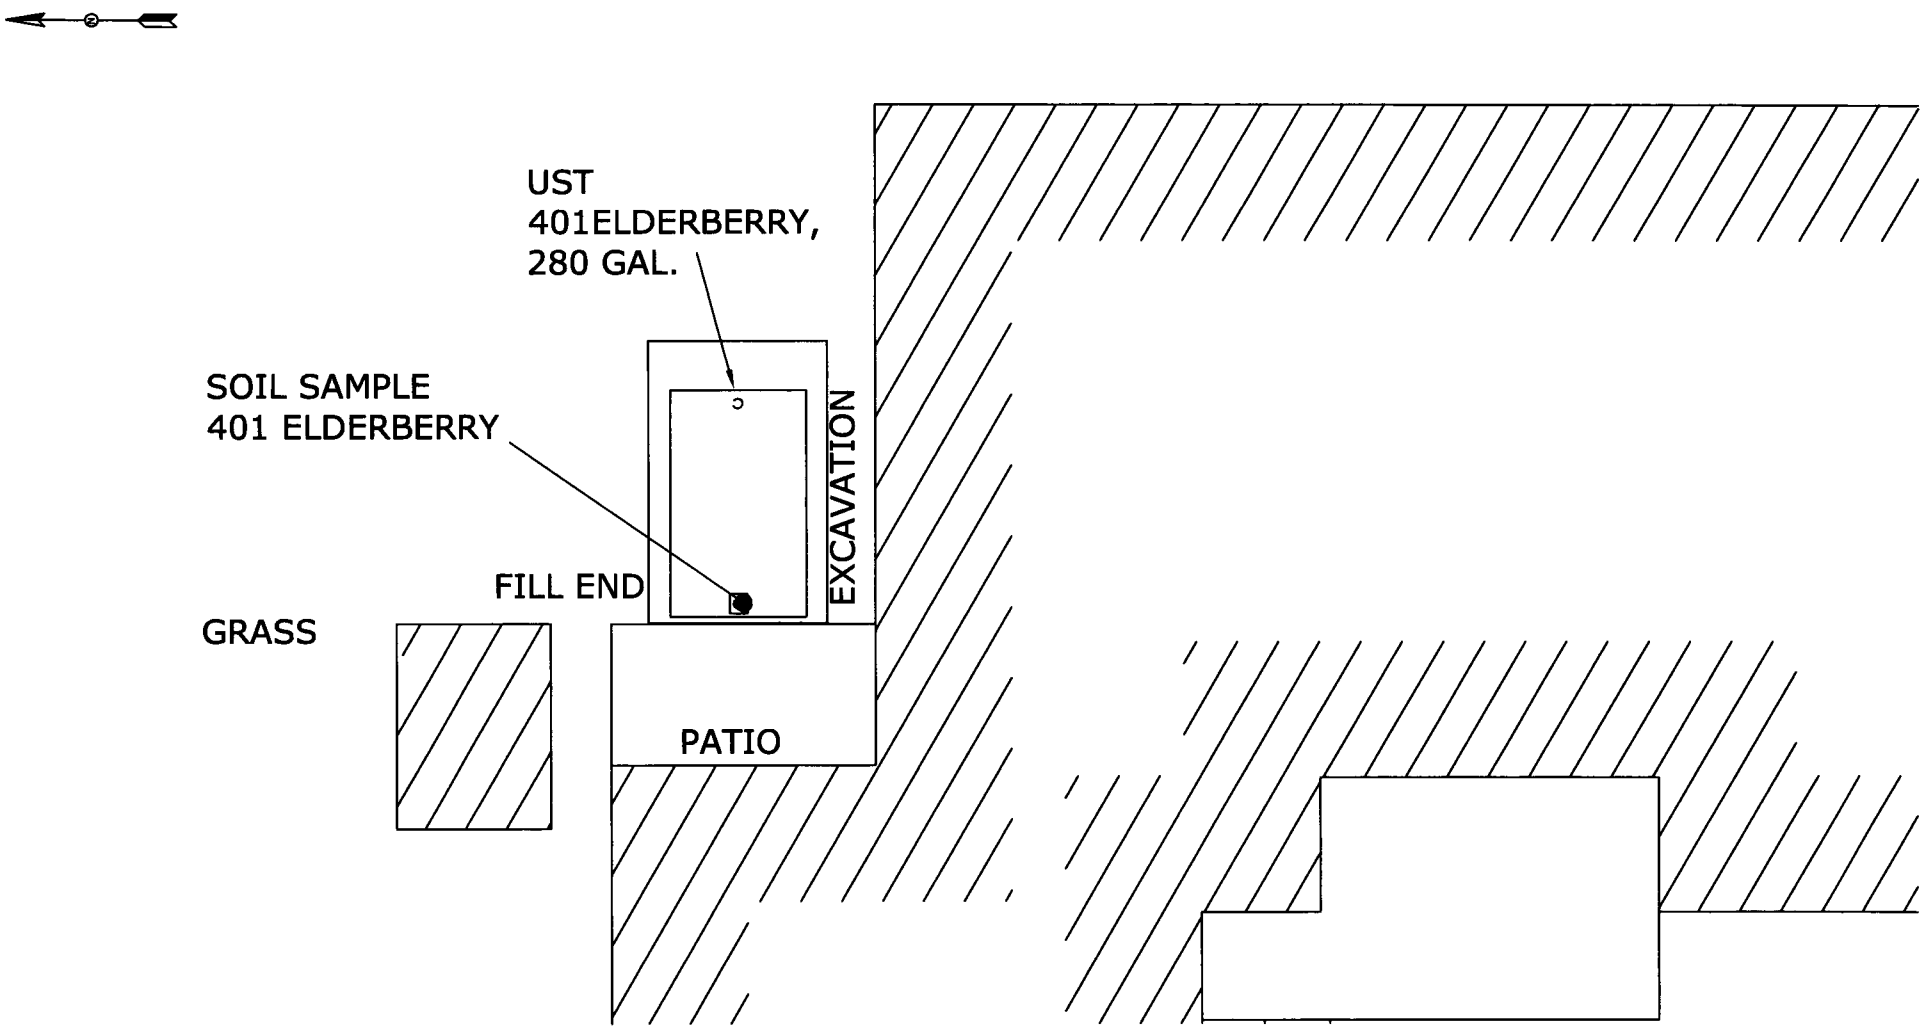
FIGURE 2 UST SAMPLE LOCATIONS
401 ELDERBERRY DRIVE, LAUREL BAY
MCAS BEAUFORT SC

depth. The sample was collected from the fill port side of the former UST to represent a worst case scenario.
