SUMMARY REPORT
194 ELDERBERRY DRIVE (FORMERLY 421 ELDERBERRY DRIVE)
LAUREL BAY MILITARY HOUSING AREA
MARINE CORPS AIR STATION BEAUFORT
BEAUFORT, SC

JUNE 2021

CDM - AECOM Multimedia Joint Venture
10560 Arrowhead Drive, Suite 500
Fairfax, Virginia 22030

Contract Number: N62470-14-D-9016
CTO WE52
JUNE 2021

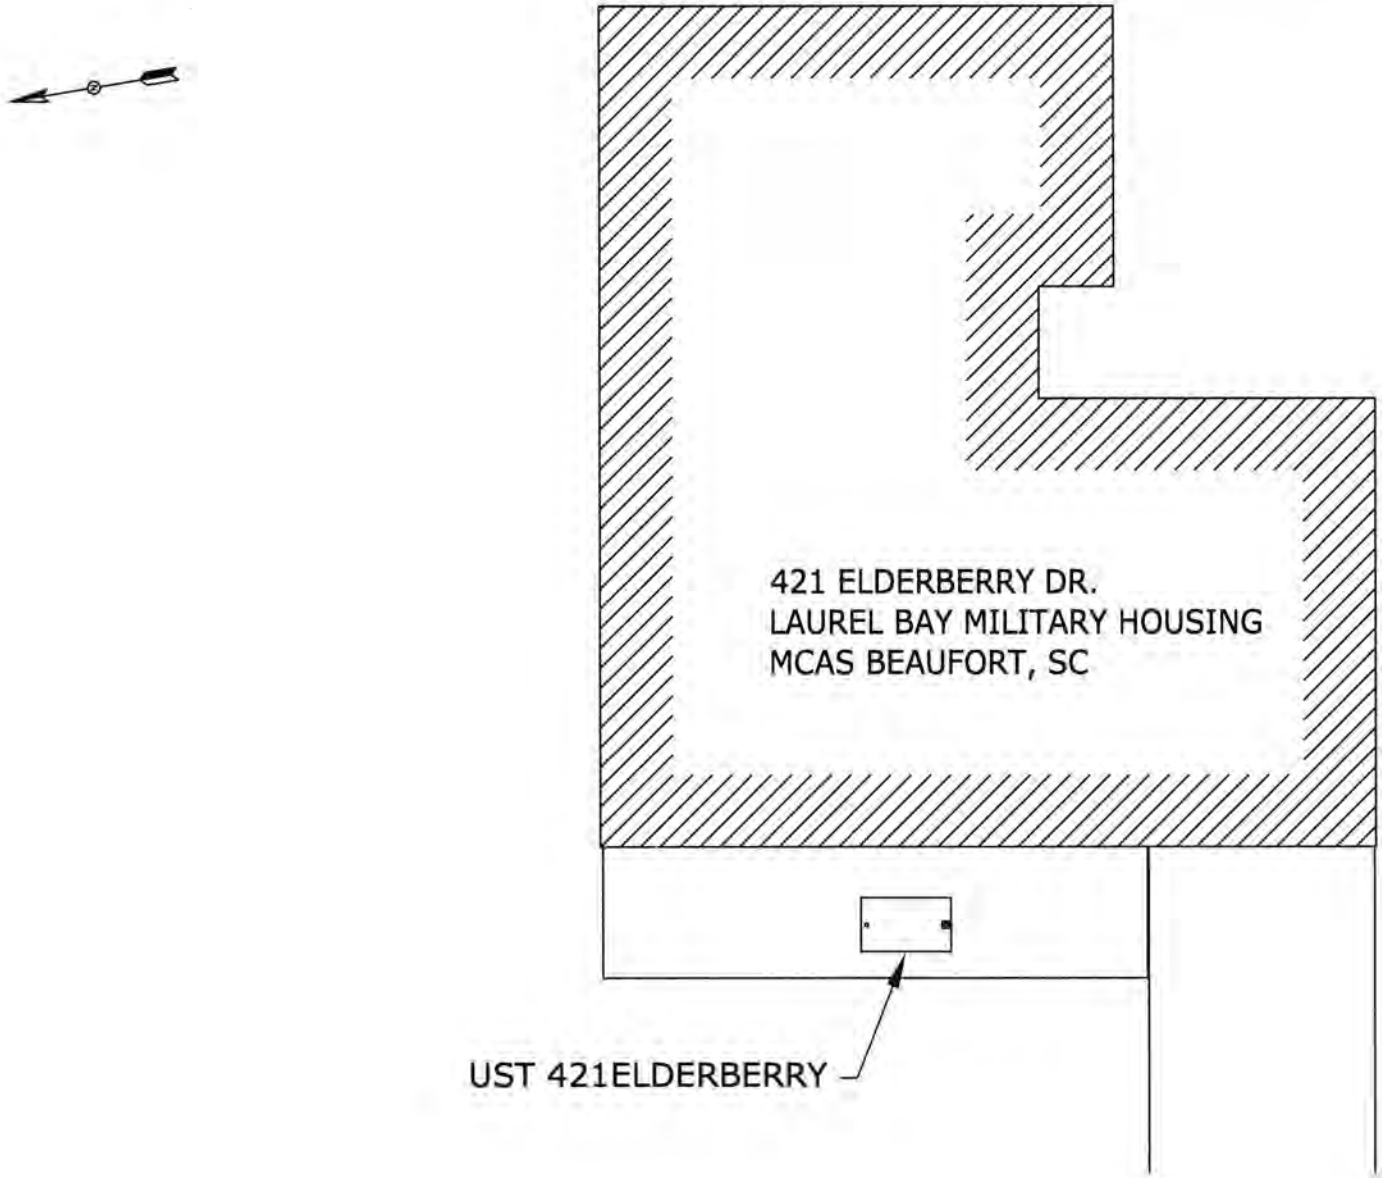
FIGURE 2 SITE MAP
421 ELDERBERRY DR., LAUREL BAY
MCAS BEAUFORT SC

TANK DEPTH BELOW GRADE
421ELDERBERRY = 36"

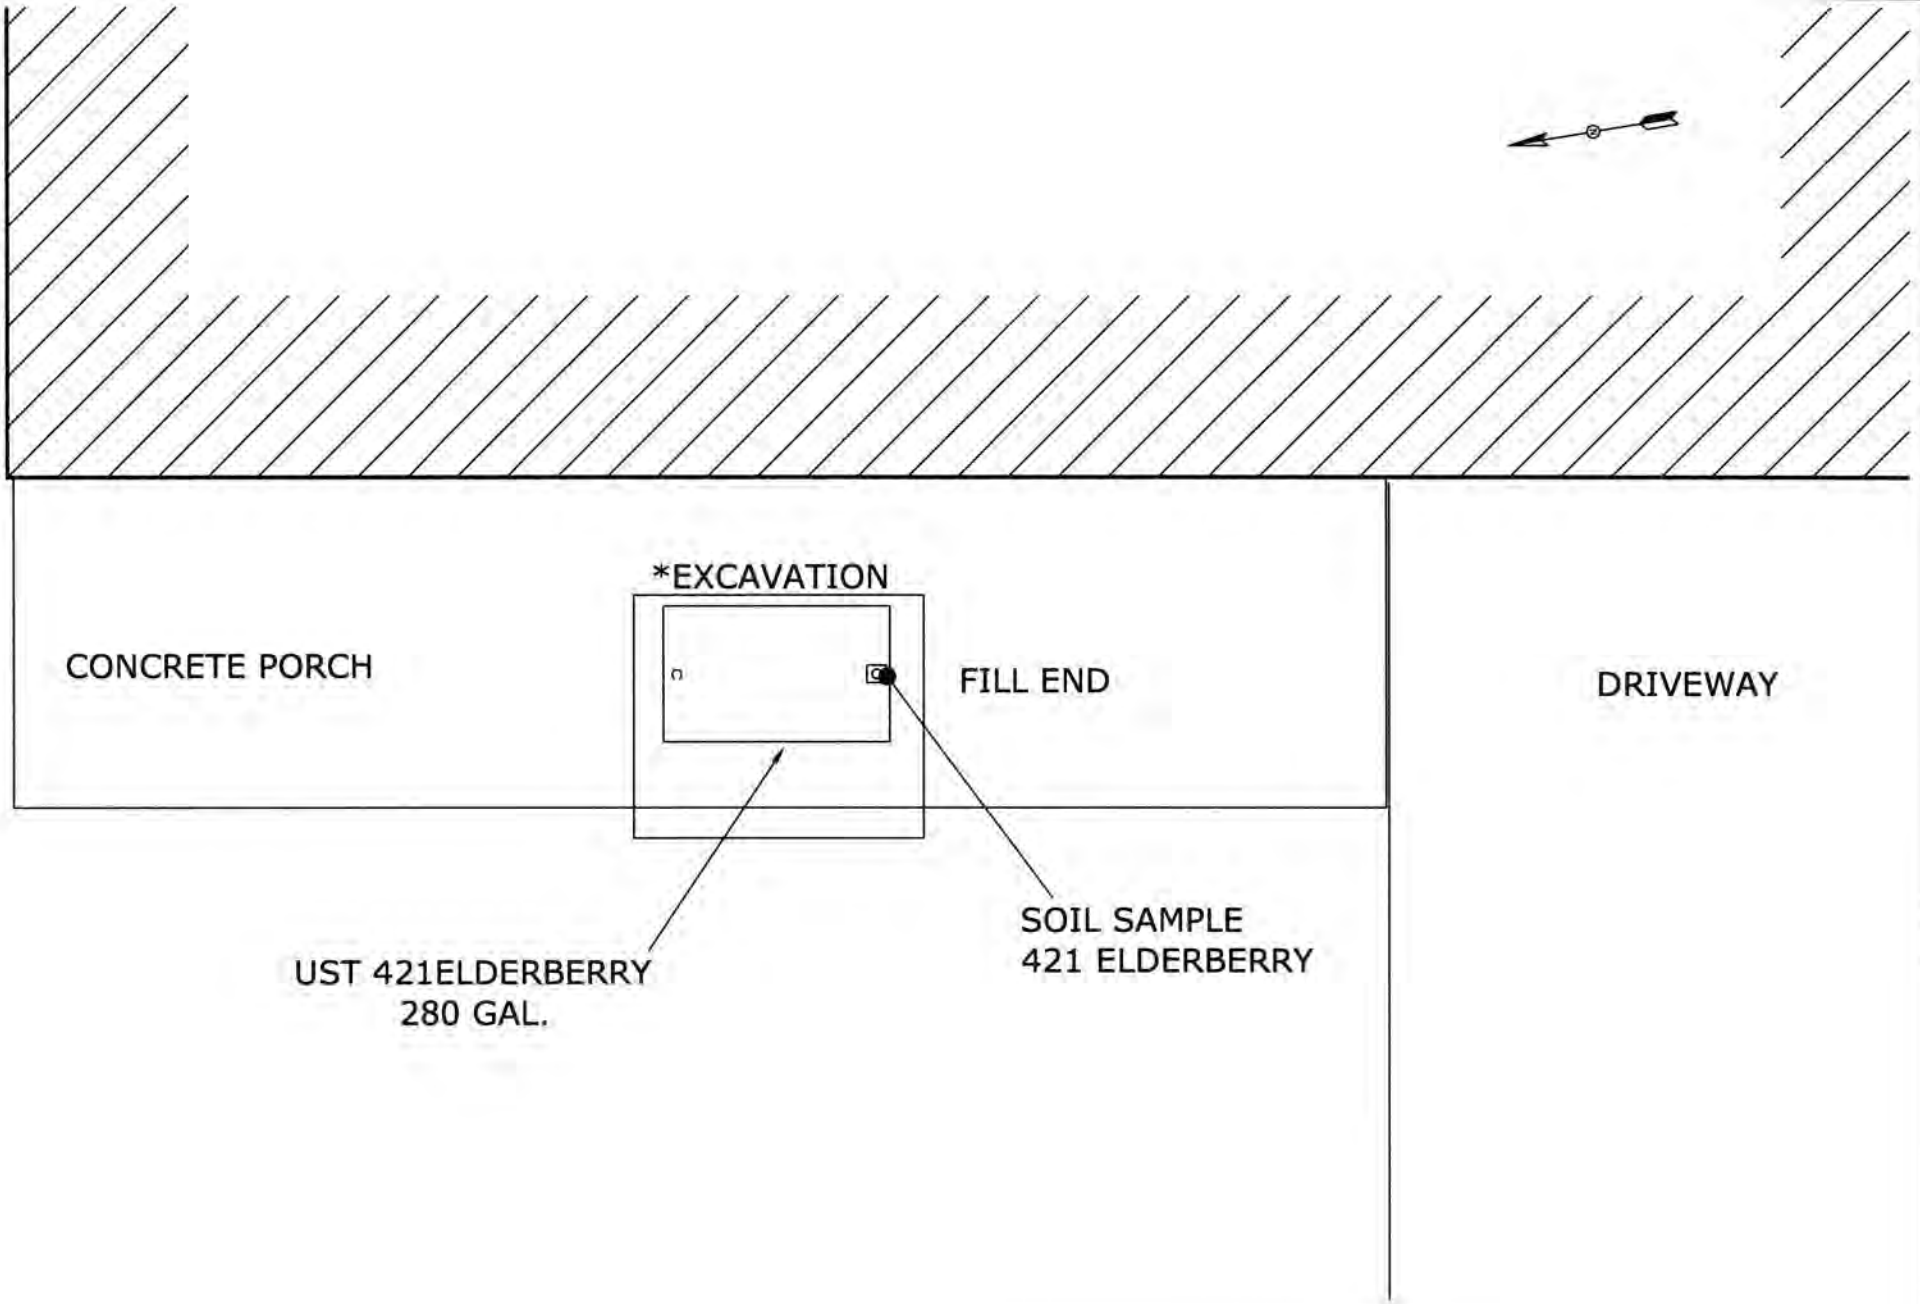
FIGURE 3 UST SAMPLE LOCATIONS
421 ELDERBERRY DR., LAUREL BAY
MCAS BEAUFORT SC

*A PORTION OF THE PORCH WAS REMOVED TO FACILITATE TANK EXTRACTION.
