SUMMARY REPORT
405 ELDERBERRY DRIVE (FORMERLY 440 ELDERBERRY DRIVE)
LAUREL BAY MILITARY HOUSING AREA
MARINE CORPS AIR STATION BEAUFORT
BEAUFORT, SC

JUNE 2021

CDM - AECOM Multimedia Joint Venture
10560 Arrowhead Drive, Suite 500
Fairfax, Virginia 22030

Contract Number: N62470-14-D-9016 CTO WE52
JUNE 2021

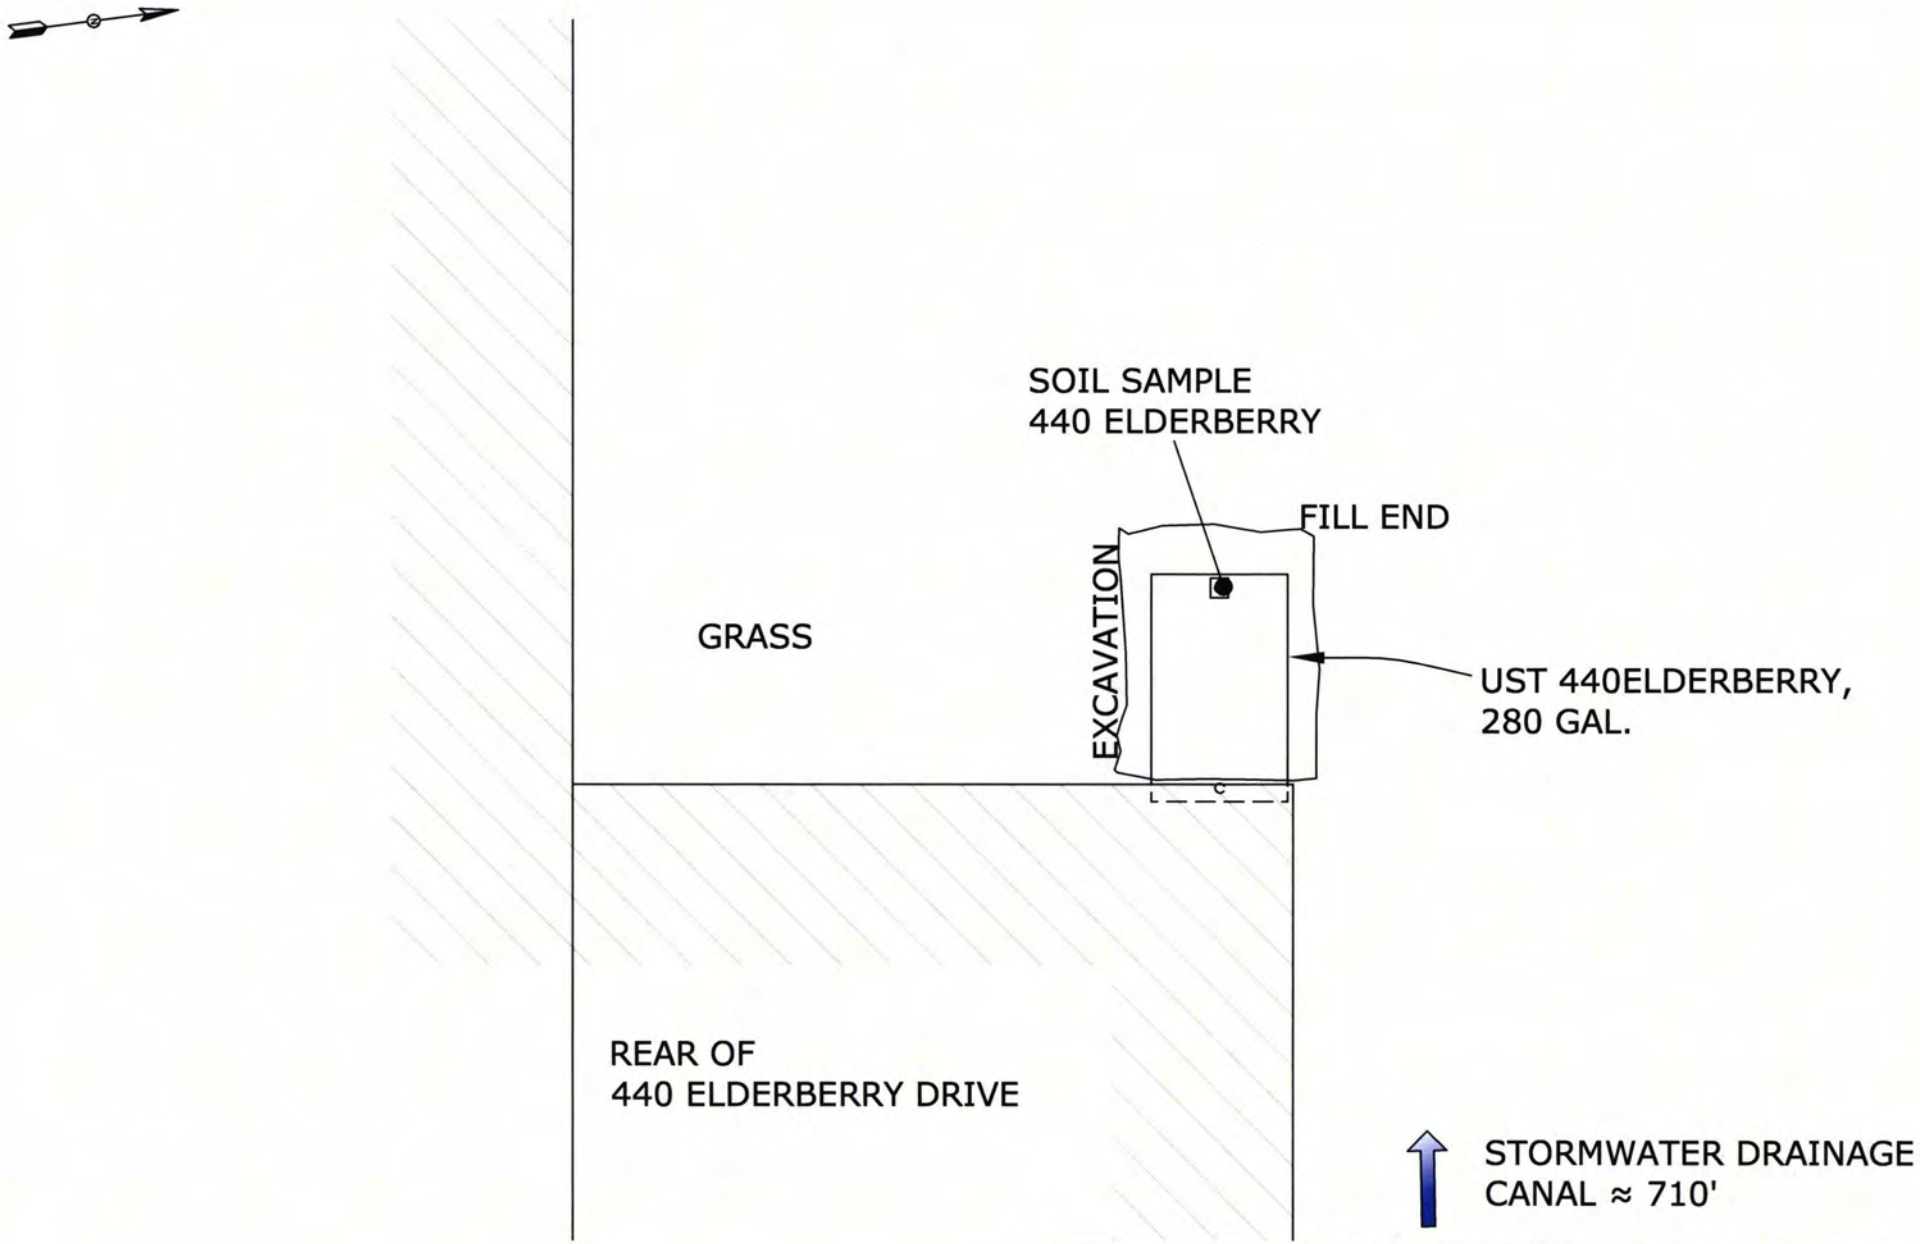
FIGURE 2 SITE MAP
440 ELDERBERRY DR., LAUREL BAY
MCAS BEAUFORT SC

UST 440ELDERBERRY WAS
24" BELOW GRADE.
