SUMMARY REPORT
421 ELDERBERRY DRIVE (FORMERLY 442 ELDERBERRY DRIVE)
LAUREL BAY MILITARY HOUSING AREA
MARINE CORPS AIR STATION BEAUFORT
BEAUFORT, SC

JUNE 2021

CDM - AECOM Multimedia Joint Venture
10560 Arrowhead Drive, Suite 500
Fairfax, Virginia 22030

Contract Number: N62470-14-D-9016
CTO WE52
JUNE 2021

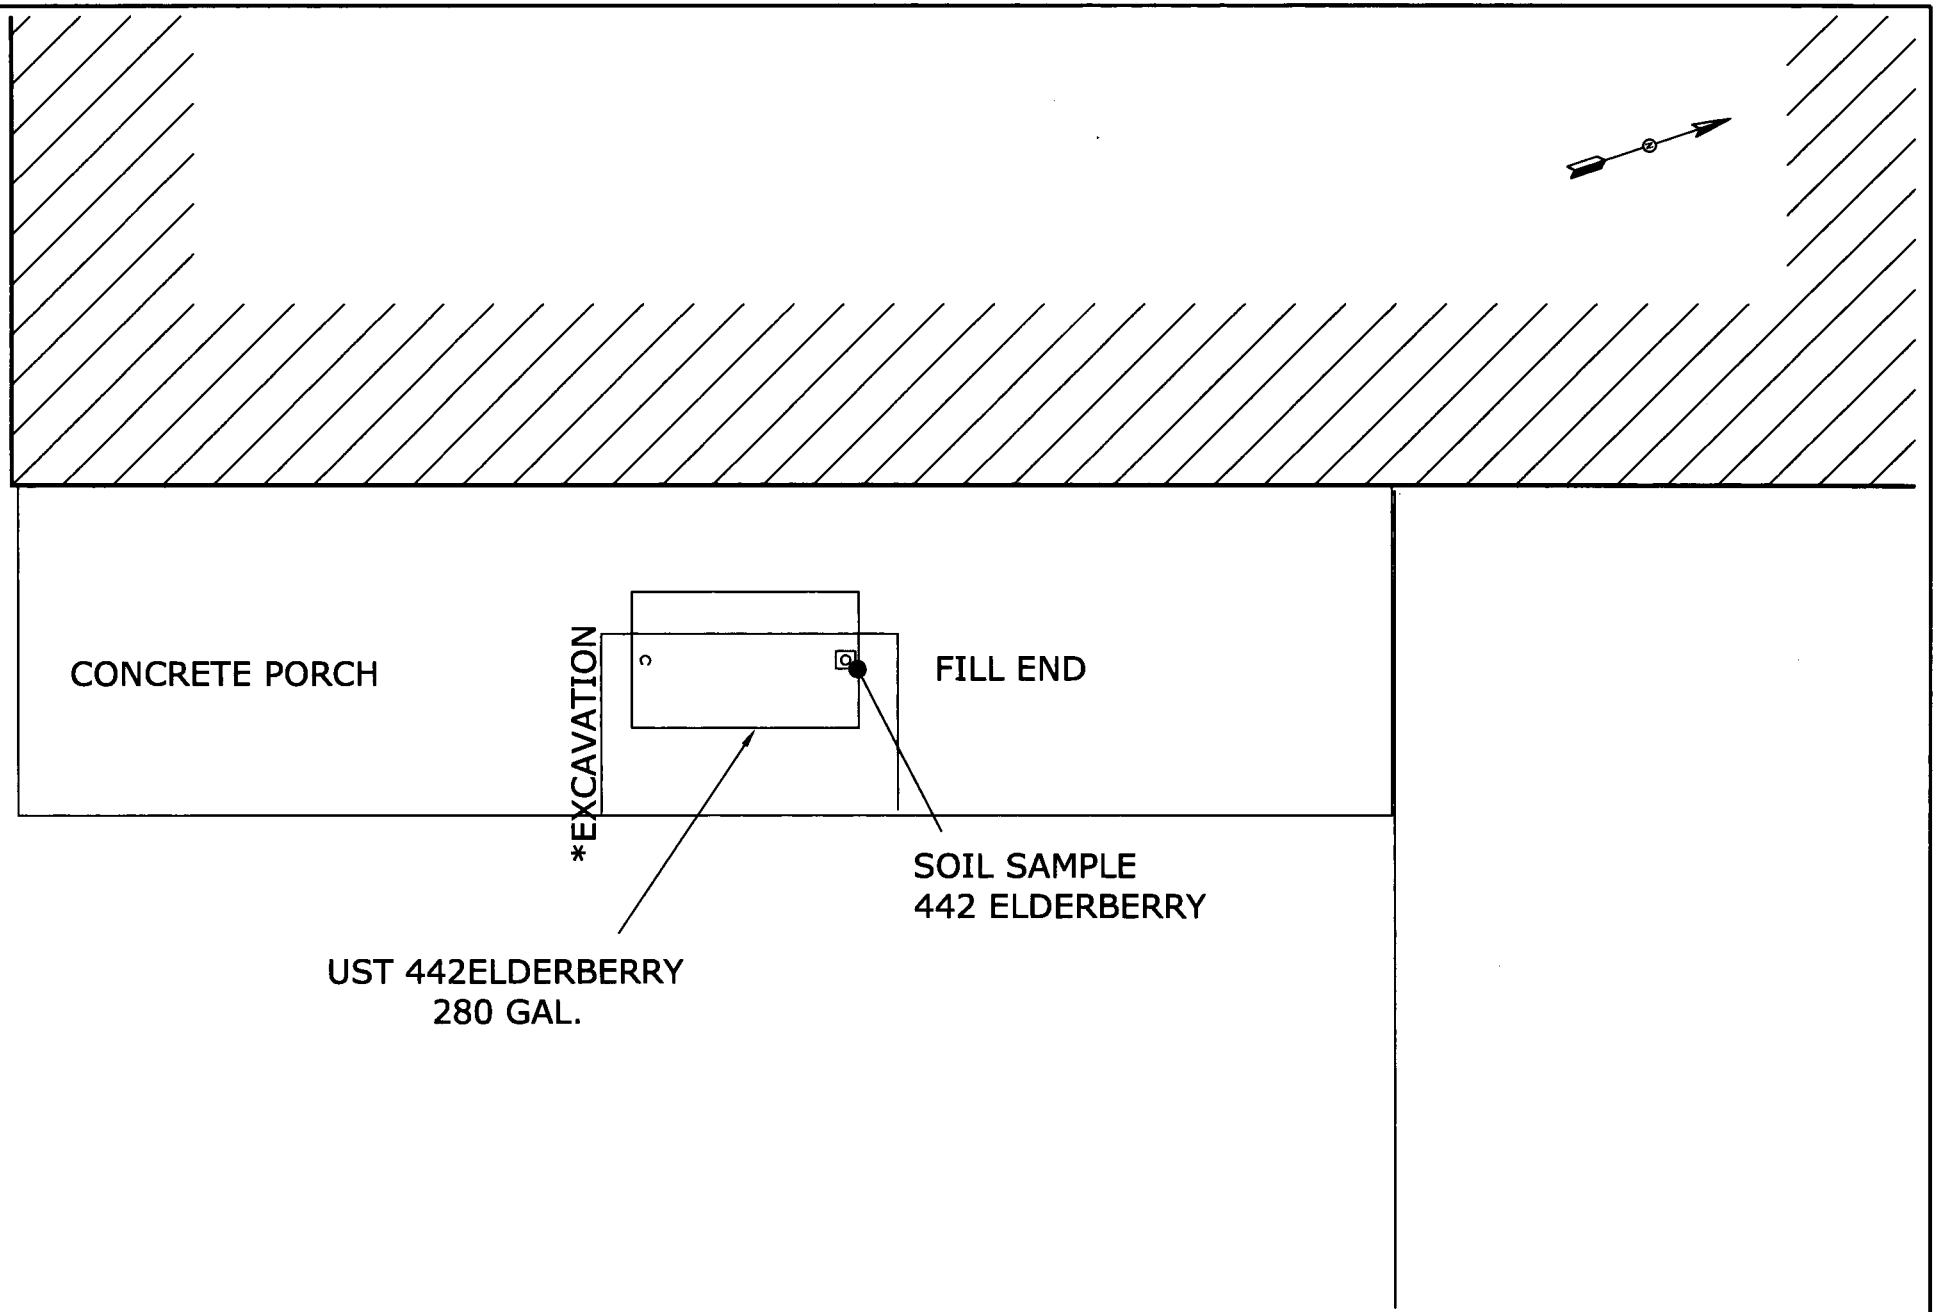
FIGURE 2 SITE MAP
442 ELDERBERRY DR., LAUREL BAY
MCAS BEAUFORT SC

*A PORTION OF THE PORCH WAS REMOVED TO FACILITATE TANK EXTRACTION.
