SUMMARY REPORT
473 ELDERBERRY DRIVE (FORMERLY 448 ELDERBERRY DRIVE)
LAUREL BAY MILITARY HOUSING AREA
MARINE CORPS AIR STATION BEAUFORT
BEAUFORT, SC

JUNE 2021

Contract Number: N62470-14-D-9016
CTO WE52
JUNE 2021

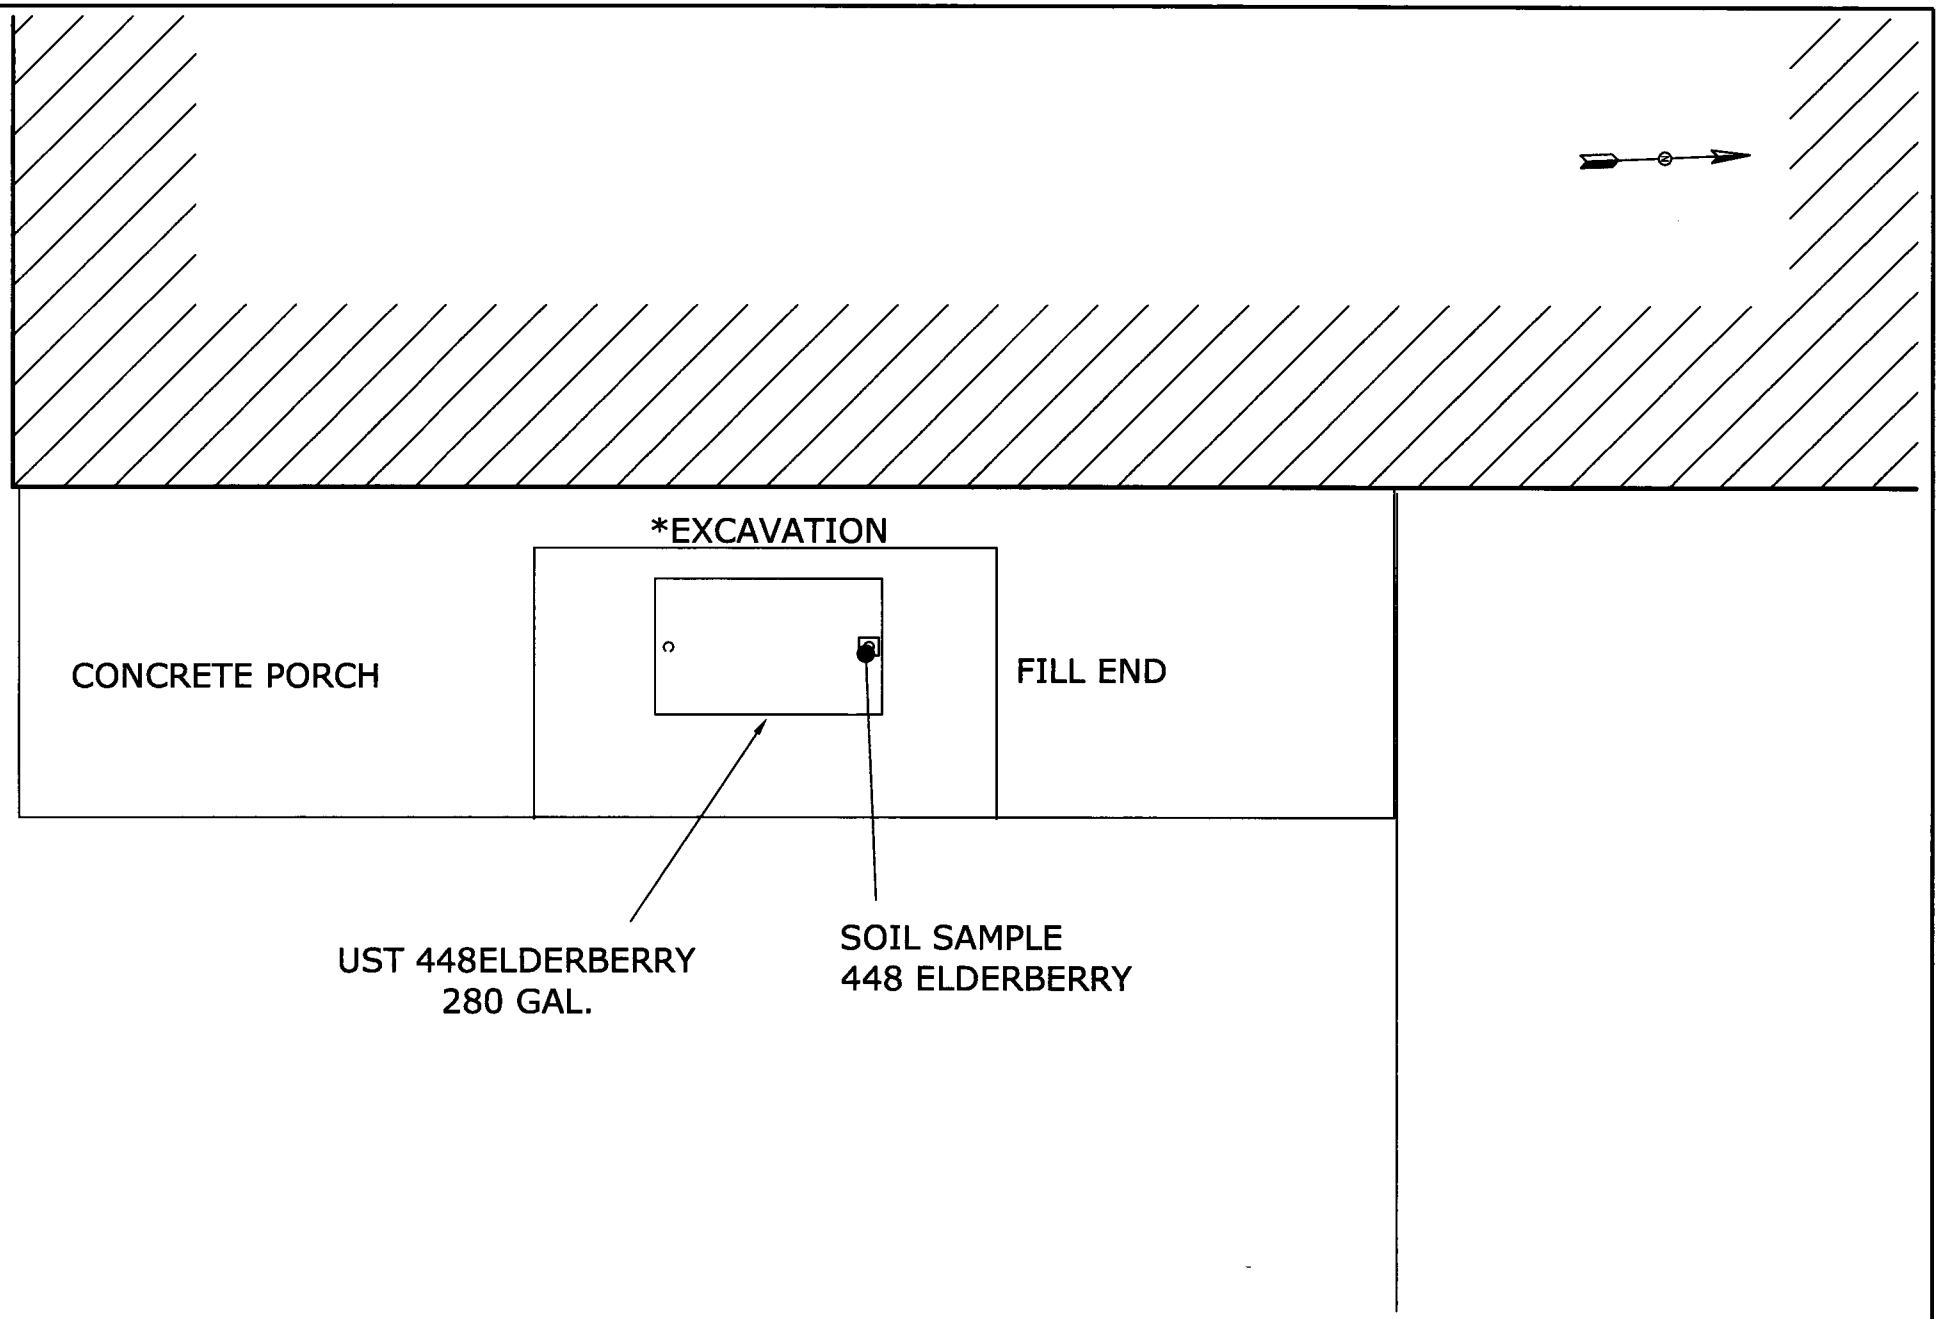
*A PORTION OF THE PORCH WAS REMOVED TO FACILITATE TANK EXTRACTION.
