SUMMARY REPORT
518 ELDERBERRY DRIVE (FORMERLY 453 ELDERBERRY DRIVE)
LAUREL BAY MILITARY HOUSING AREA
MARINE CORPS AIR STATION BEAUFORT
BEAUFORT, SC

JUNE 2021

Contract Number: N62470-14-D-9016
CTO WE52
JUNE 2021

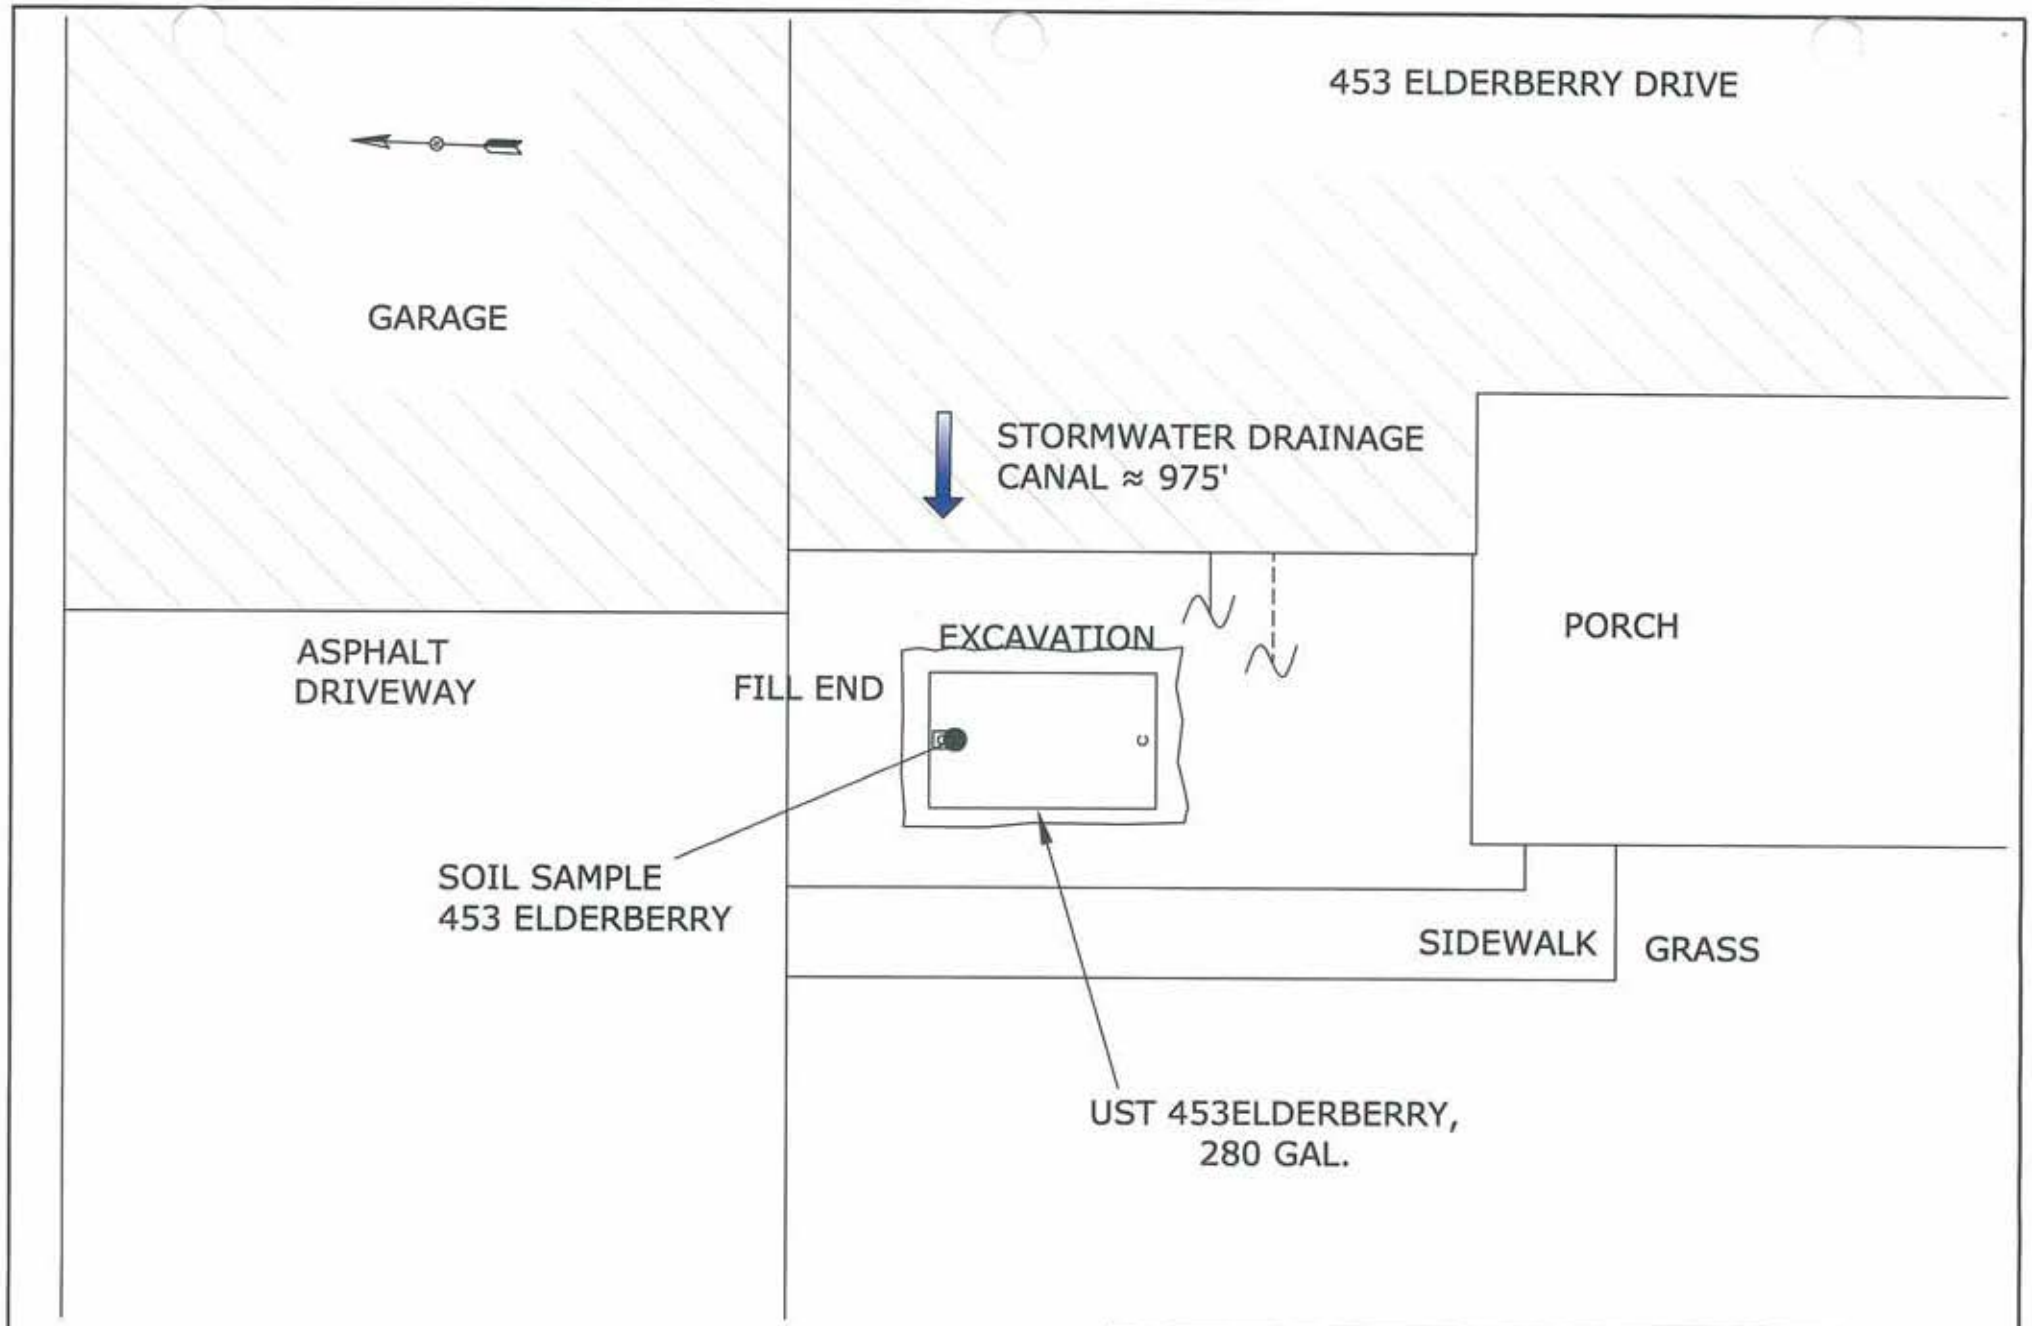
FIGURE 3 UST SAMPLE LOCATIONS
453 ELDERBERRY DR., LAUREL BAY
MCAS BEAUFORT SC

Picture 1: Location of UST 453Elderberry.

Picture 2: UST 453Elderberry excavation in progress.
