SUMMARY REPORT
551 ELDERBERRY DRIVE (FORMERLY 458 ELDERBERRY DRIVE)
LAUREL BAY MILITARY HOUSING AREA
MARINE CORPS AIR STATION BEAUFORT
BEAUFORT, SC

JUNE 2021

CDM - AECOM Multimedia Joint Venture
10560 Arrowhead Drive, Suite 500
Fairfax, Virginia 22030

Contract Number: N62470-14-D-9016
CTO WE52
JUNE 2021

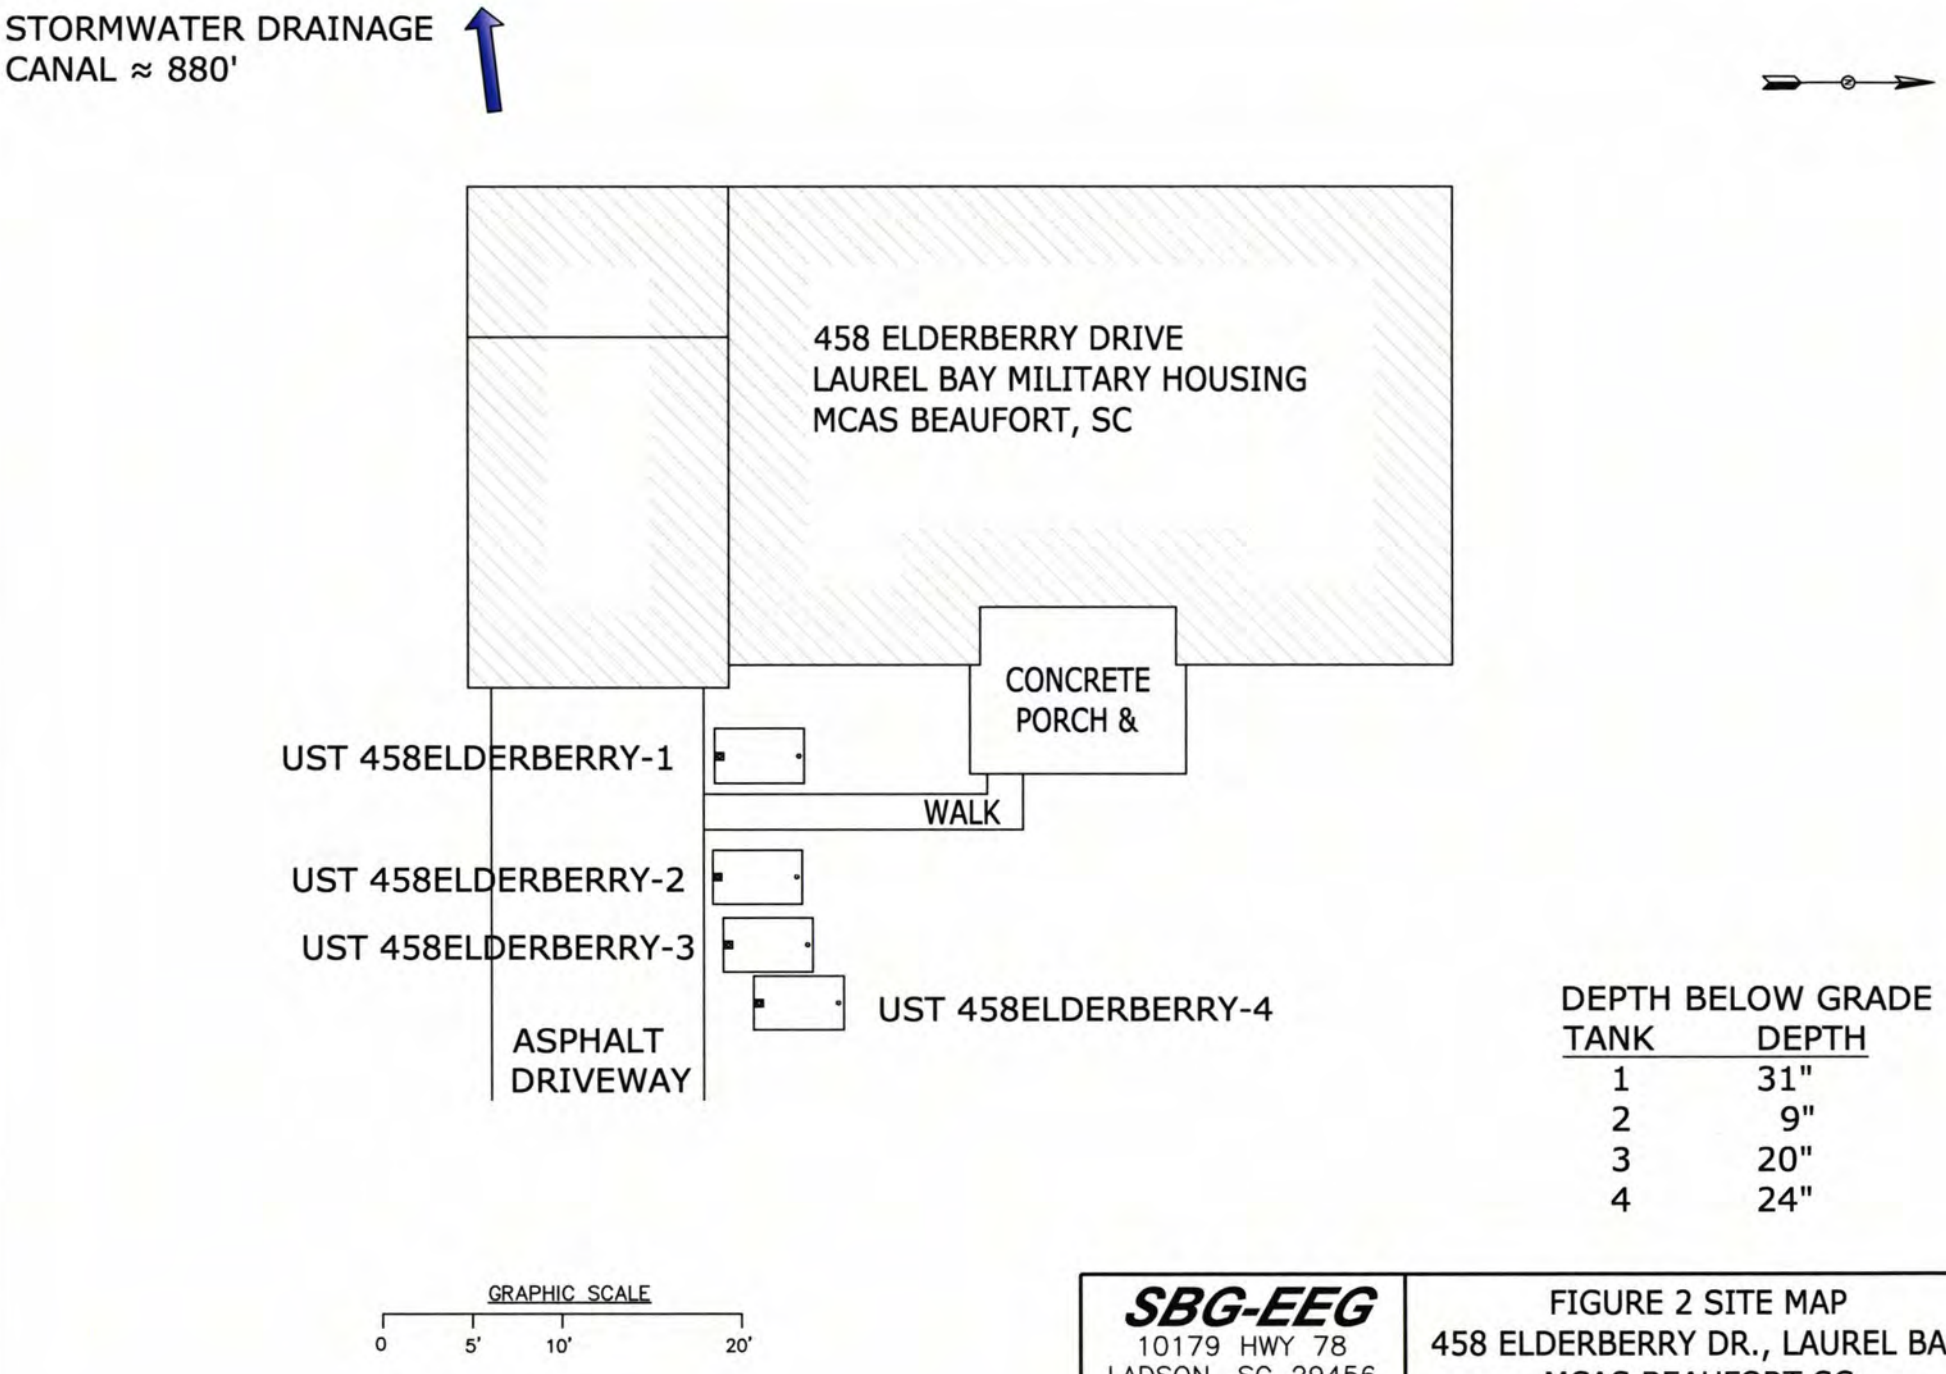
FIGURE 2 SITE MAP
458 ELDERBERRY DR., LAUREL BAY
MCAS BEAUFORT SC

DEPTH BELOW GRADE

TANK	DEPTH
1	31"
2	9"
3	20"
4	24"
