SUMMARY REPORT
565 ELDERBERRY DRIVE (FORMERLY 460 ELDERBERRY DRIVE)
LAUREL BAY MILITARY HOUSING AREA
MARINE CORPS AIR STATION BEAUFORT
BEAUFORT, SC

Contract Number: N62470-14-D-9016
CTO WE52
JUNE 2021

Underground Storage Tank (UST) Assessment Report

460 Elderberry Drive, Laurel Bay Military Housing Area
Street Address or State Road (as applicable)

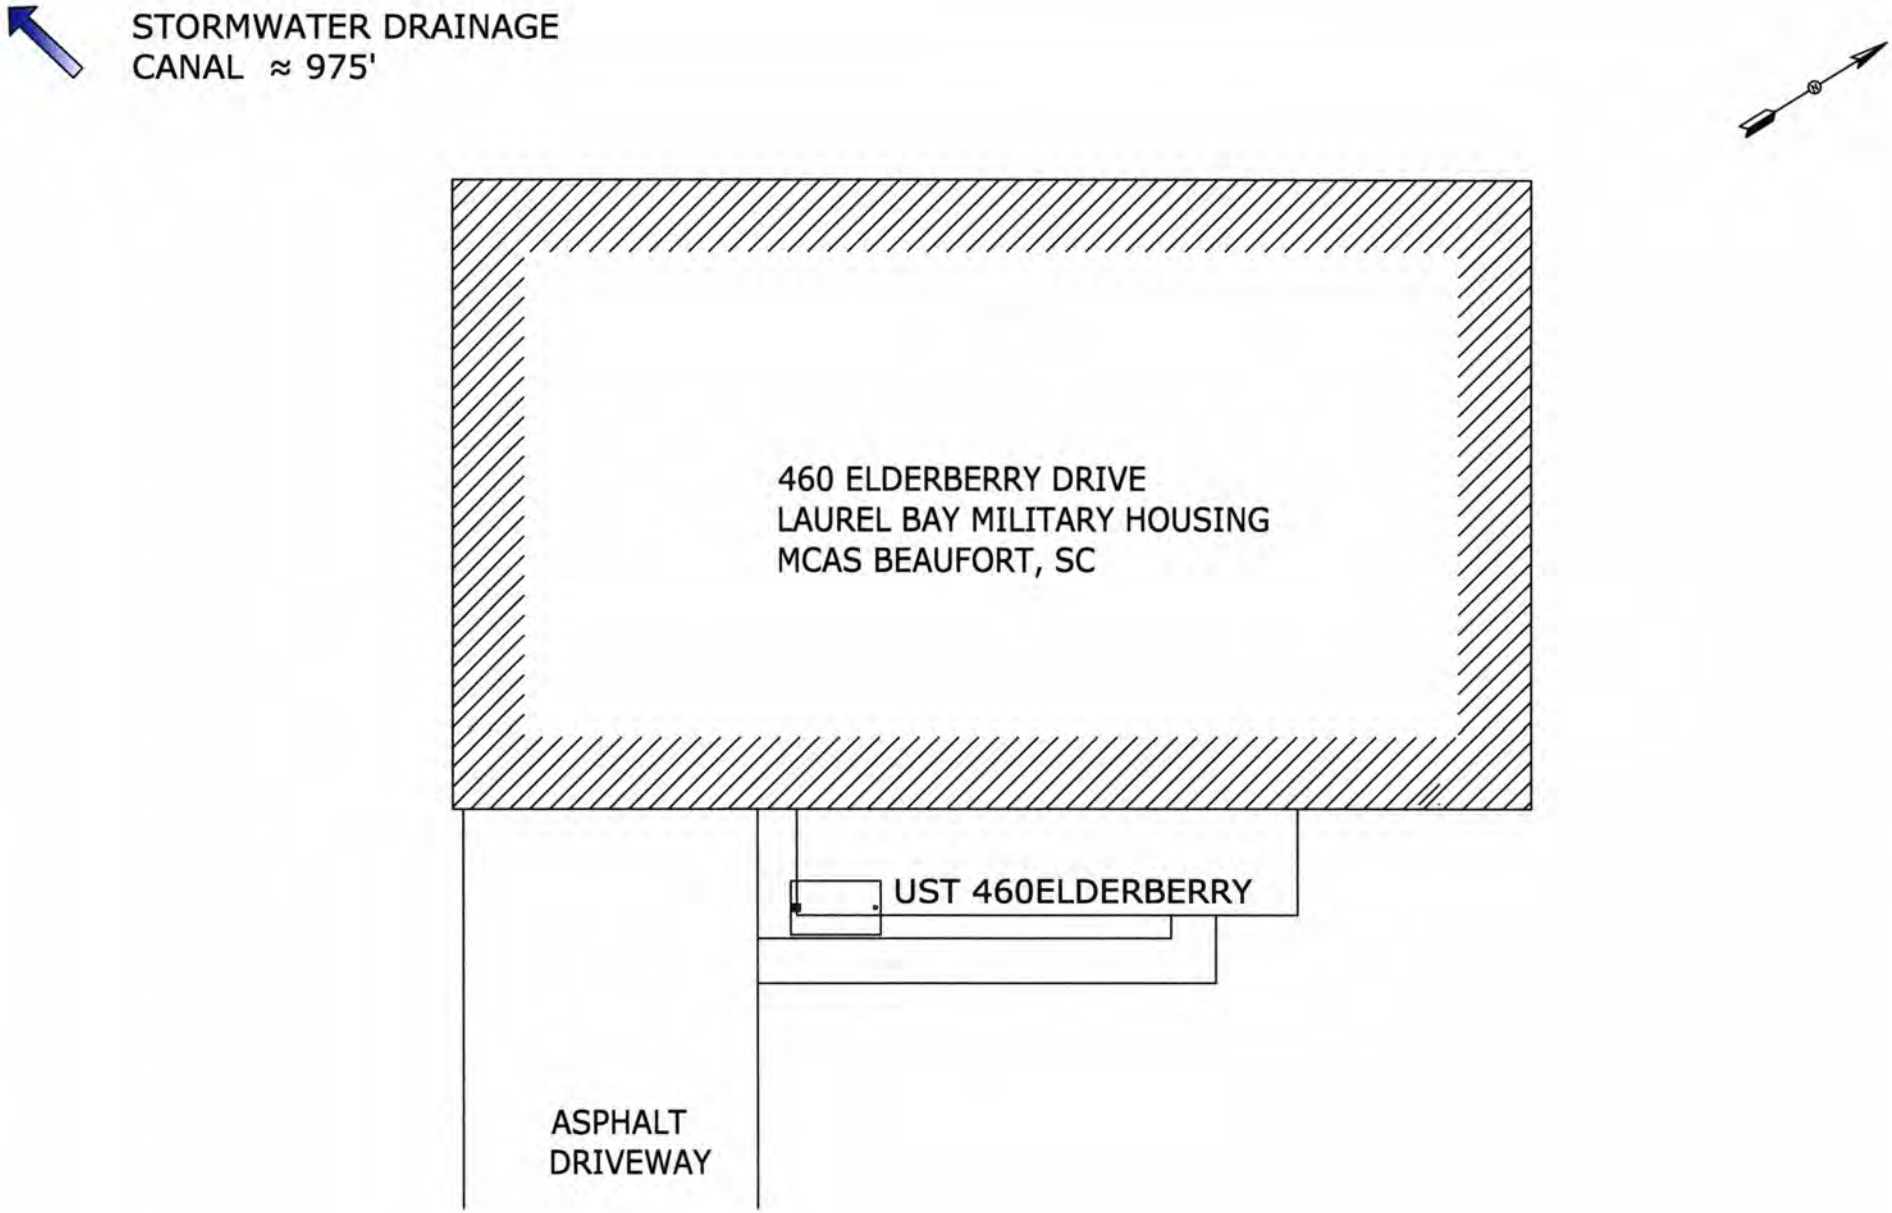
FIGURE 2 SITE MAP
460 ELDERBERRY DRIVE, LAUREL BAY
MCAS BEAUFORT SC

UST 460ELDERBERRY WAS 27" BELOW GRADE.

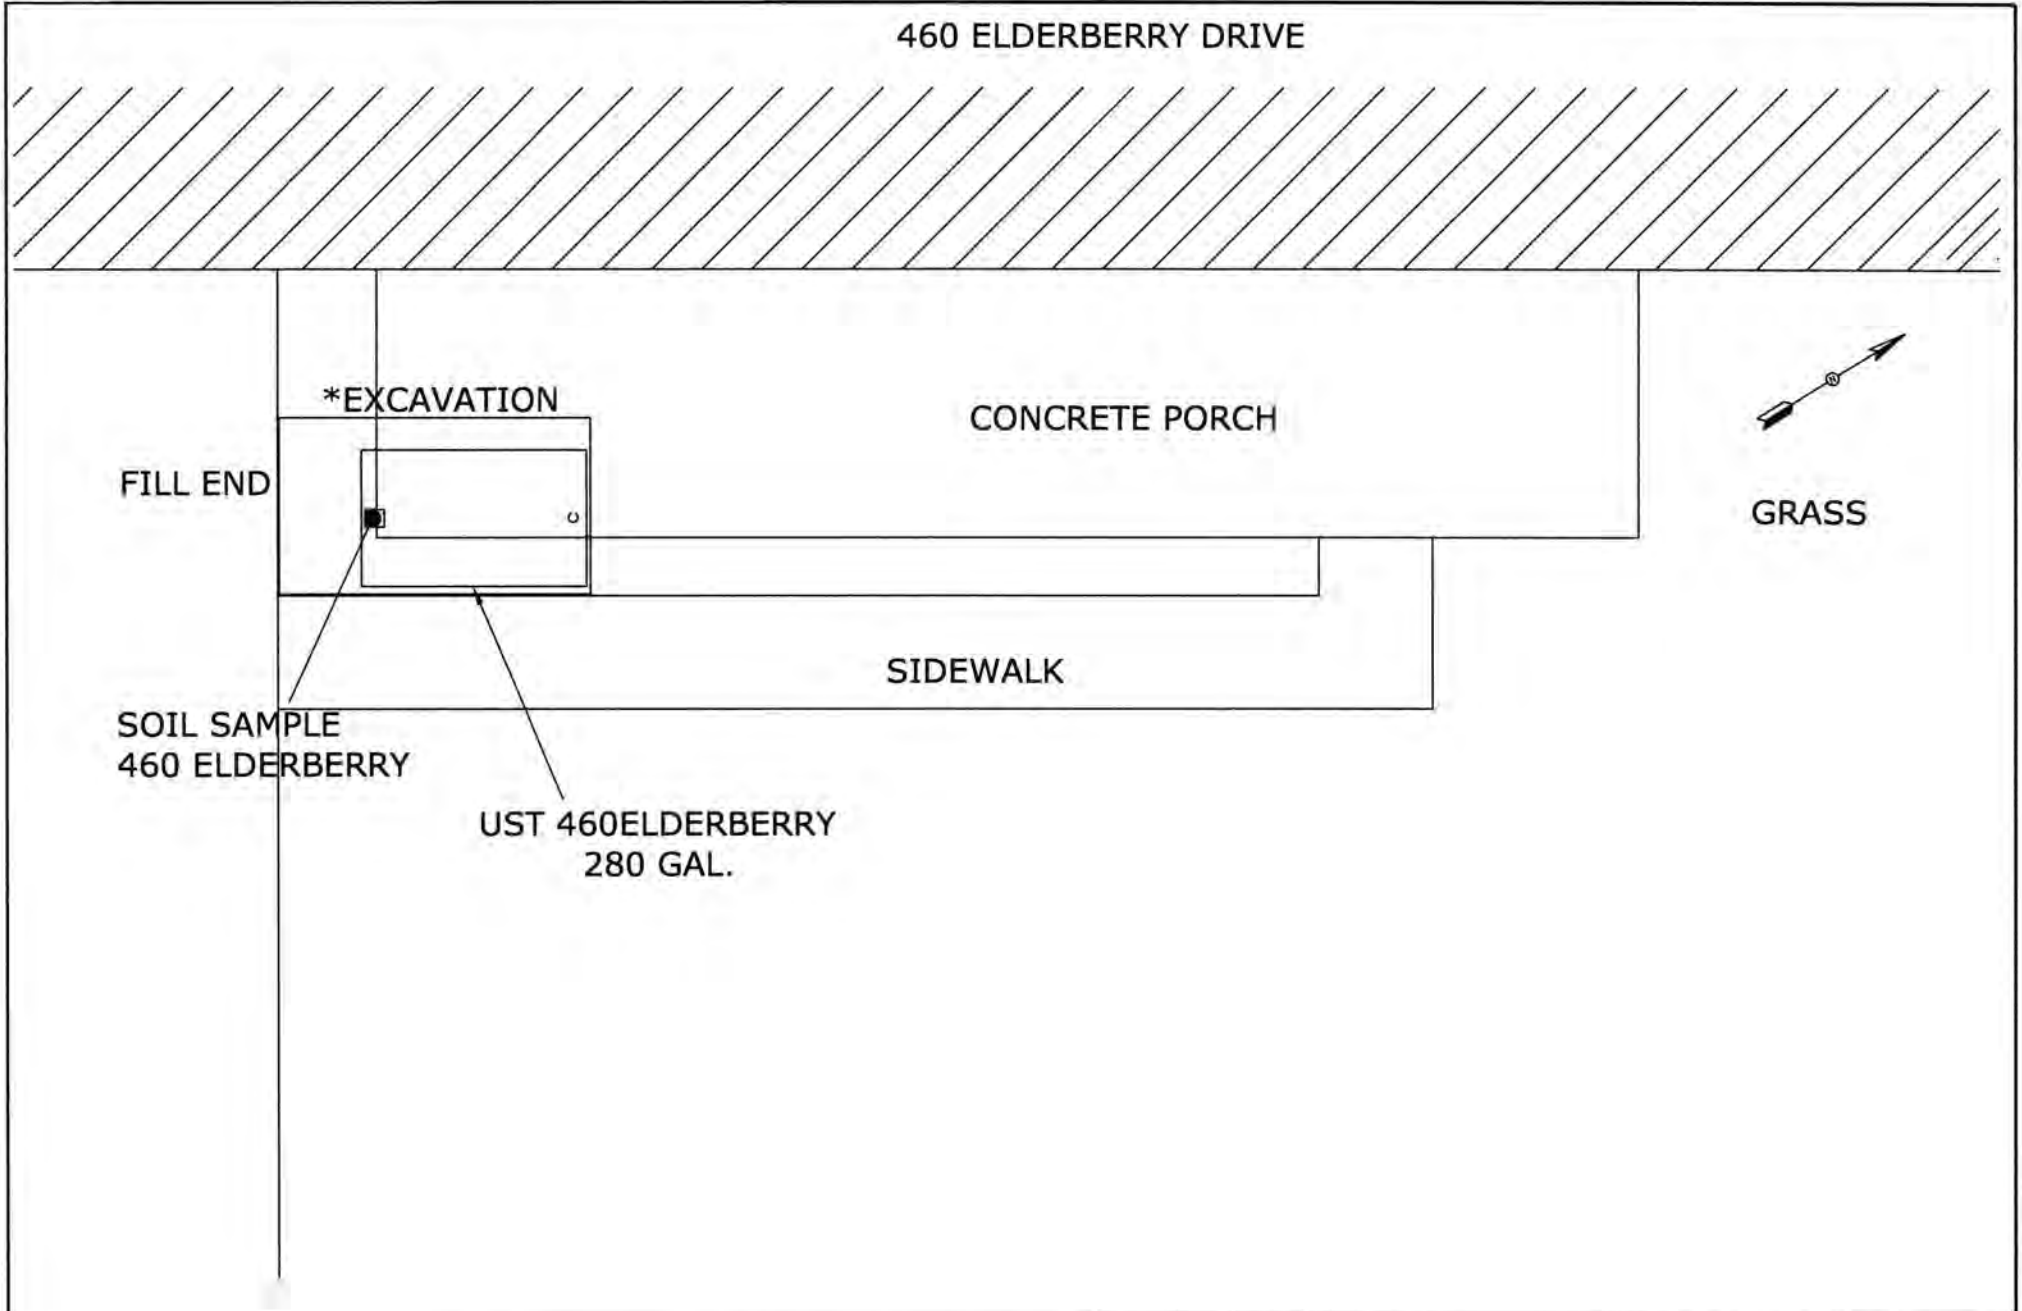
FIGURE 3 SITE MAP
460 ELDERBERRY DRIVE, LAUREL BAY
MCAS BEAUFORT SC

*A PORTION OF THE CONCRETE PORCH WAS REMOVED TO FACILITATE TANK EXTRACTION.
