SUMMARY REPORT

204 WEST LAUREL BAY BOULEVARD (FORMERLY 535 WEST LAUREL BAY BOULEVARD)

LAUREL BAY MILITARY HOUSING AREA

MARINE CORPS AIR STATION BEAUFORT

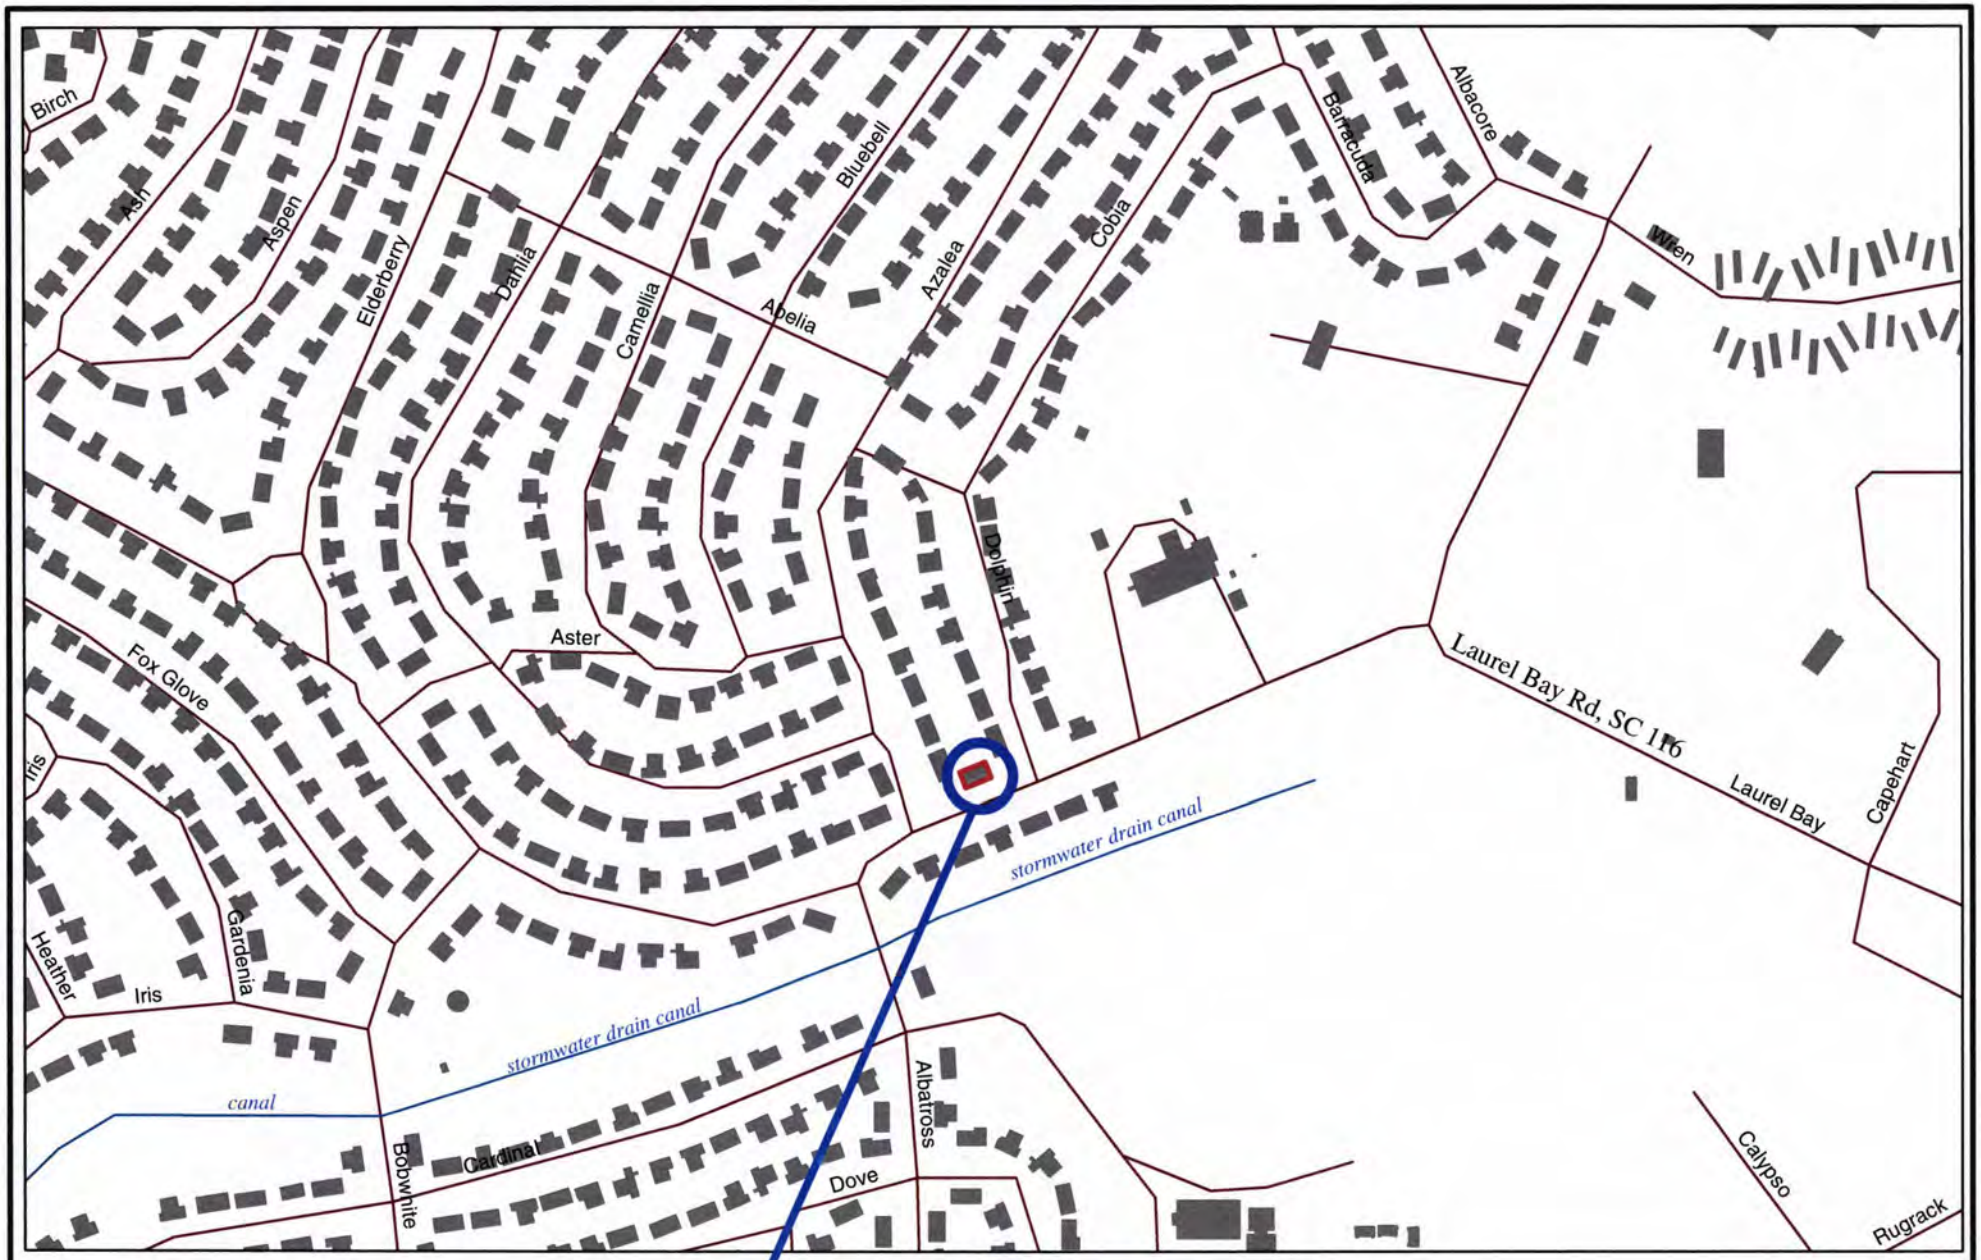
FIGURE 2 SITE MAP
535 LAUREL BAY BLVD., LAUREL BAY
MCAS BEAUFORT SC

On August 6, 2013, a single 280 gallon heating oil UST was removed from the concrete porch area at 204 West Laurel Bay Boulevard (Formerly 535 West Laurel Bay Boulevard). The former UST location is indicated on Figures 2 and 3 of the UST Assessment Report (Appendix B). The UST was removed and properly disposed of (i.e., shipped offsite for recycling or transported to a landfill). There was no visual evidence (i.e., staining or sheen) of petroleum impact at the time of the UST removal. According to the UST Assessment Report (Appendix B), the depth to the base of the UST was 6'0" bgs and a single soil sample was collected from that depth. The

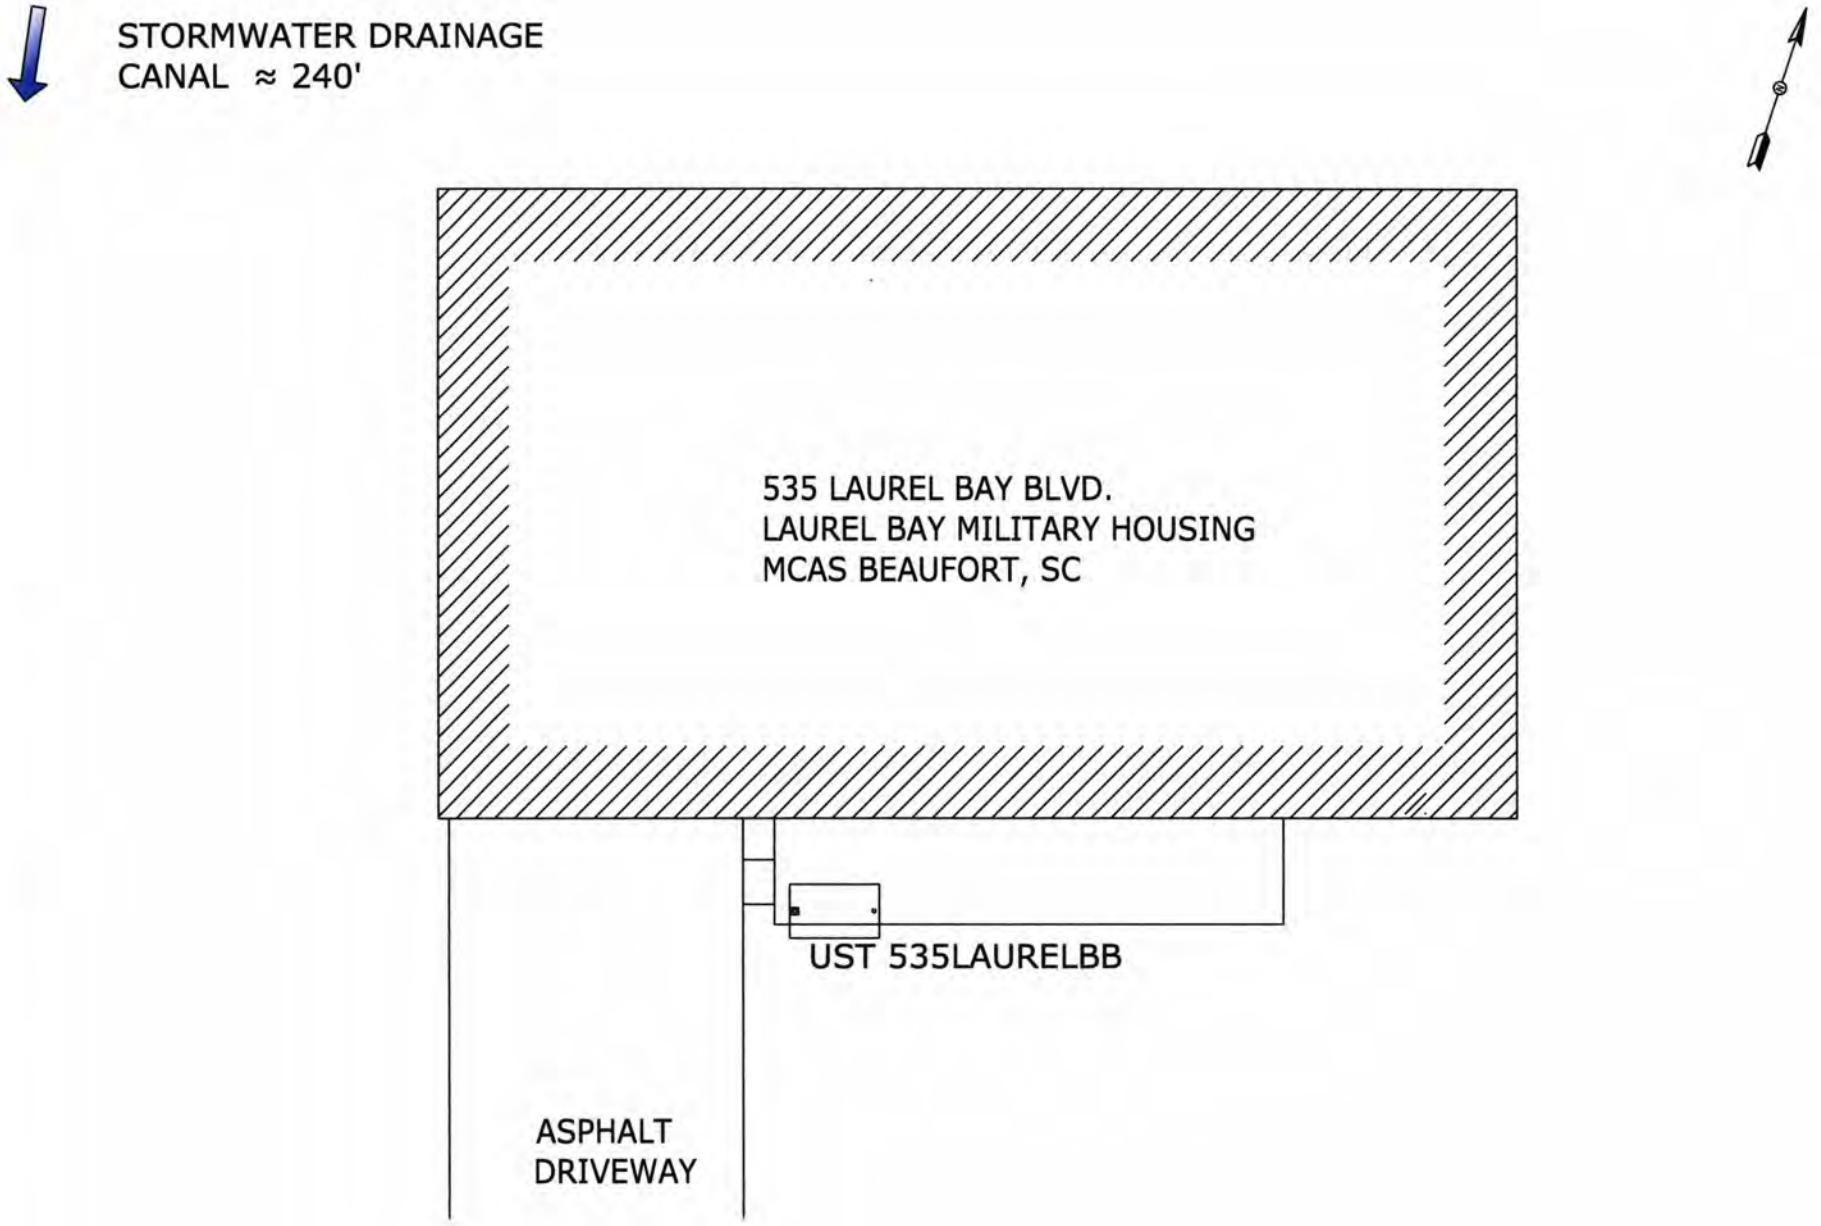
UST 535LAURELBB WAS 36" BELOW GRADE.
