SUMMARY REPORT
42 DAHLIA DRIVE (FORMERLY 553 DAHLIA DRIVE)
LAUREL BAY MILITARY HOUSING AREA
MARINE CORPS AIR STATION BEAUFORT
BEAUFORT, SC

Contract Number: N62470-14-D-9016
CTO WE52
JUNE 2021

Underground Storage Tank (UST) Assessment Report

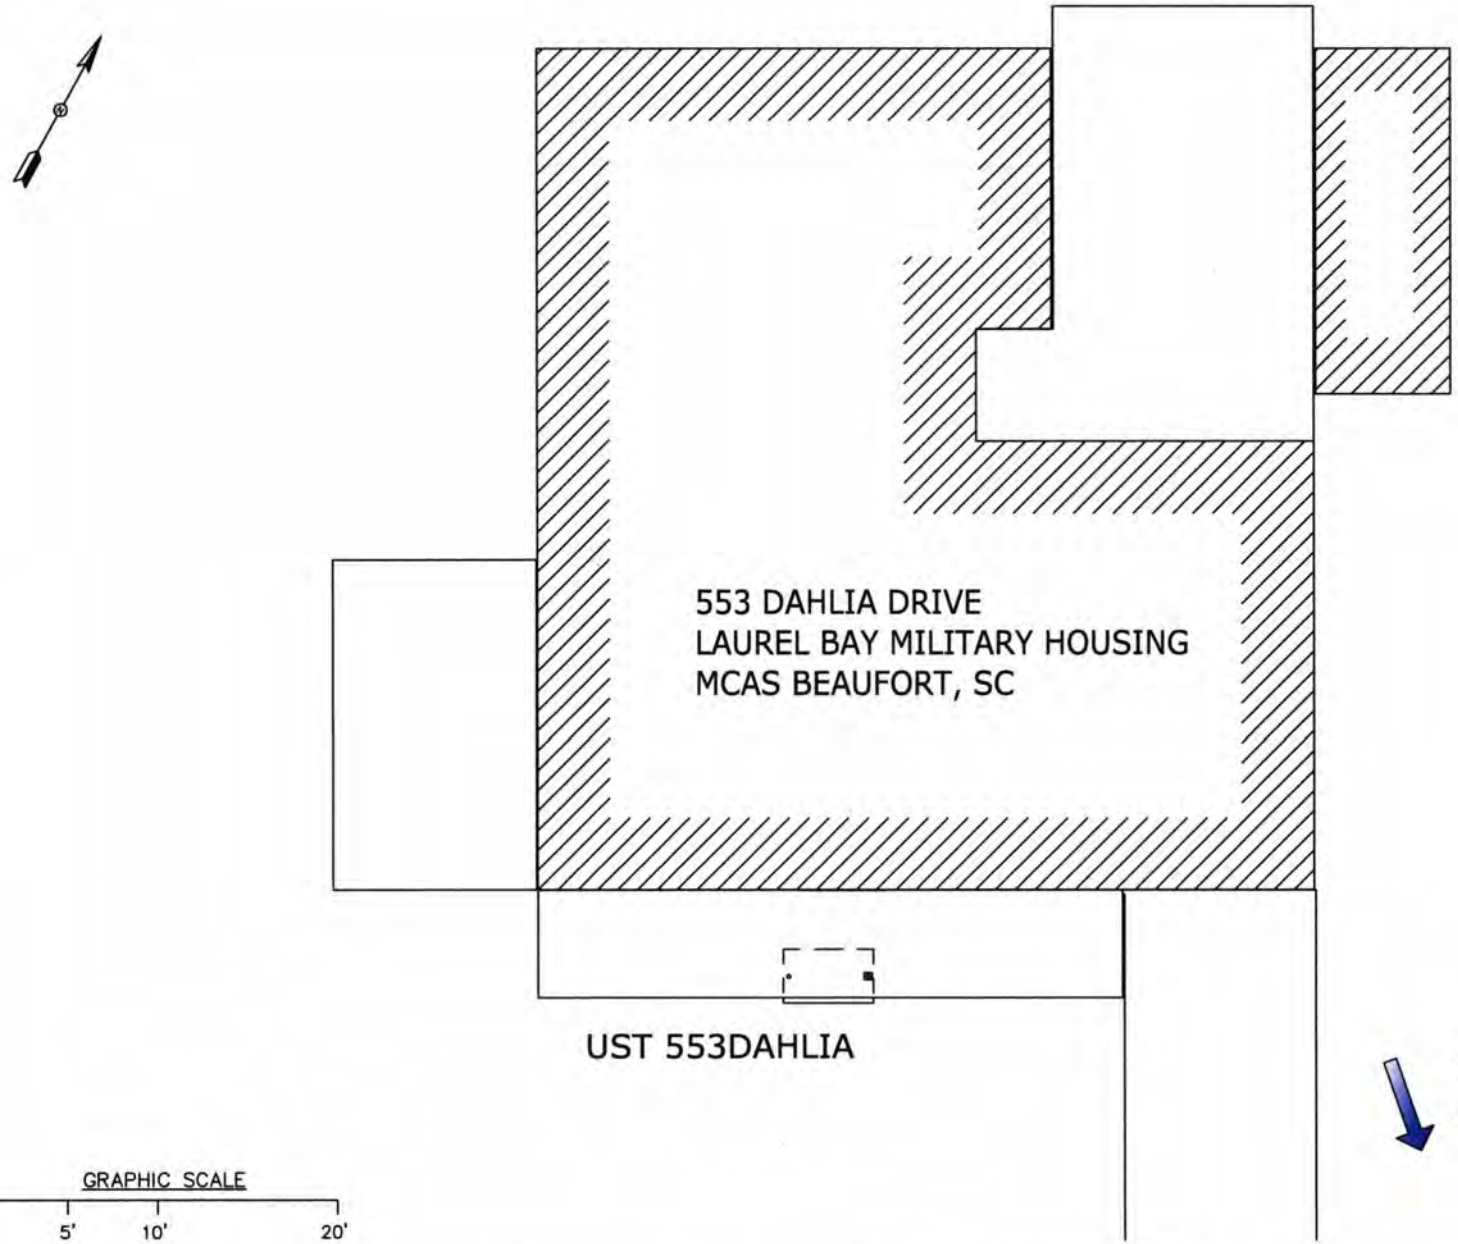
FIGURE 2 SITE MAP
553 DAHLIA DRIVE, LAUREL BAY
MCAS BEAUFORT SC

TANK DEPTH BELOW GRADE
553DAHLIA = 39"

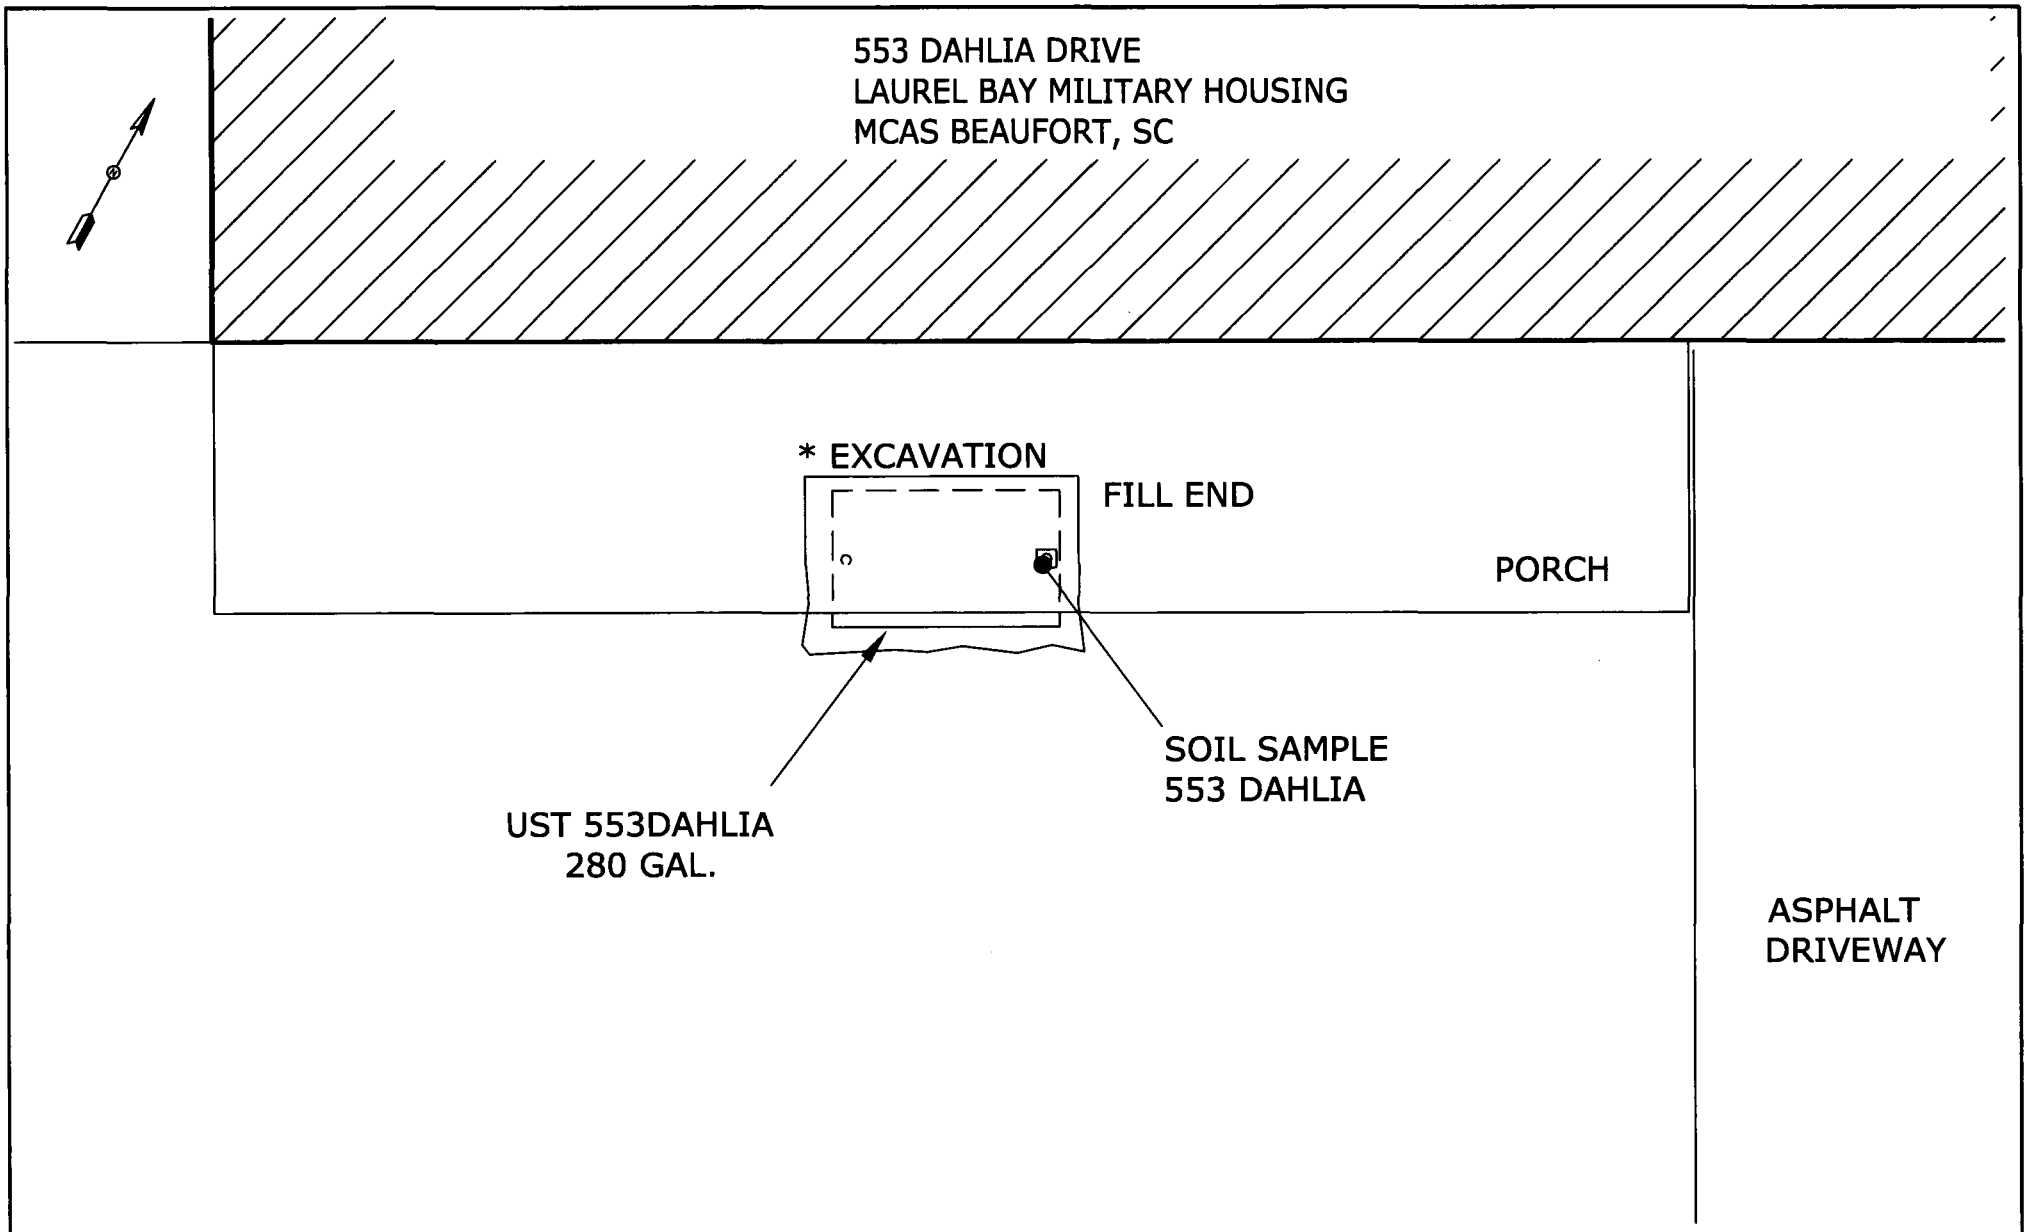
FIGURE 3 UST SAMPLE LOCATIONS
553 DAHLIA DRIVE, LAUREL BAY
MCAS BEAUFORT SC

* A PORTION OF THE PORCH WAS REMOVED TO FACILITATE TANK EXTRACTION.
