SUMMARY REPORT
132 DAHLIA DRIVE (FORMERLY 563 DAHLIA DRIVE)
LAUREL BAY MILITARY HOUSING AREA
MARINE CORPS AIR STATION BEAUFORT
BEAUFORT, SC

Contract Number: N62470-14-D-9016
CTO WE52
JUNE 2021

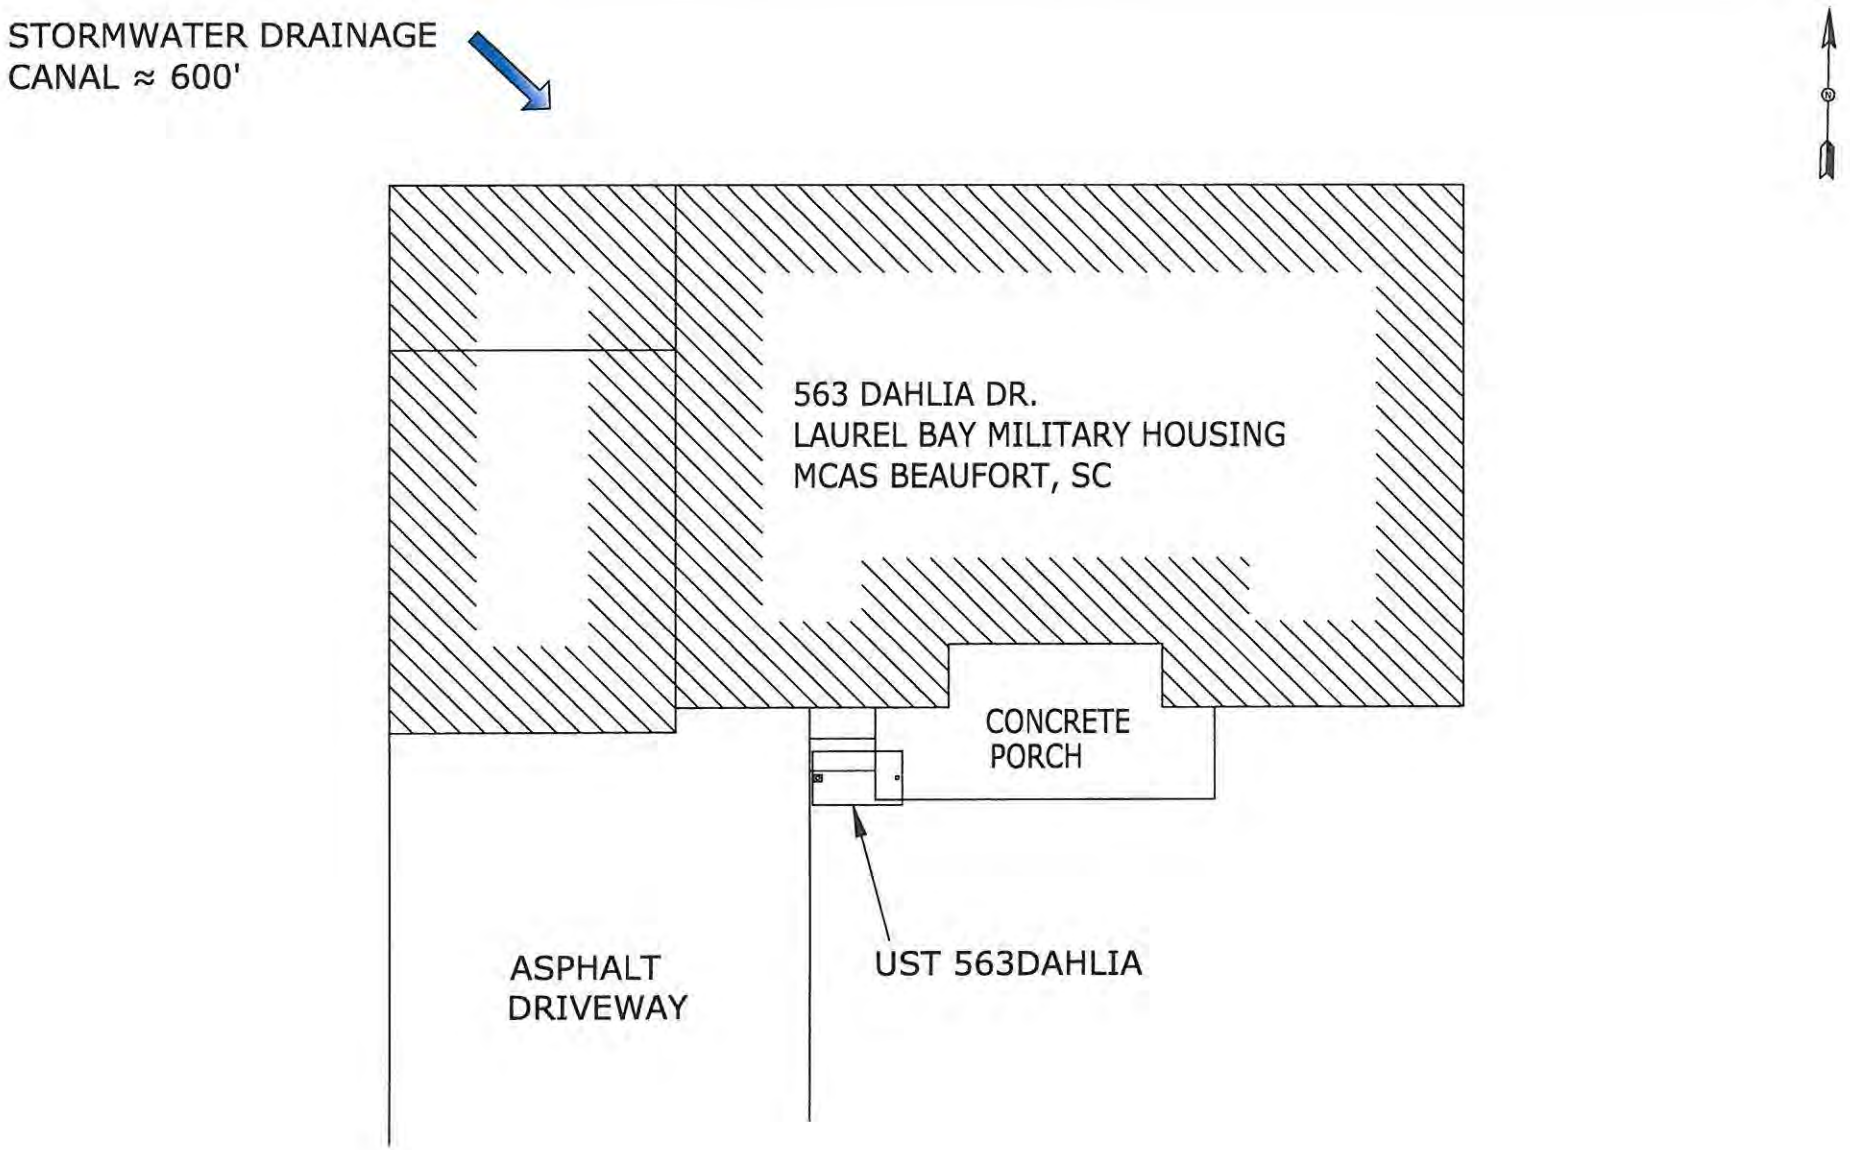
FIGURE 1 SITE MAP
563 DAHLIA DR., LAUREL BAY
MCAS BEAUFORT SC

UST 563DAHLIA WAS
36" BELOW GRADE.

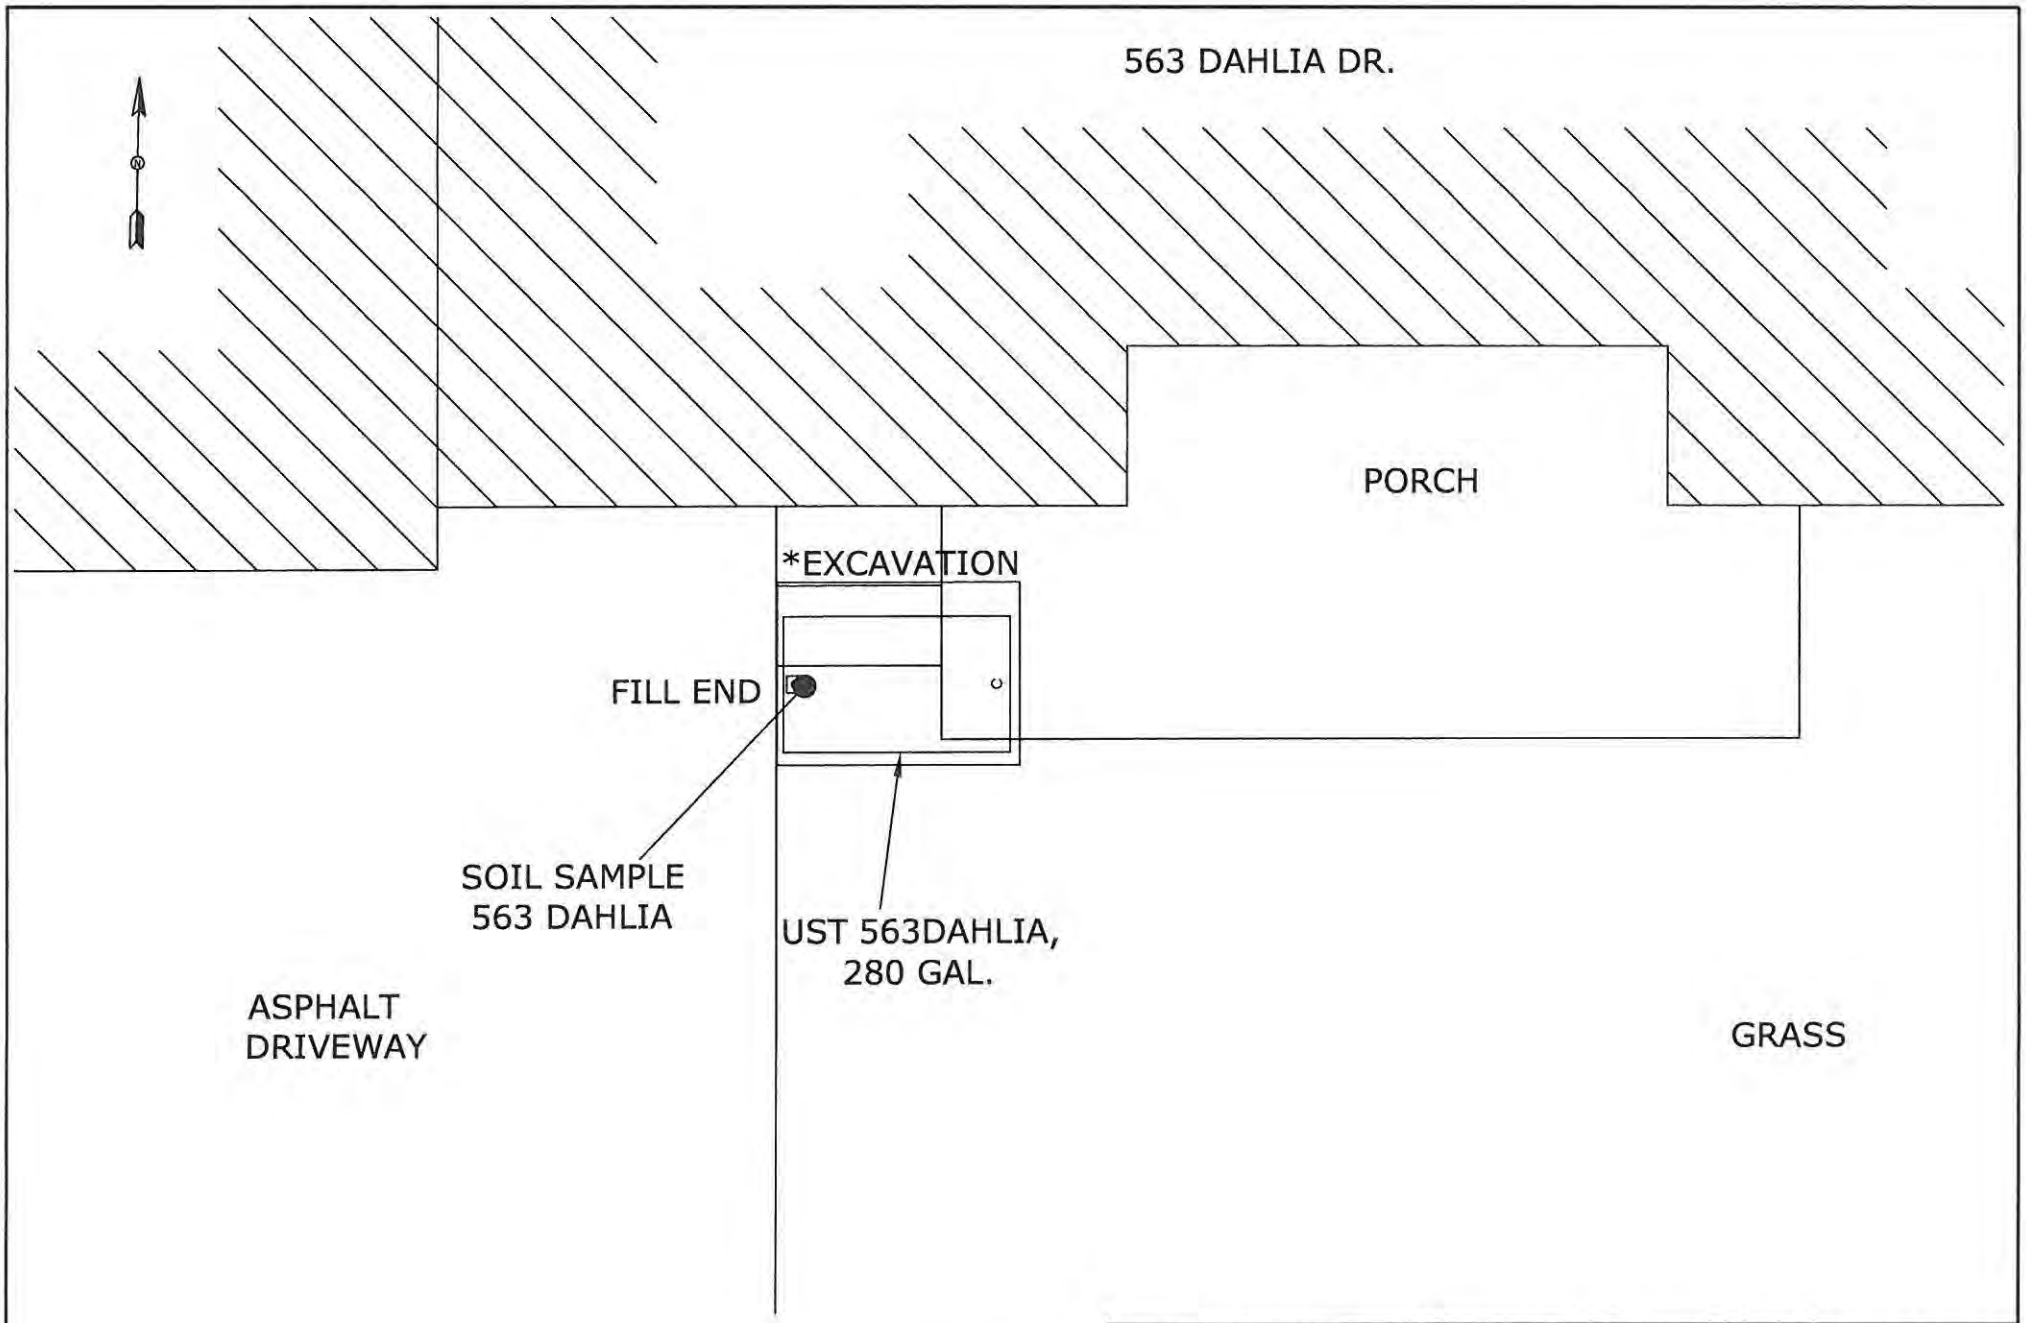
FIGURE 2 UST SAMPLE LOCATION
563 DAHLIA DR., LAUREL BAY
MCAS BEAUFORT SC

*A PORTION OF THE CONCRETE PORCH WAS REMOVED TO FACILITATE TANK EXTRACTION.
