SUMMARY REPORT
317 DAHLIA DRIVE (FORMERLY 612 DAHLIA DRIVE)
LAUREL BAY MILITARY HOUSING AREA
MARINE CORPS AIR STATION BEAUFORT
BEAUFORT, SC

Contract Number: N62470-14-D-9016
CTO WE52
JUNE 2021

Underground Storage Tank (UST) Assessment Report

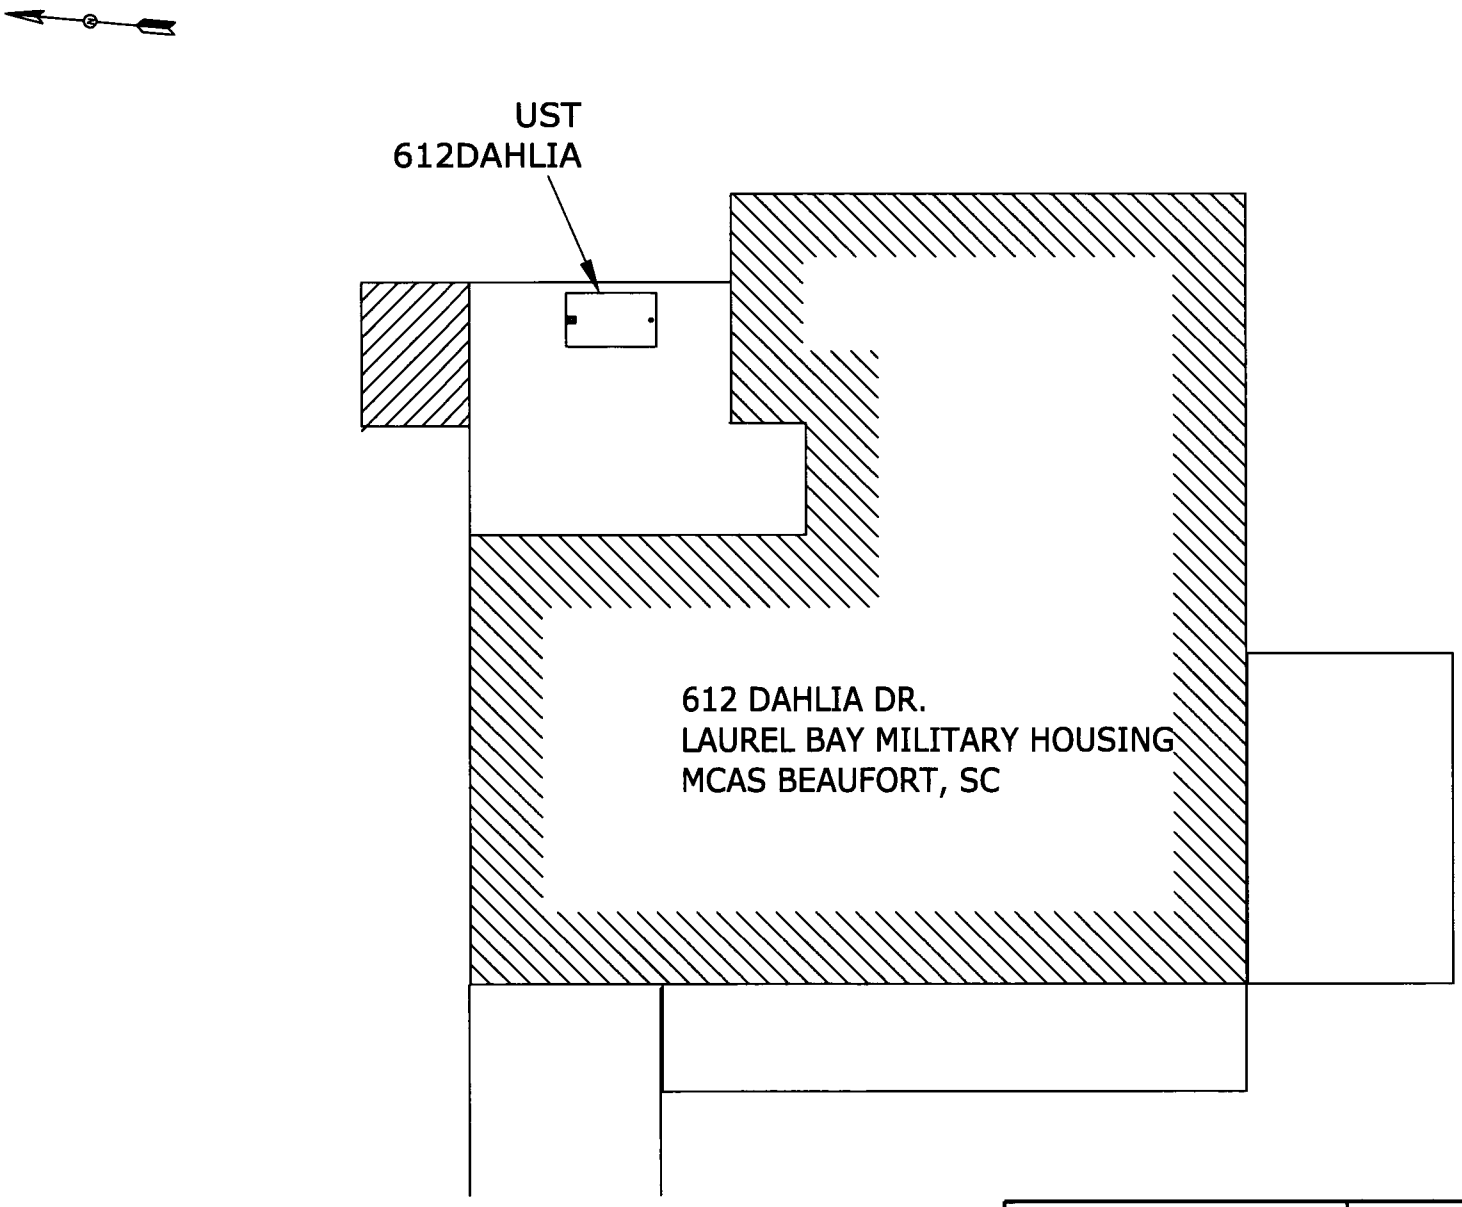
FIGURE 1 SITE MAP
612 DAHLIA DR., LAUREL BAY
MCAS BEAUFORT SC

TANK DEPTH BELOW GRADE
612DAHLIA = 28"

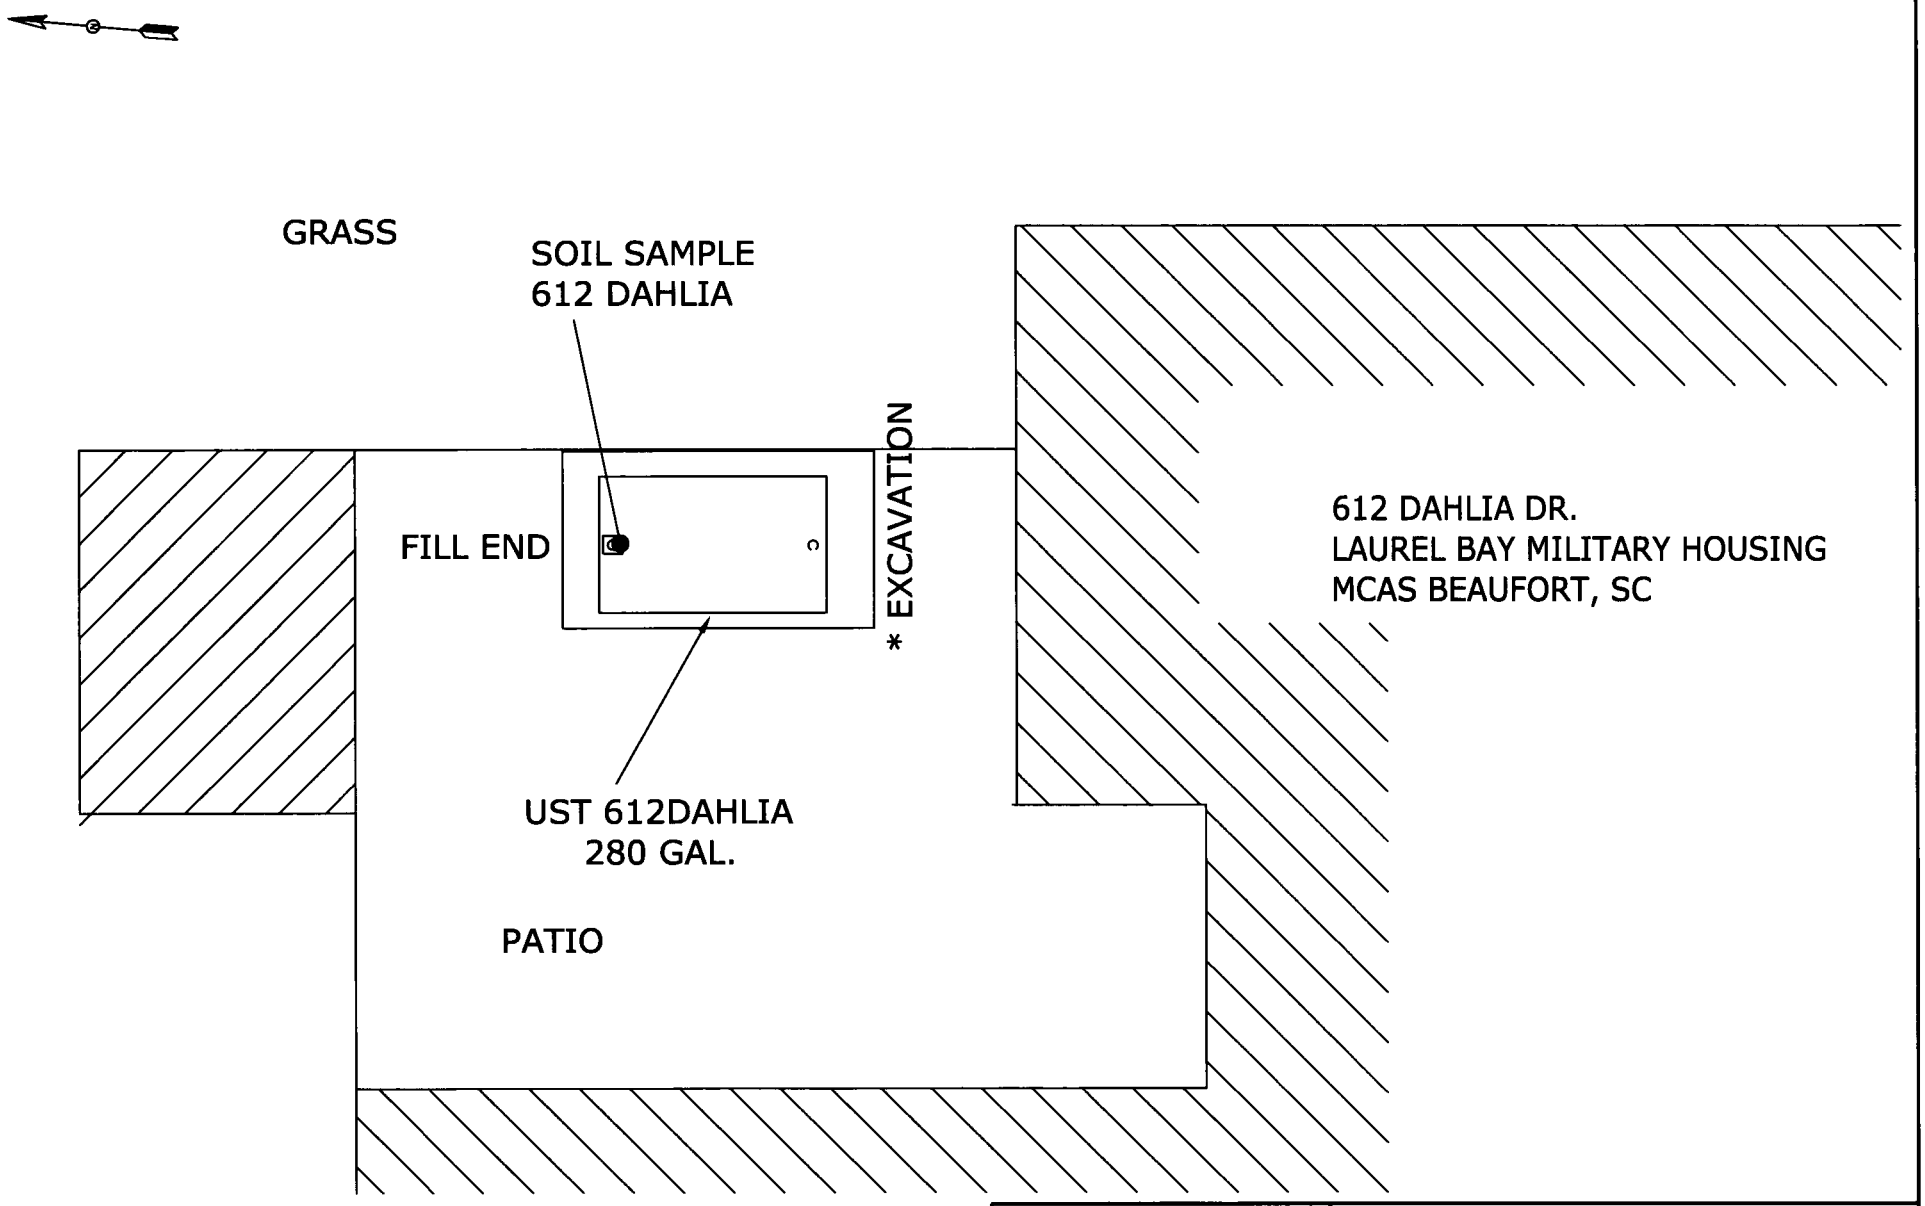
FIGURE 2 UST SAMPLE LOCATION
612 DAHLIA DR., LAUREL BAY
MCAS BEAUFORT SC

* A PORTION OF THE PATIO WAS REMOVED TO FACILITATE TANK EXTRACTION.
