SUMMARY REPORT
549 DAHLIA DRIVE (FORMERLY 638 DAHLIA DRIVE)
LAUREL BAY MILITARY HOUSING AREA
MARINE CORPS AIR STATION BEAUFORT
BEAUFORT, SC

Contract Number: N62470-14-D-9016
CTO WE52
JUNE 202**1**

Underground Storage Tank (UST) Assessment Report

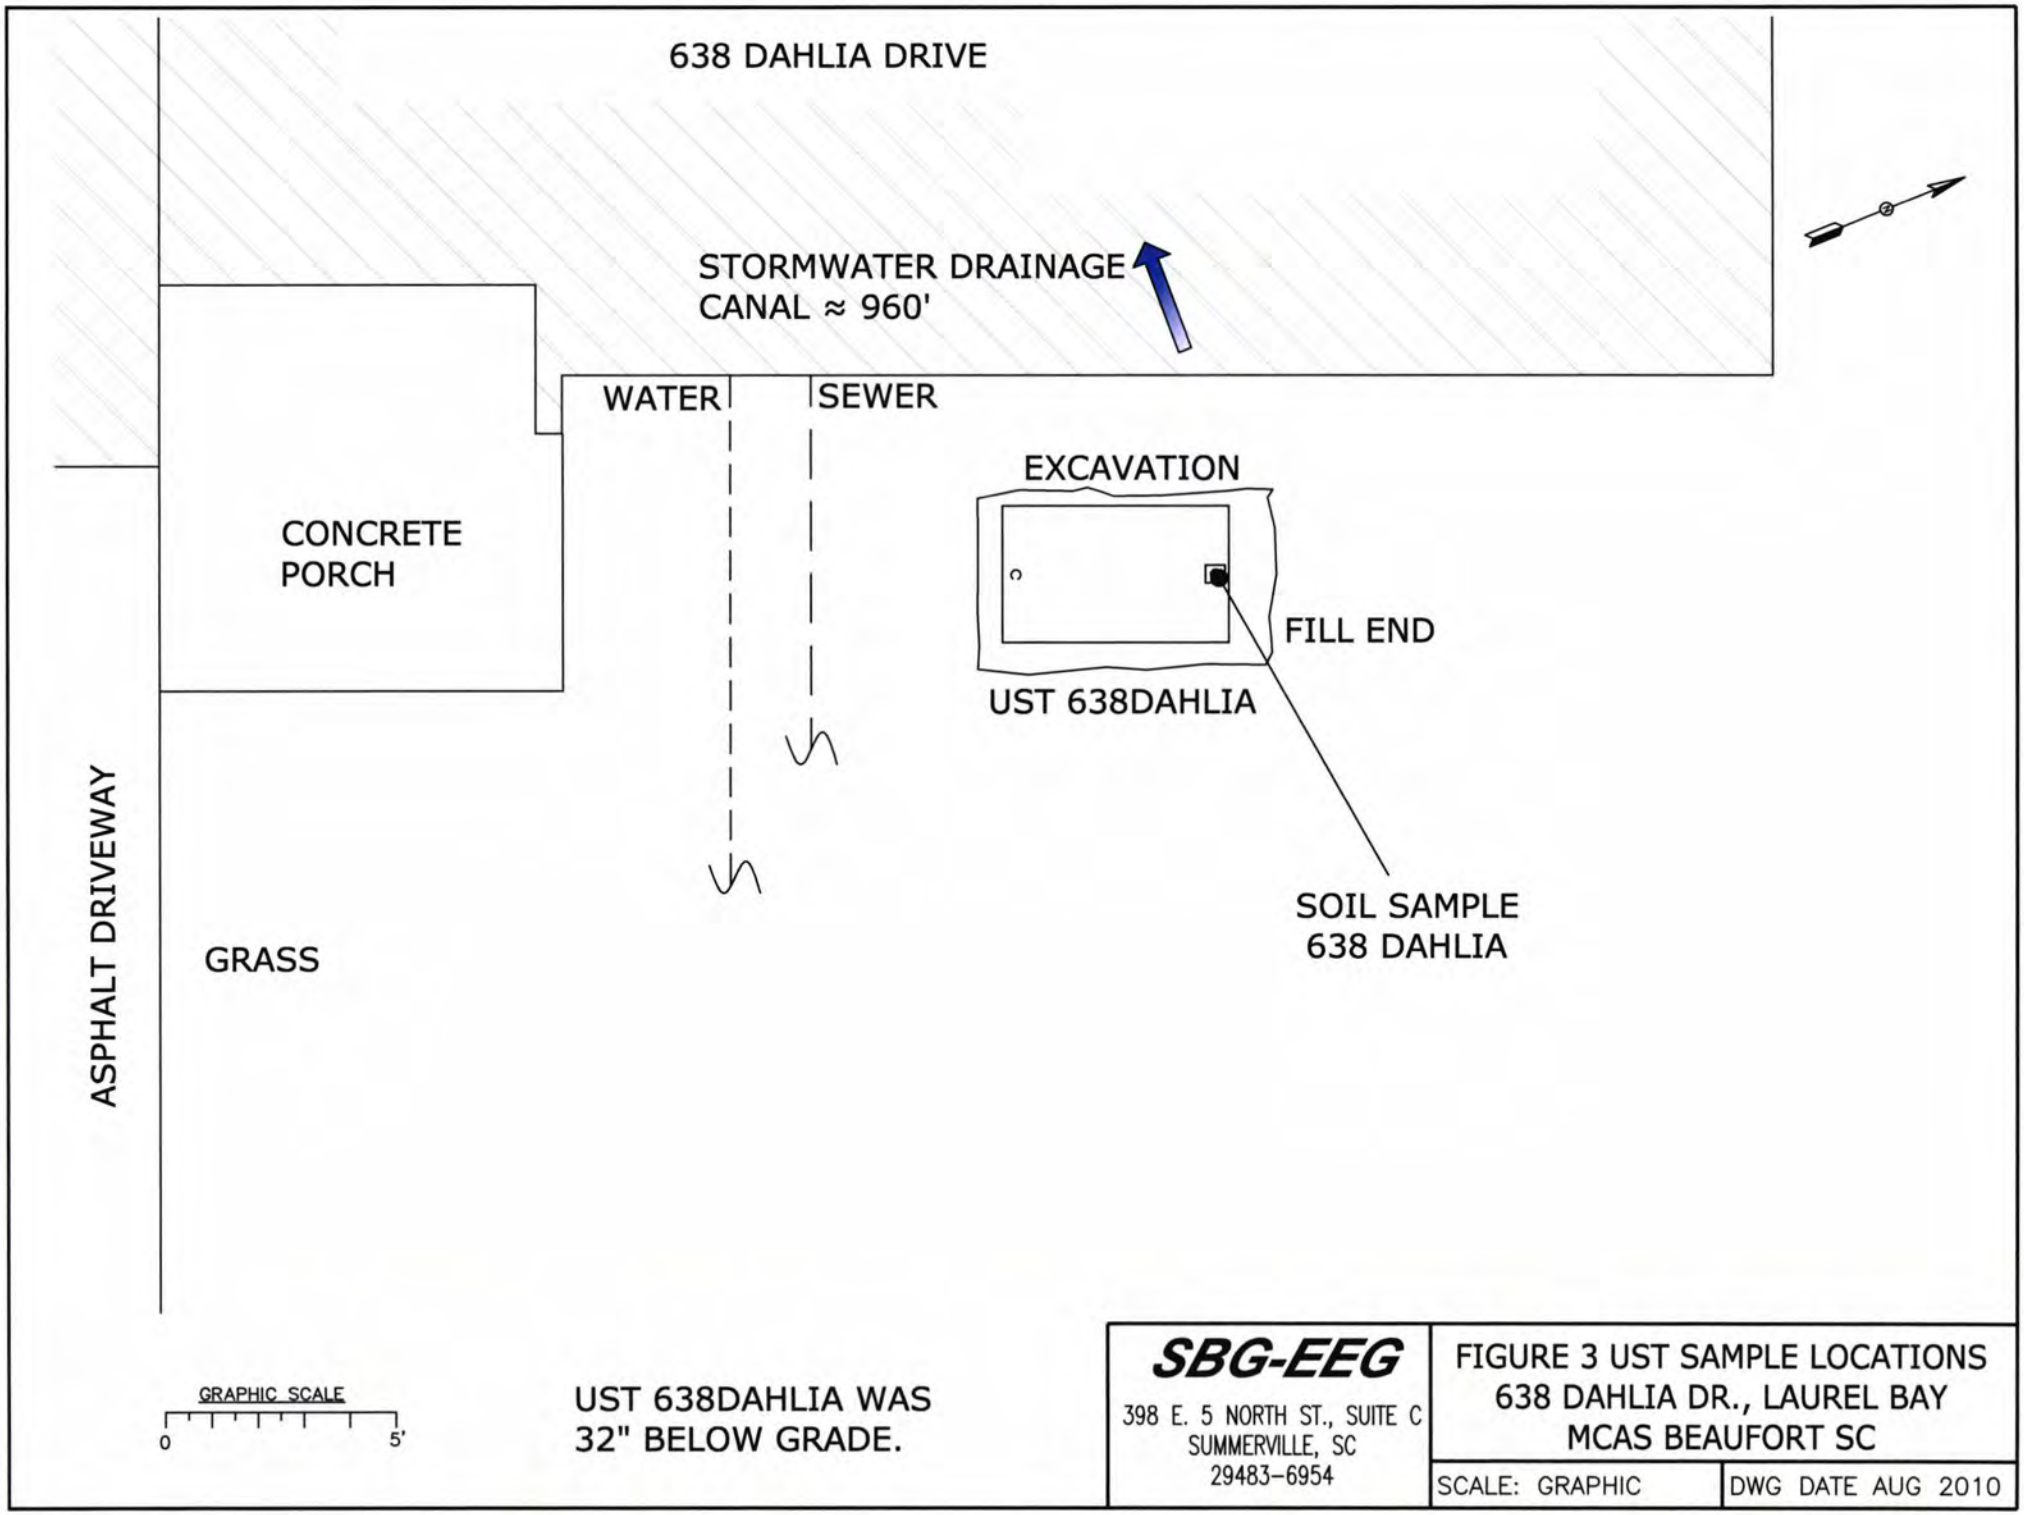
FIGURE 3 UST SAMPLE LOCATIONS
638 DAHLIA DR., LAUREL BAY
MCAS BEAUFORT SC

On June 28, 2010, a single 280 gallon heating oil UST was removed from the front landscaped bed area at 549 Dahlia Drive (Formerly 638 Dahlia Drive). The former UST location is indicated on Figures 2 and 3 of the UST Assessment Report (Appendix B). The UST was removed and properly disposed of (i.e., shipped offsite for recycling or transported to a landfill). There was no visual evidence (i.e., staining or sheen) of petroleum impact at the time of the UST removal. According to the UST Assessment Report (Appendix B), the depth to the base of the UST was 5'8" bgs and a single soil sample was collected from that depth. The sample was collected from the fill port side of the former UST to represent a worst case scenario.
