SUMMARY REPORT
603 DAHLIA DRIVE (FORMERLY 644 DAHLIA DRIVE)
LAUREL BAY MILITARY HOUSING AREA
MARINE CORPS AIR STATION BEAUFORT
BEAUFORT, SC

JUNE 2021

Contract Number: N62470-14-D-9016
CTO WE52
JUNE 2021

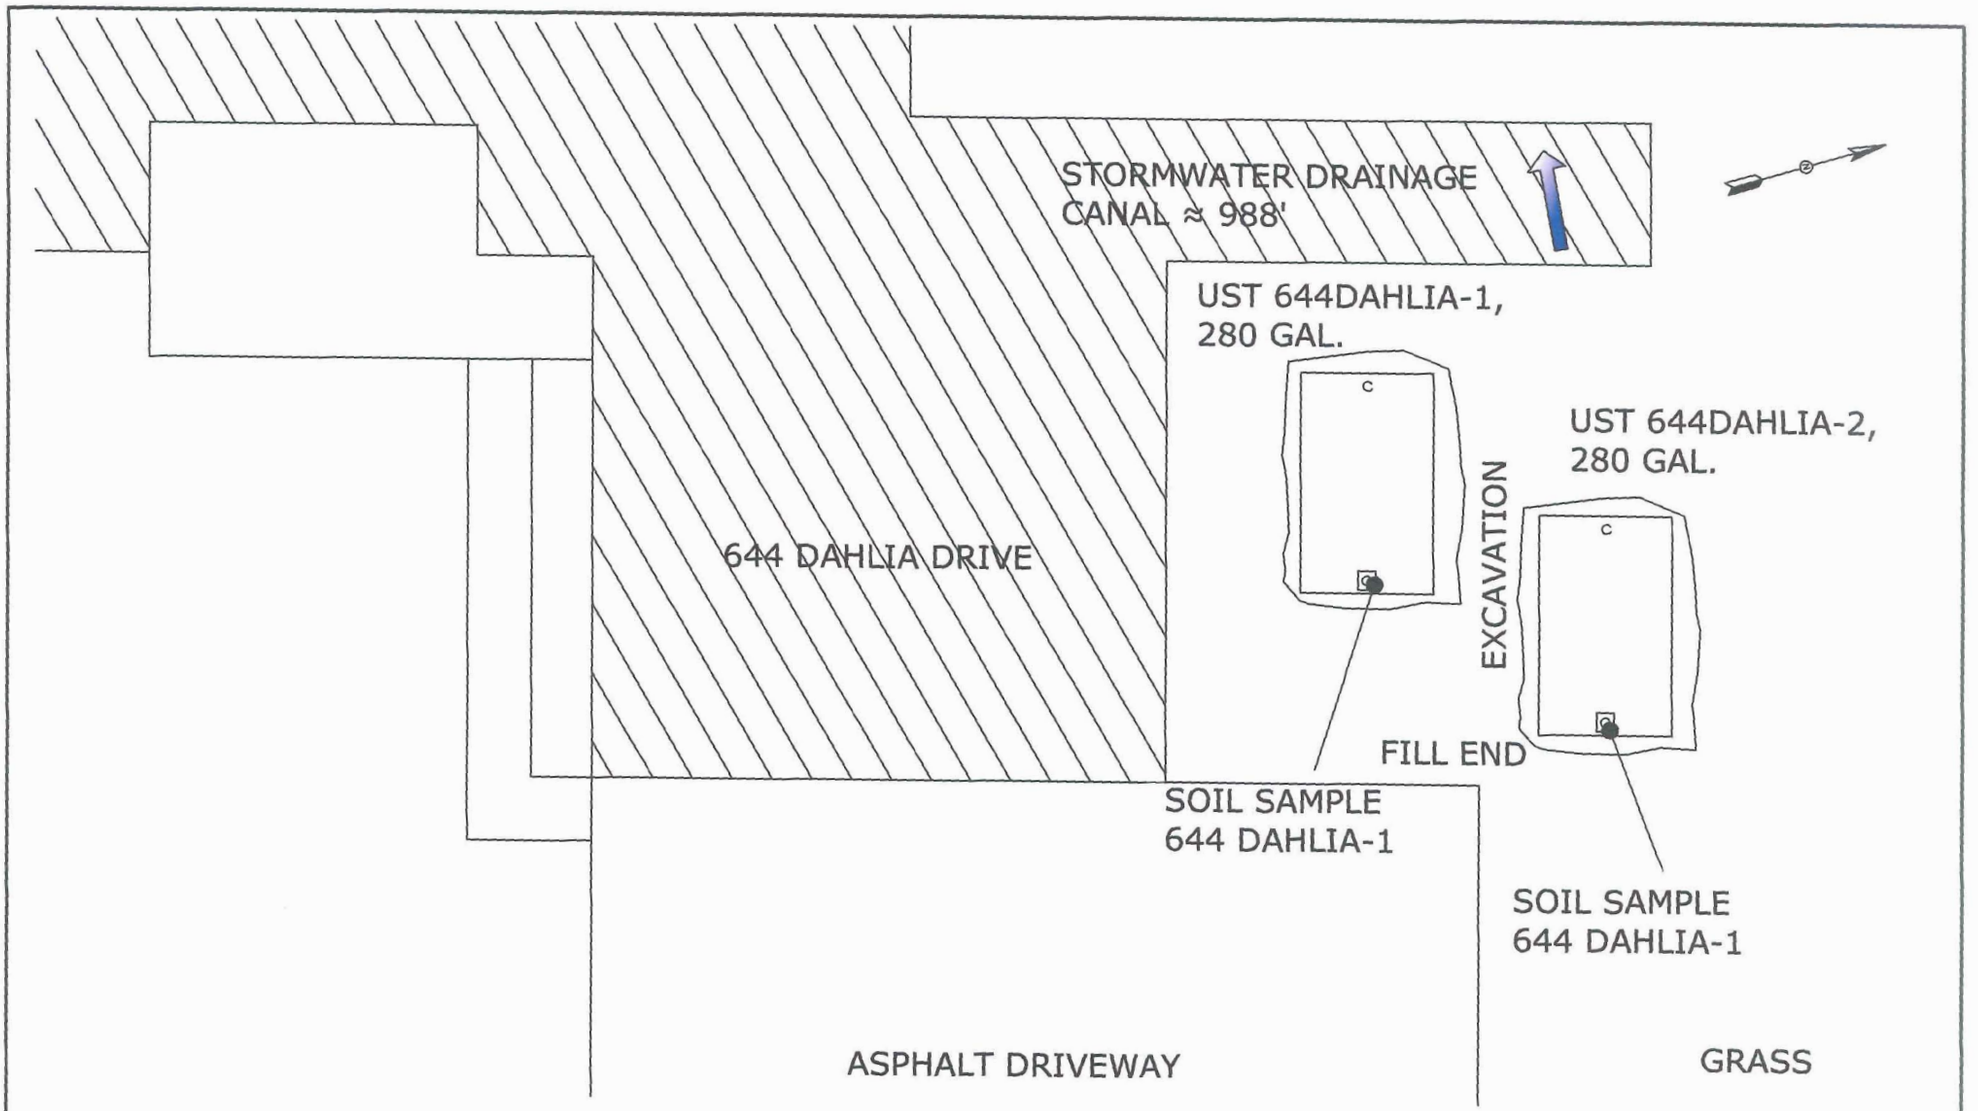
FIGURE 3 UST SAMPLE LOCATIONS
644 DAHLIA DRIVE, LAUREL BAY
MCAS BEAUFORT SC

TANK DEPTH BELOW GRADE
-1 = 36"
-2 = 14"
