SUMMARY REPORT
182 CAMELLIA DRIVE (FORMERLY 669 CAMELLIA DRIVE)
LAUREL BAY MILITARY HOUSING AREA
MARINE CORPS AIR STATION BEAUFORT
BEAUFORT, SC

Contract Number: N62470-14-D-9016
CTO WE52
JUNE 2021

Underground Storage Tank (UST) Assessment Report

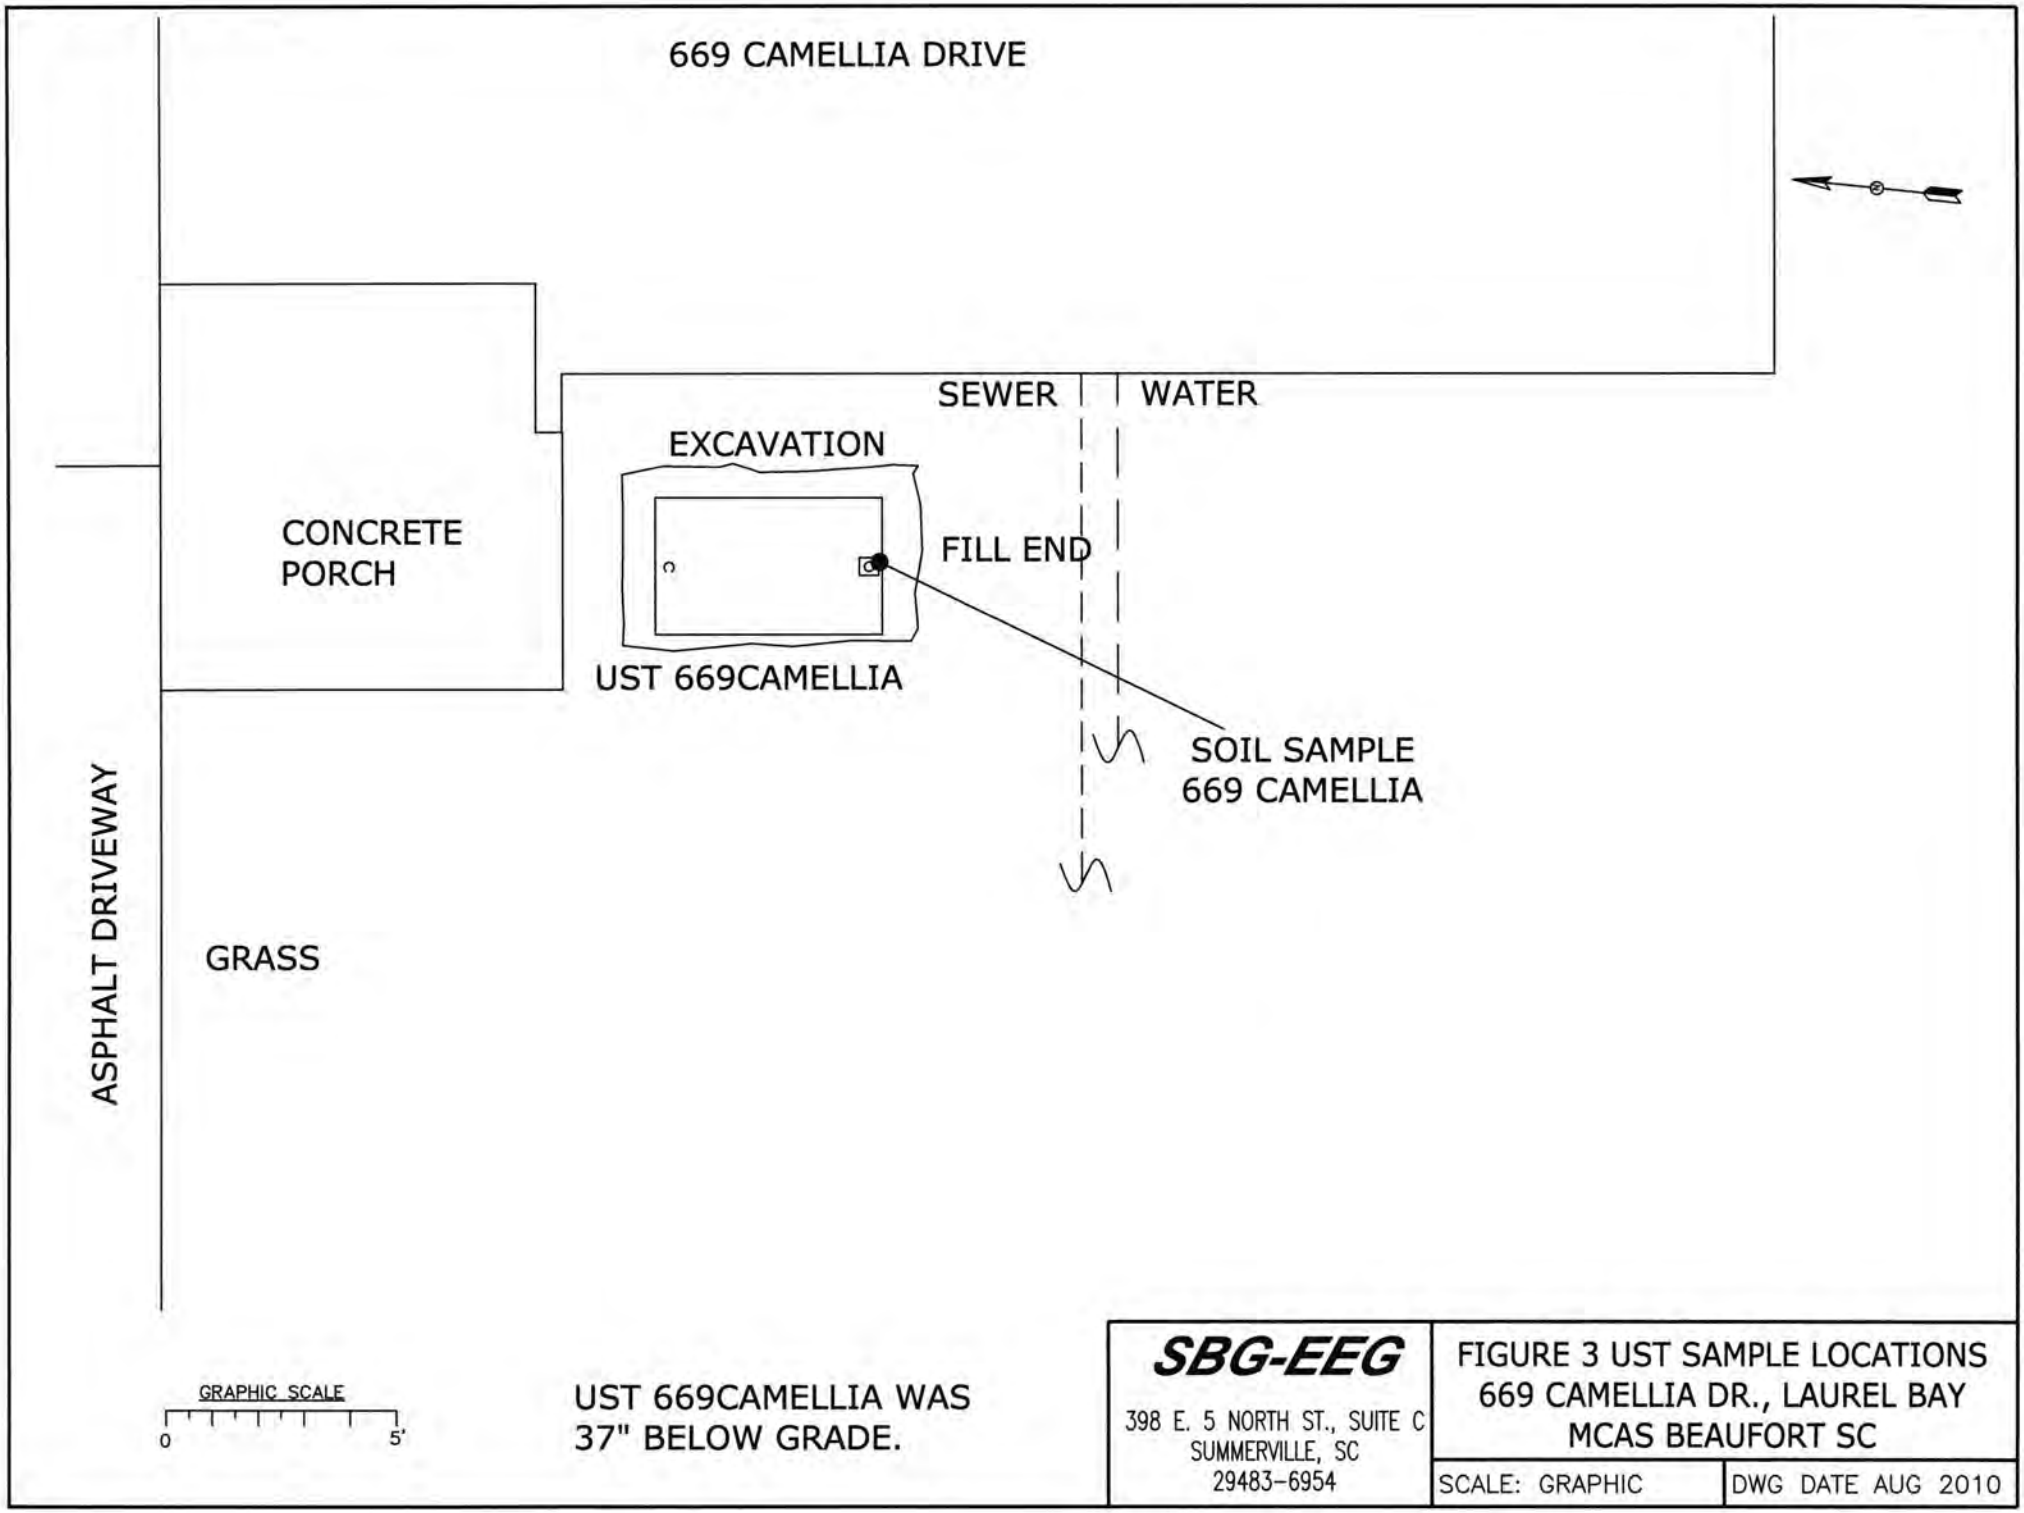
FIGURE 3 UST SAMPLE LOCATIONS
669 CAMELLIA DR., LAUREL BAY
MCAS BEAUFORT SC

UST 669CAMELLIA WAS
37" BELOW GRADE.
