SUMMARY REPORT
279 CAMELLIA DRIVE (FORMERLY 682 CAMELLIA DRIVE)
LAUREL BAY MILITARY HOUSING AREA
MARINE CORPS AIR STATION BEAUFORT
BEAUFORT, SC

JUNE 2021

Contract Number: N62470-14-D-9016
CTO WE52
JUNE 2021

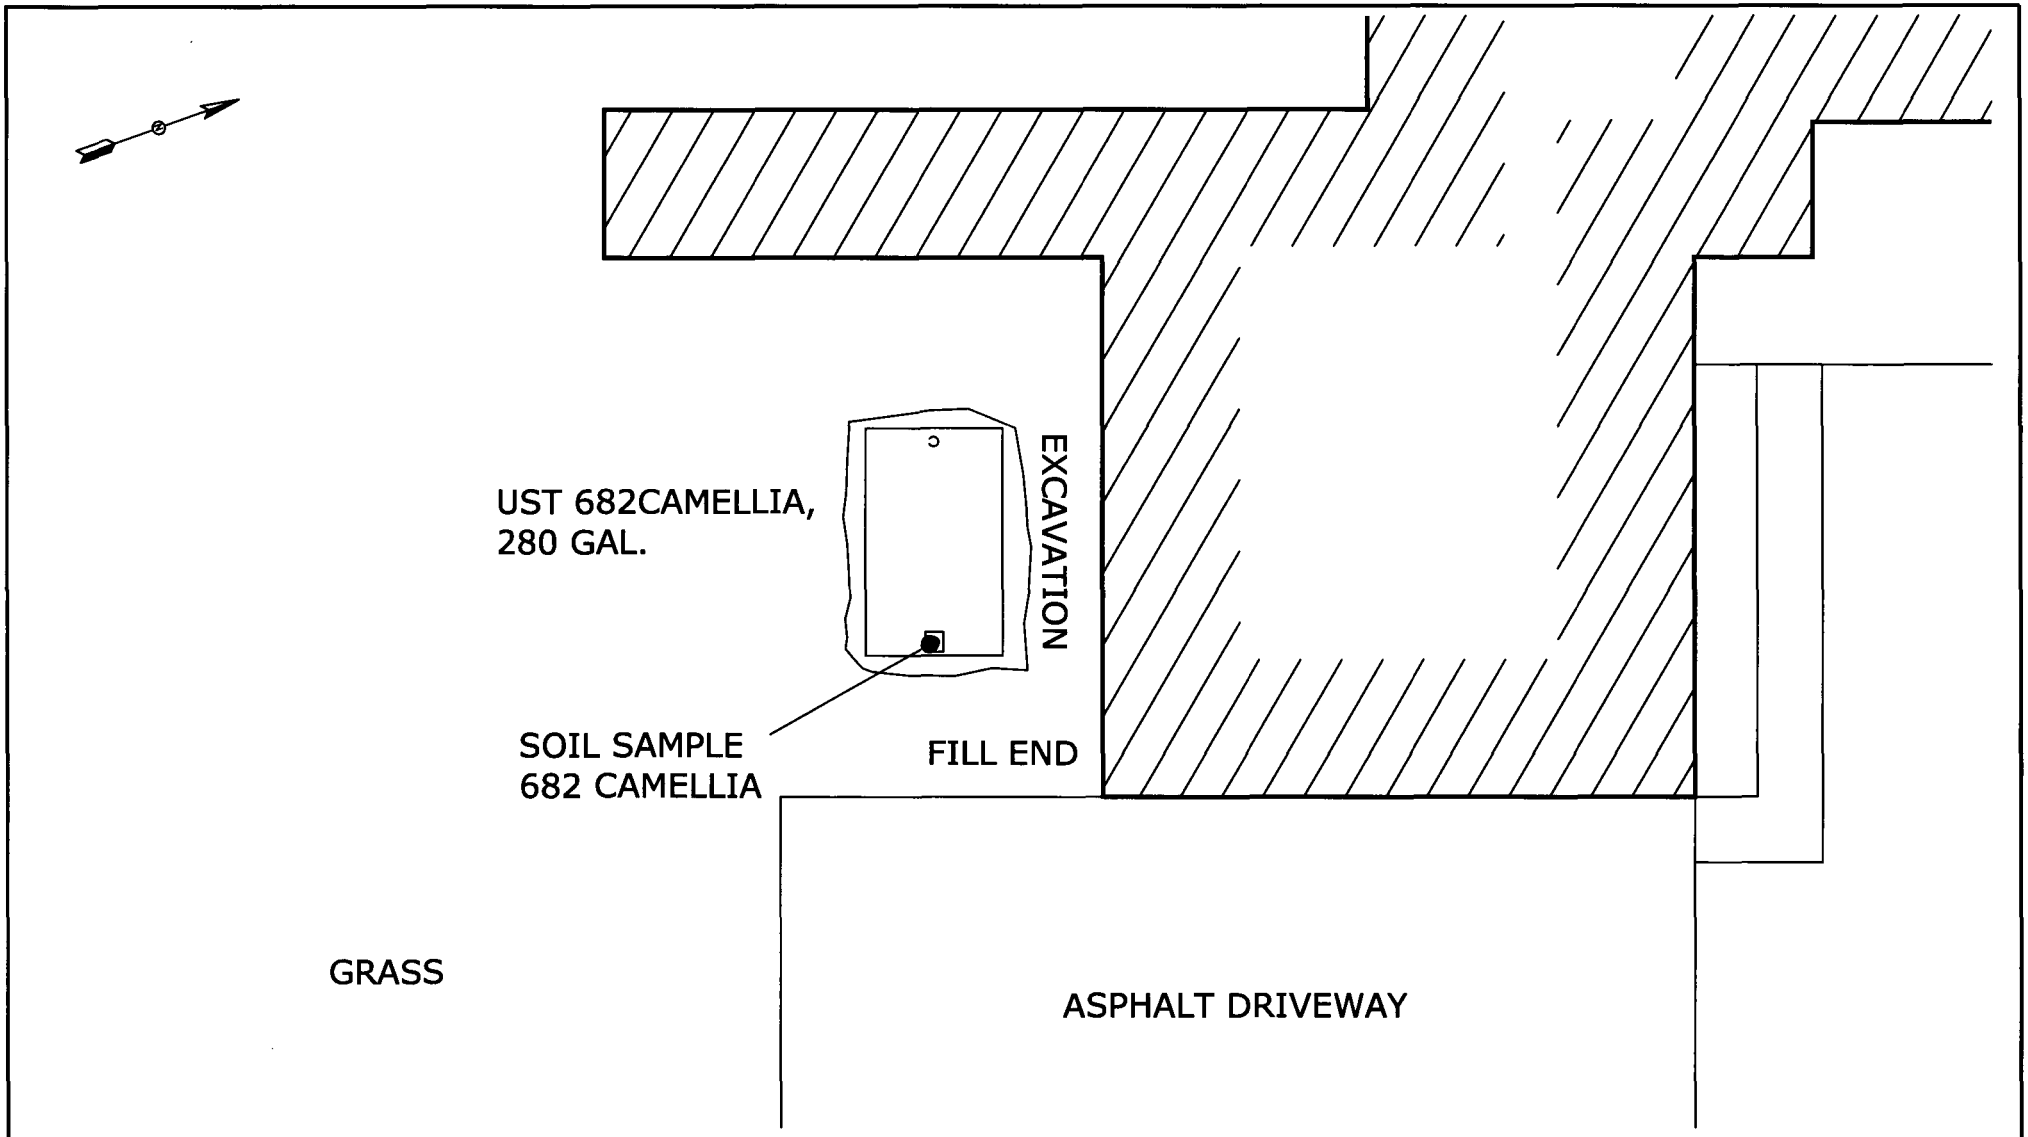
FIGURE 3 UST SAMPLE LOCATIONS
682 CAMELLIA DRIVE LAUREL BAY
MCAS BEAUFORT SC

UST 682CAMELLIA WAS
40" BELOW GRADE.
