SUMMARY REPORT
344 CAMELLIA DRIVE (FORMERLY 689 CAMELLIA DRIVE)
LAUREL BAY MILITARY HOUSING AREA
MARINE CORPS AIR STATION BEAUFORT
BEAUFORT, SC

Contract Number: N62470-14-D-9016
CTO WE52
JUNE 2021

Underground Storage Tank (UST) Assessment Report

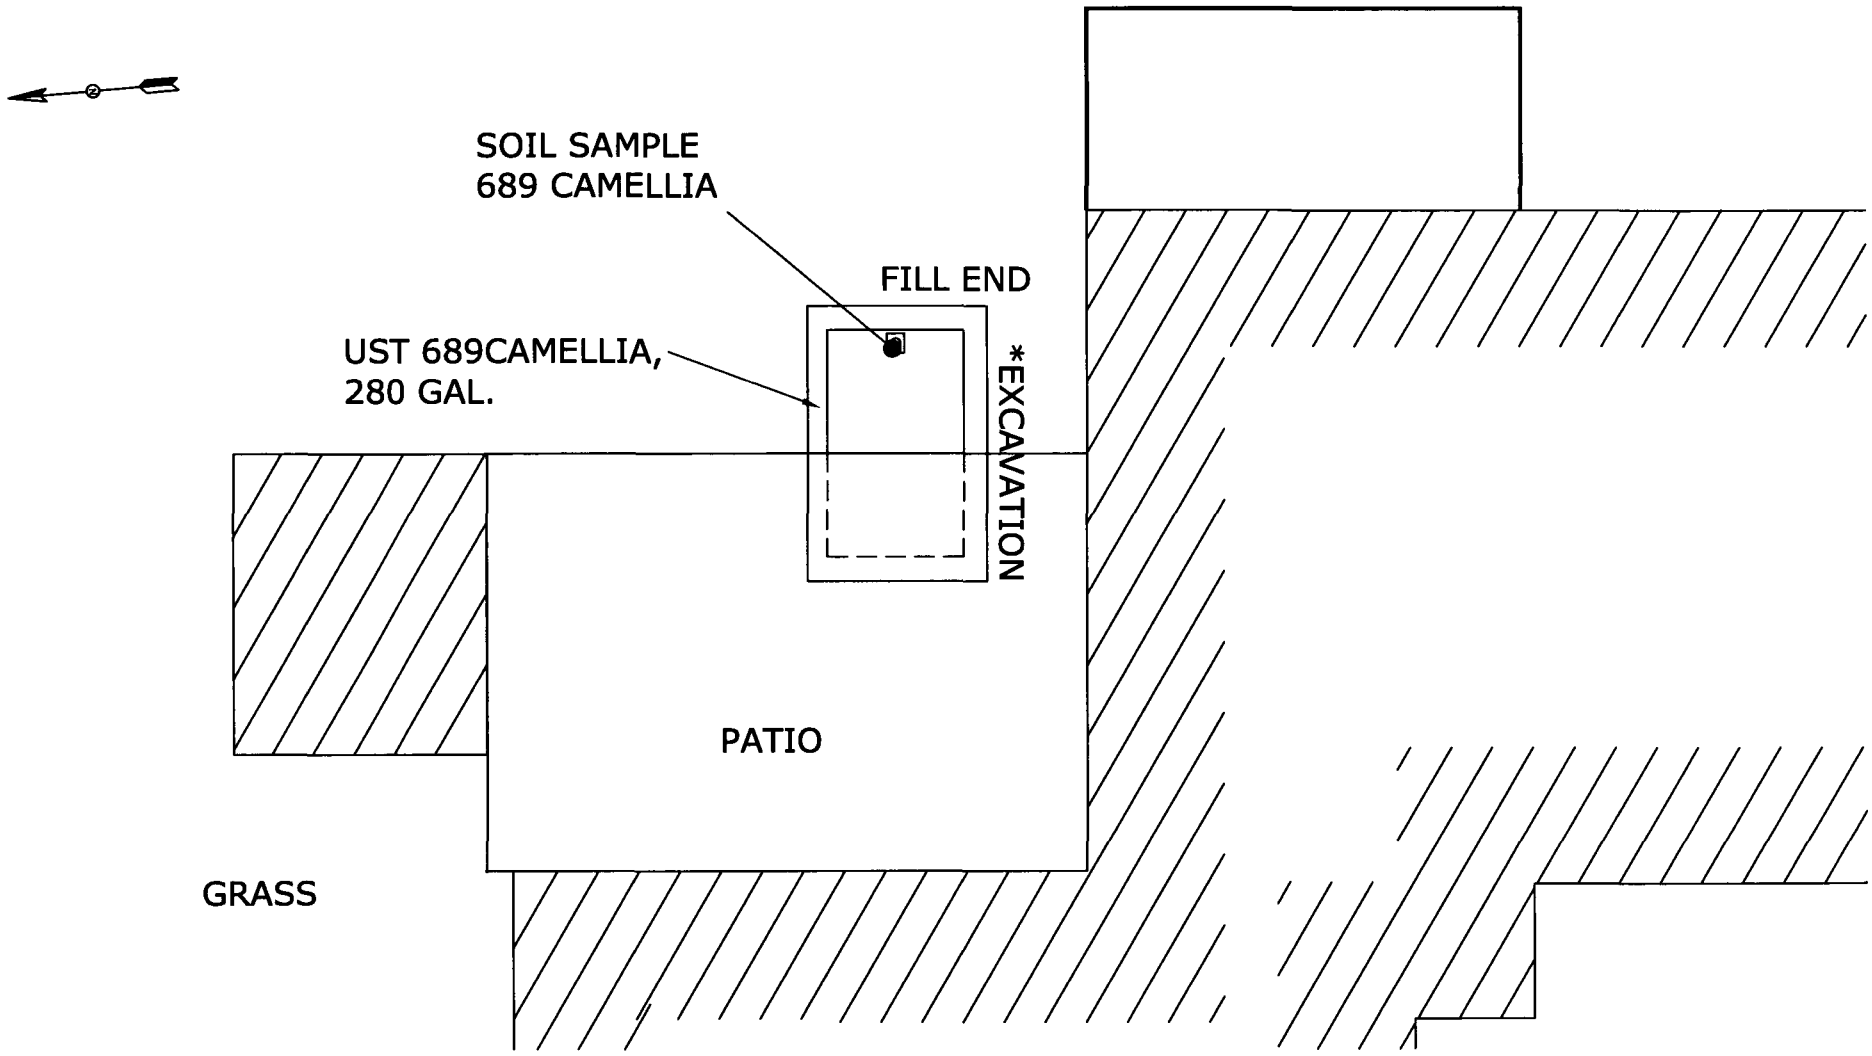
FIGURE 2 UST SAMPLE LOCATION
689 CAMELLIA DR. LAUREL BAY
MCAS BEAUFORT SC

UST 689CAMELLIA WAS
30" BELOW GRADE.

*A PORTION OF THE CONCRETE PATIO WAS REMOVED TO FACILITATE TANK EXTRACTION.
