SUMMARY REPORT
216 AZALEA DRIVE (FORMERLY 819 AZALEA DRIVE)
LAUREL BAY MILITARY HOUSING AREA
MARINE CORPS AIR STATION BEAUFORT
BEAUFORT, SC

JUNE 2021

Contract Number: N62470-14-D-9016
CTO WE52
JUNE 2021

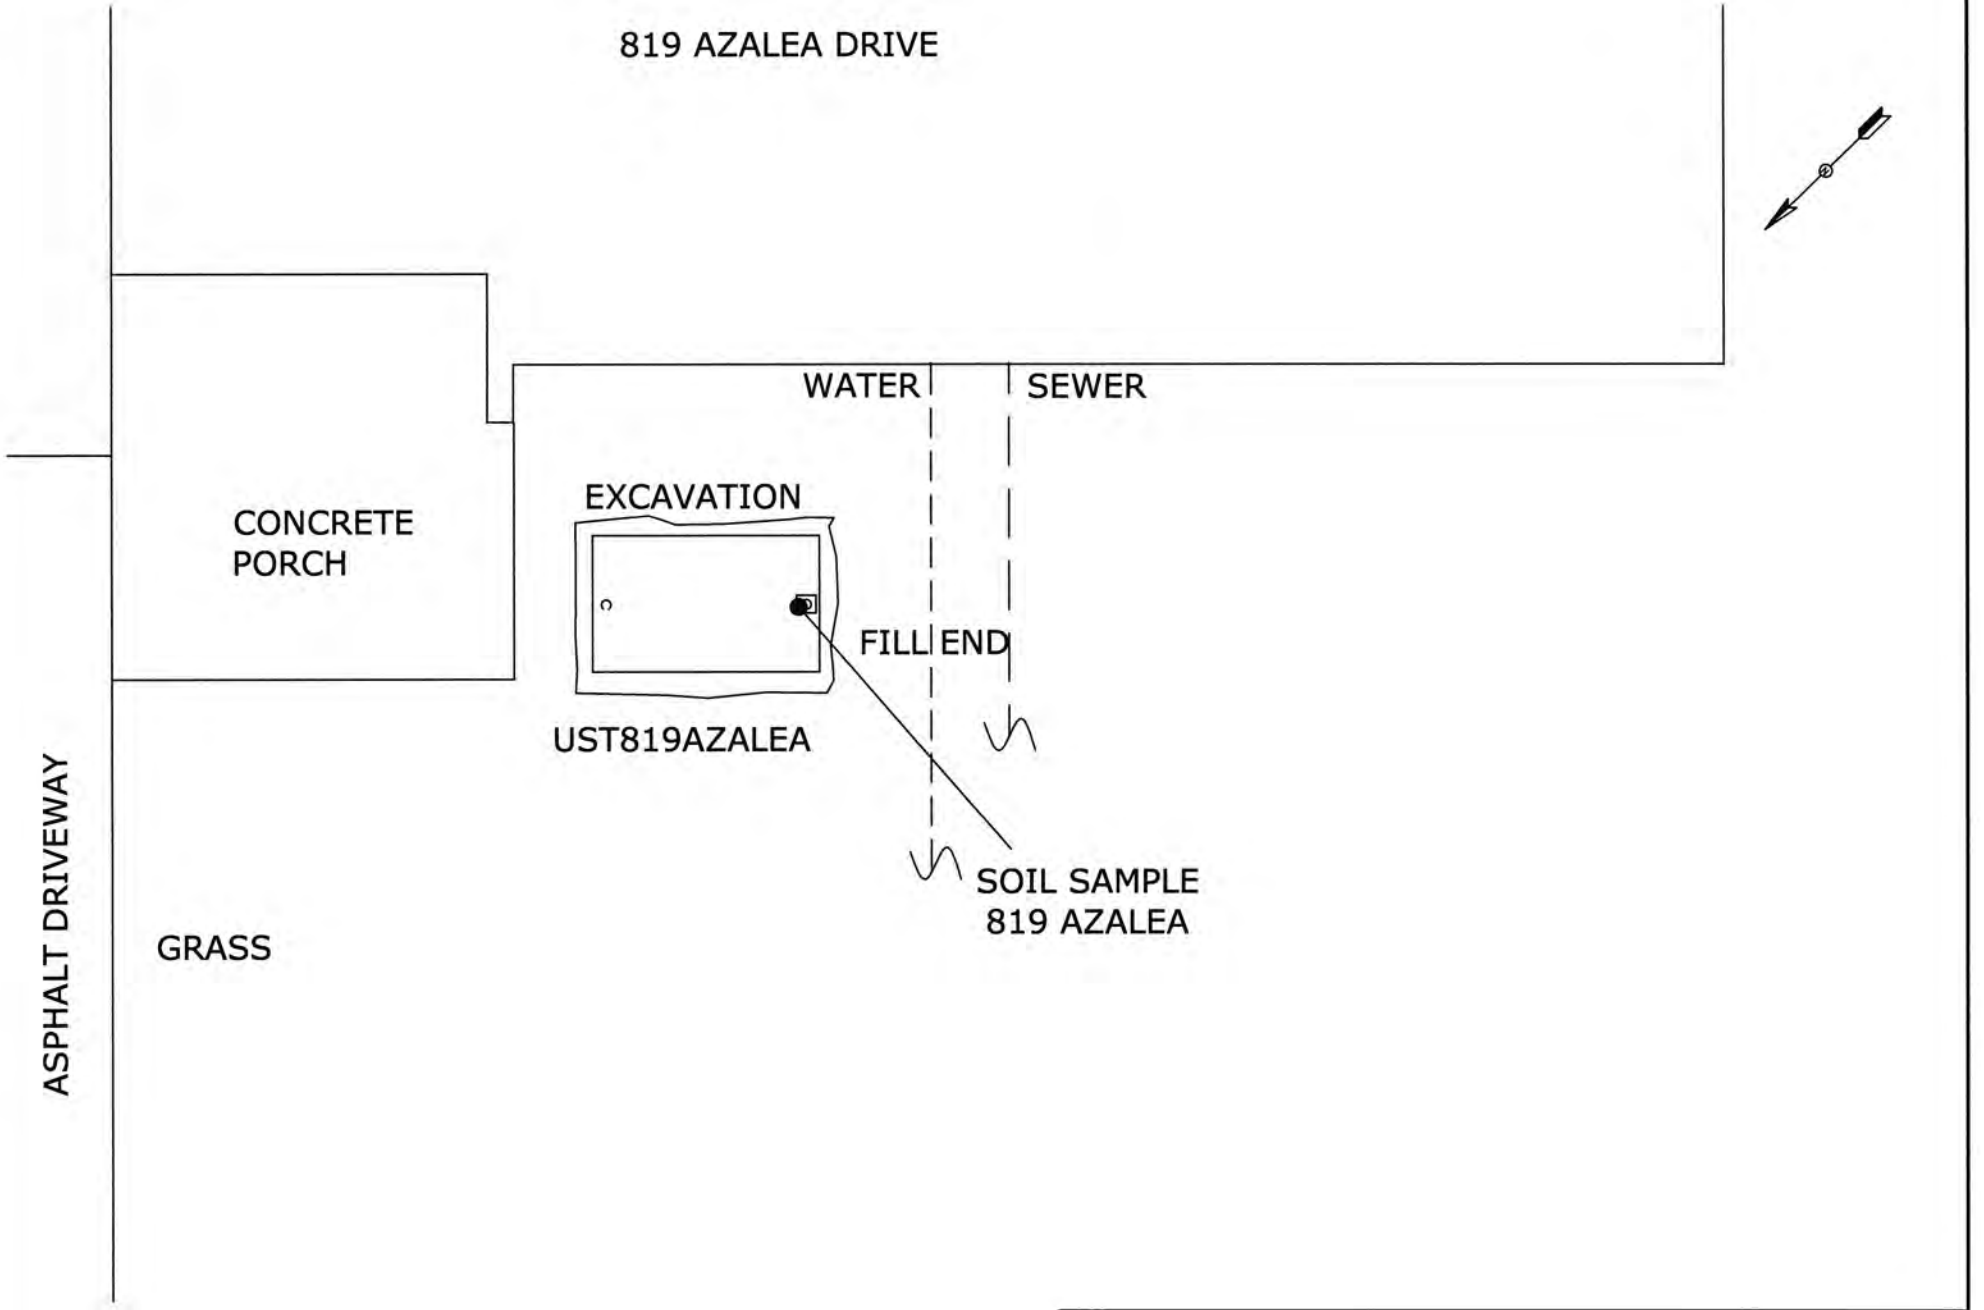
FIGURE 2 SITE MAP
819 AZALEA DR., LAUREL BAY
MCAS BEAUFORT SC

UST 819AZALEA WAS
41" BELOW GRADE.
