SUMMARY REPORT
369 AZALEA DRIVE (FORMERLY 828 AZALEA DRIVE)
LAUREL BAY MILITARY HOUSING AREA
MARINE CORPS AIR STATION BEAUFORT
BEAUFORT, SC

Contract Number: N62470-14-D-9016
CTO WE52
JUNE 2021

Underground Storage Tank (UST) Assessment Report

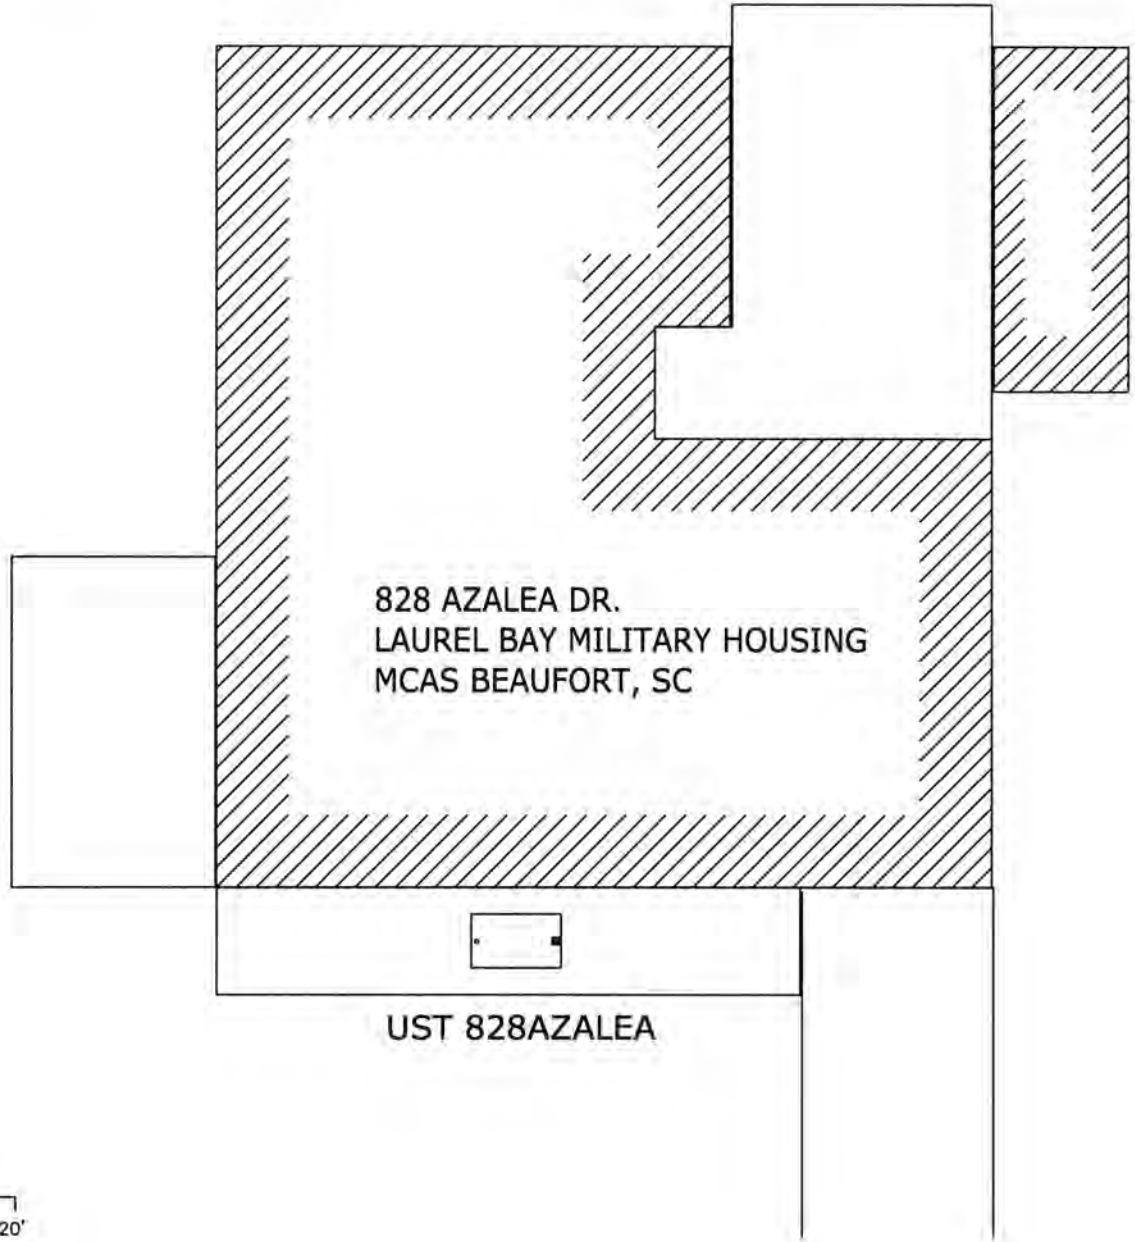
FIGURE 2 SITE MAP
828 AZALEA DR., LAUREL BAY
MCAS BEAUFORT SC

TANK DEPTH BELOW GRADE
828AZALEA = 32"

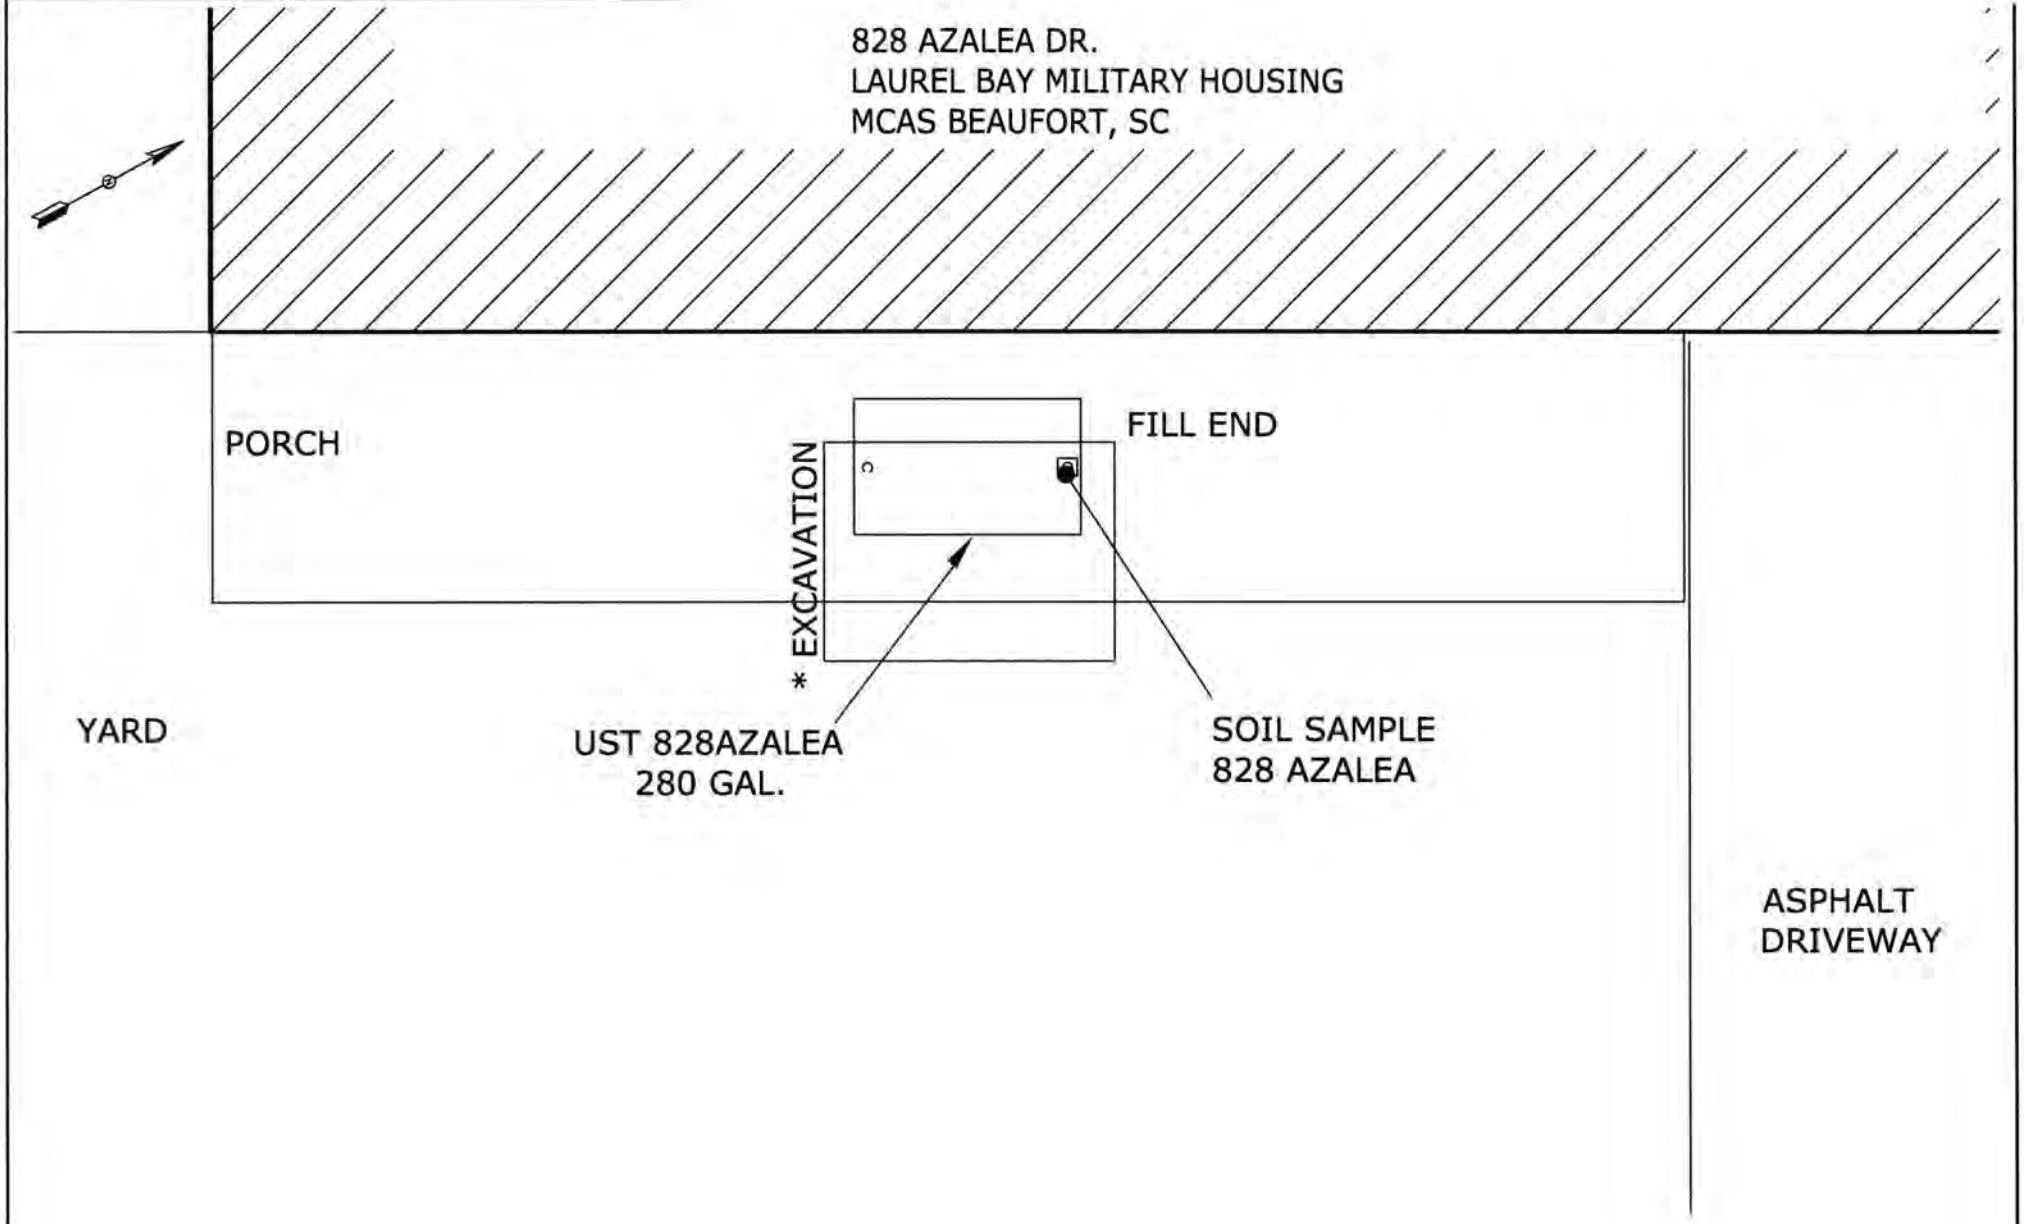
FIGURE 3 UST SAMPLE LOCATIONS
828 AZALEA DR., LAUREL BAY
MCAS BEAUFORT SC

* A PORTION OF THE PORCH WAS REMOVED TO FACILITATE TANK EXTRACTION.
