SUMMARY REPORT
148 BARRACUDA DRIVE (FORMERLY 911 BARRACUDA DRIVE)
LAUREL BAY MILITARY HOUSING AREA
MARINE CORPS AIR STATION BEAUFORT
BEAUFORT, SC

Contract Number: N62470-14-D-9016
CTO WE52
JUNE 2021

Underground Storage Tank (UST) Assessment Report

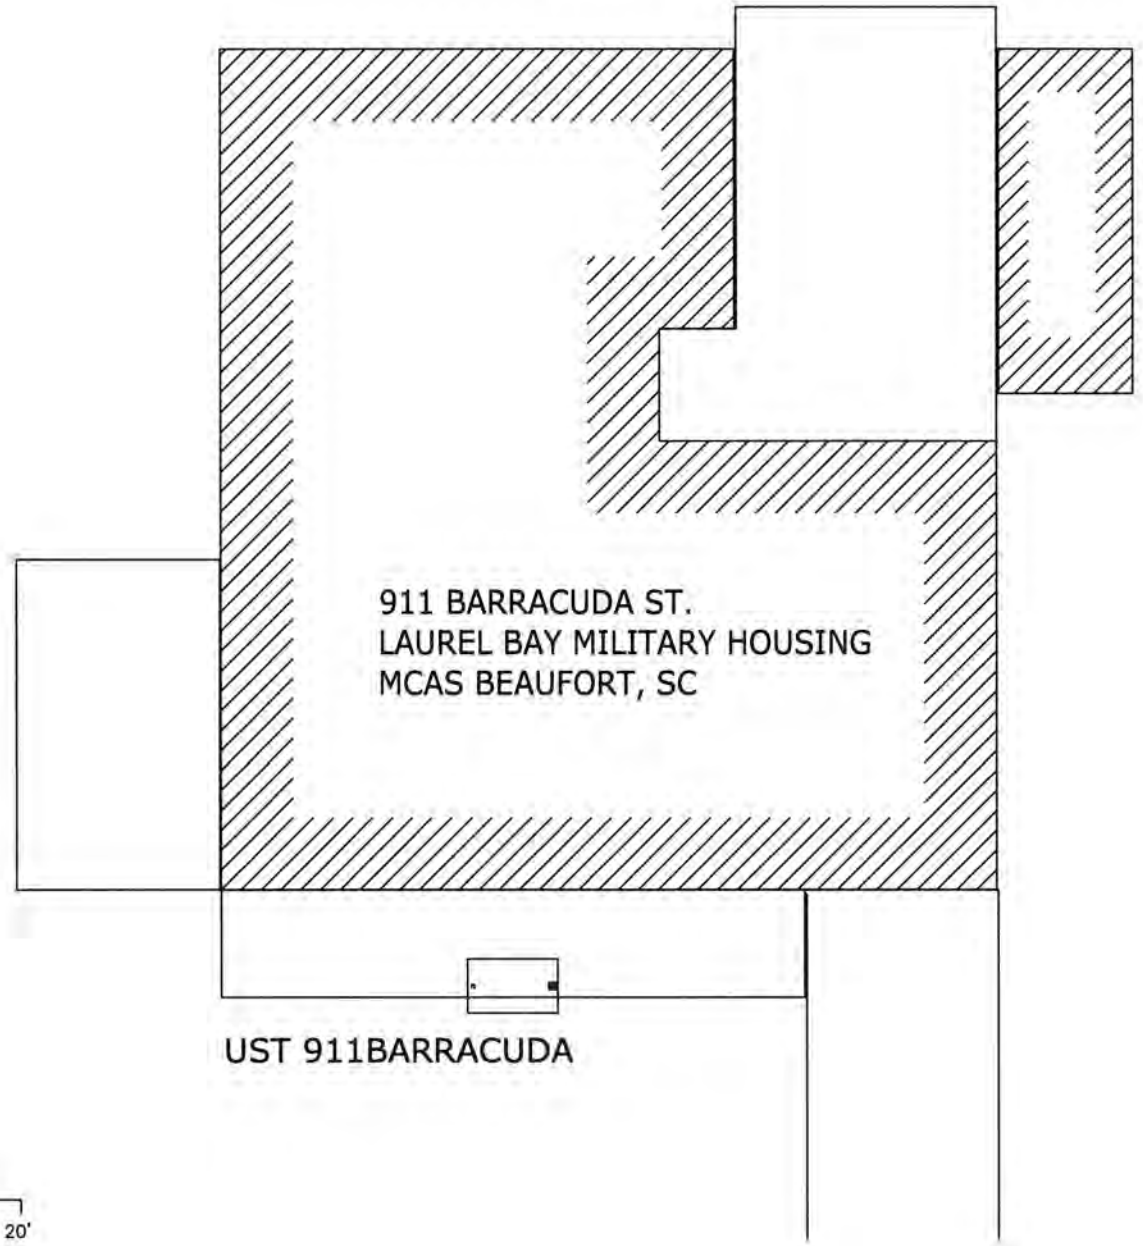
FIGURE 2 SITE MAP
911 BARRACUDA ST., LAUREL BAY
MCAS BEAUFORT SC

TANK DEPTH BELOW GRADE
911BARRACUDA = 36"

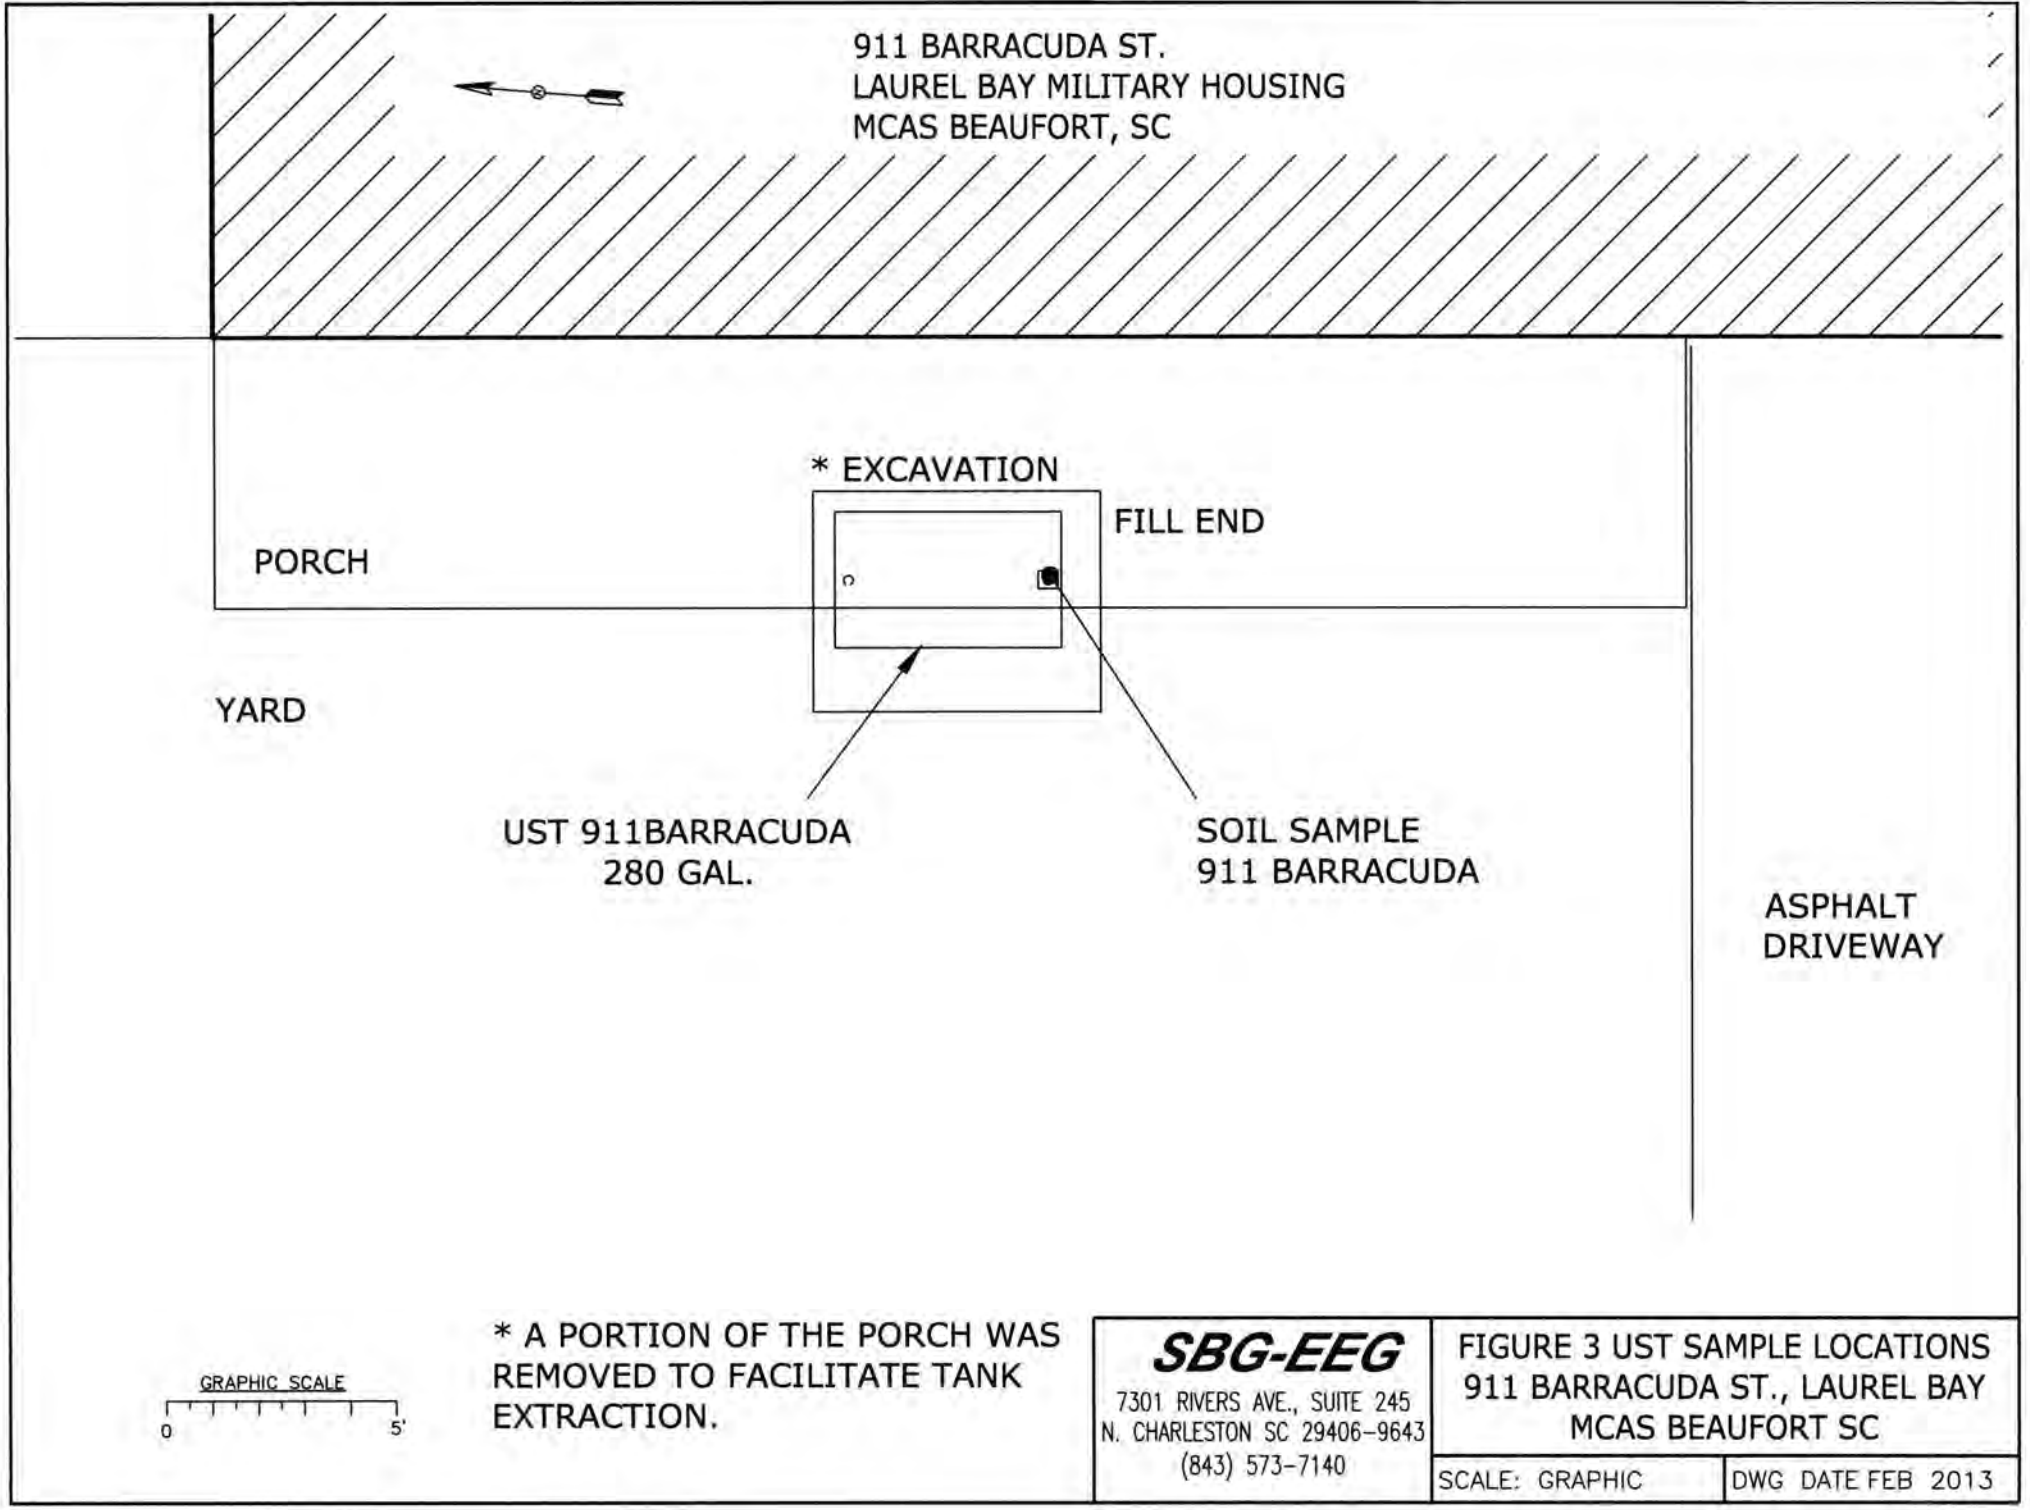
FIGURE 3 UST SAMPLE LOCATIONS
911 BARRACUDA ST., LAUREL BAY
MCAS BEAUFORT SC

* A PORTION OF THE PORCH WAS REMOVED TO FACILITATE TANK EXTRACTION.
