SUMMARY REPORT
113 BARRACUDA DRIVE (FORMERLY 914 BARRACUDA DRIVE)
LAUREL BAY MILITARY HOUSING AREA
MARINE CORPS AIR STATION BEAUFORT
BEAUFORT, SC

JUNE 2021

Contract Number: N62470-14-D-9016
CTO WE52
JUNE 2021

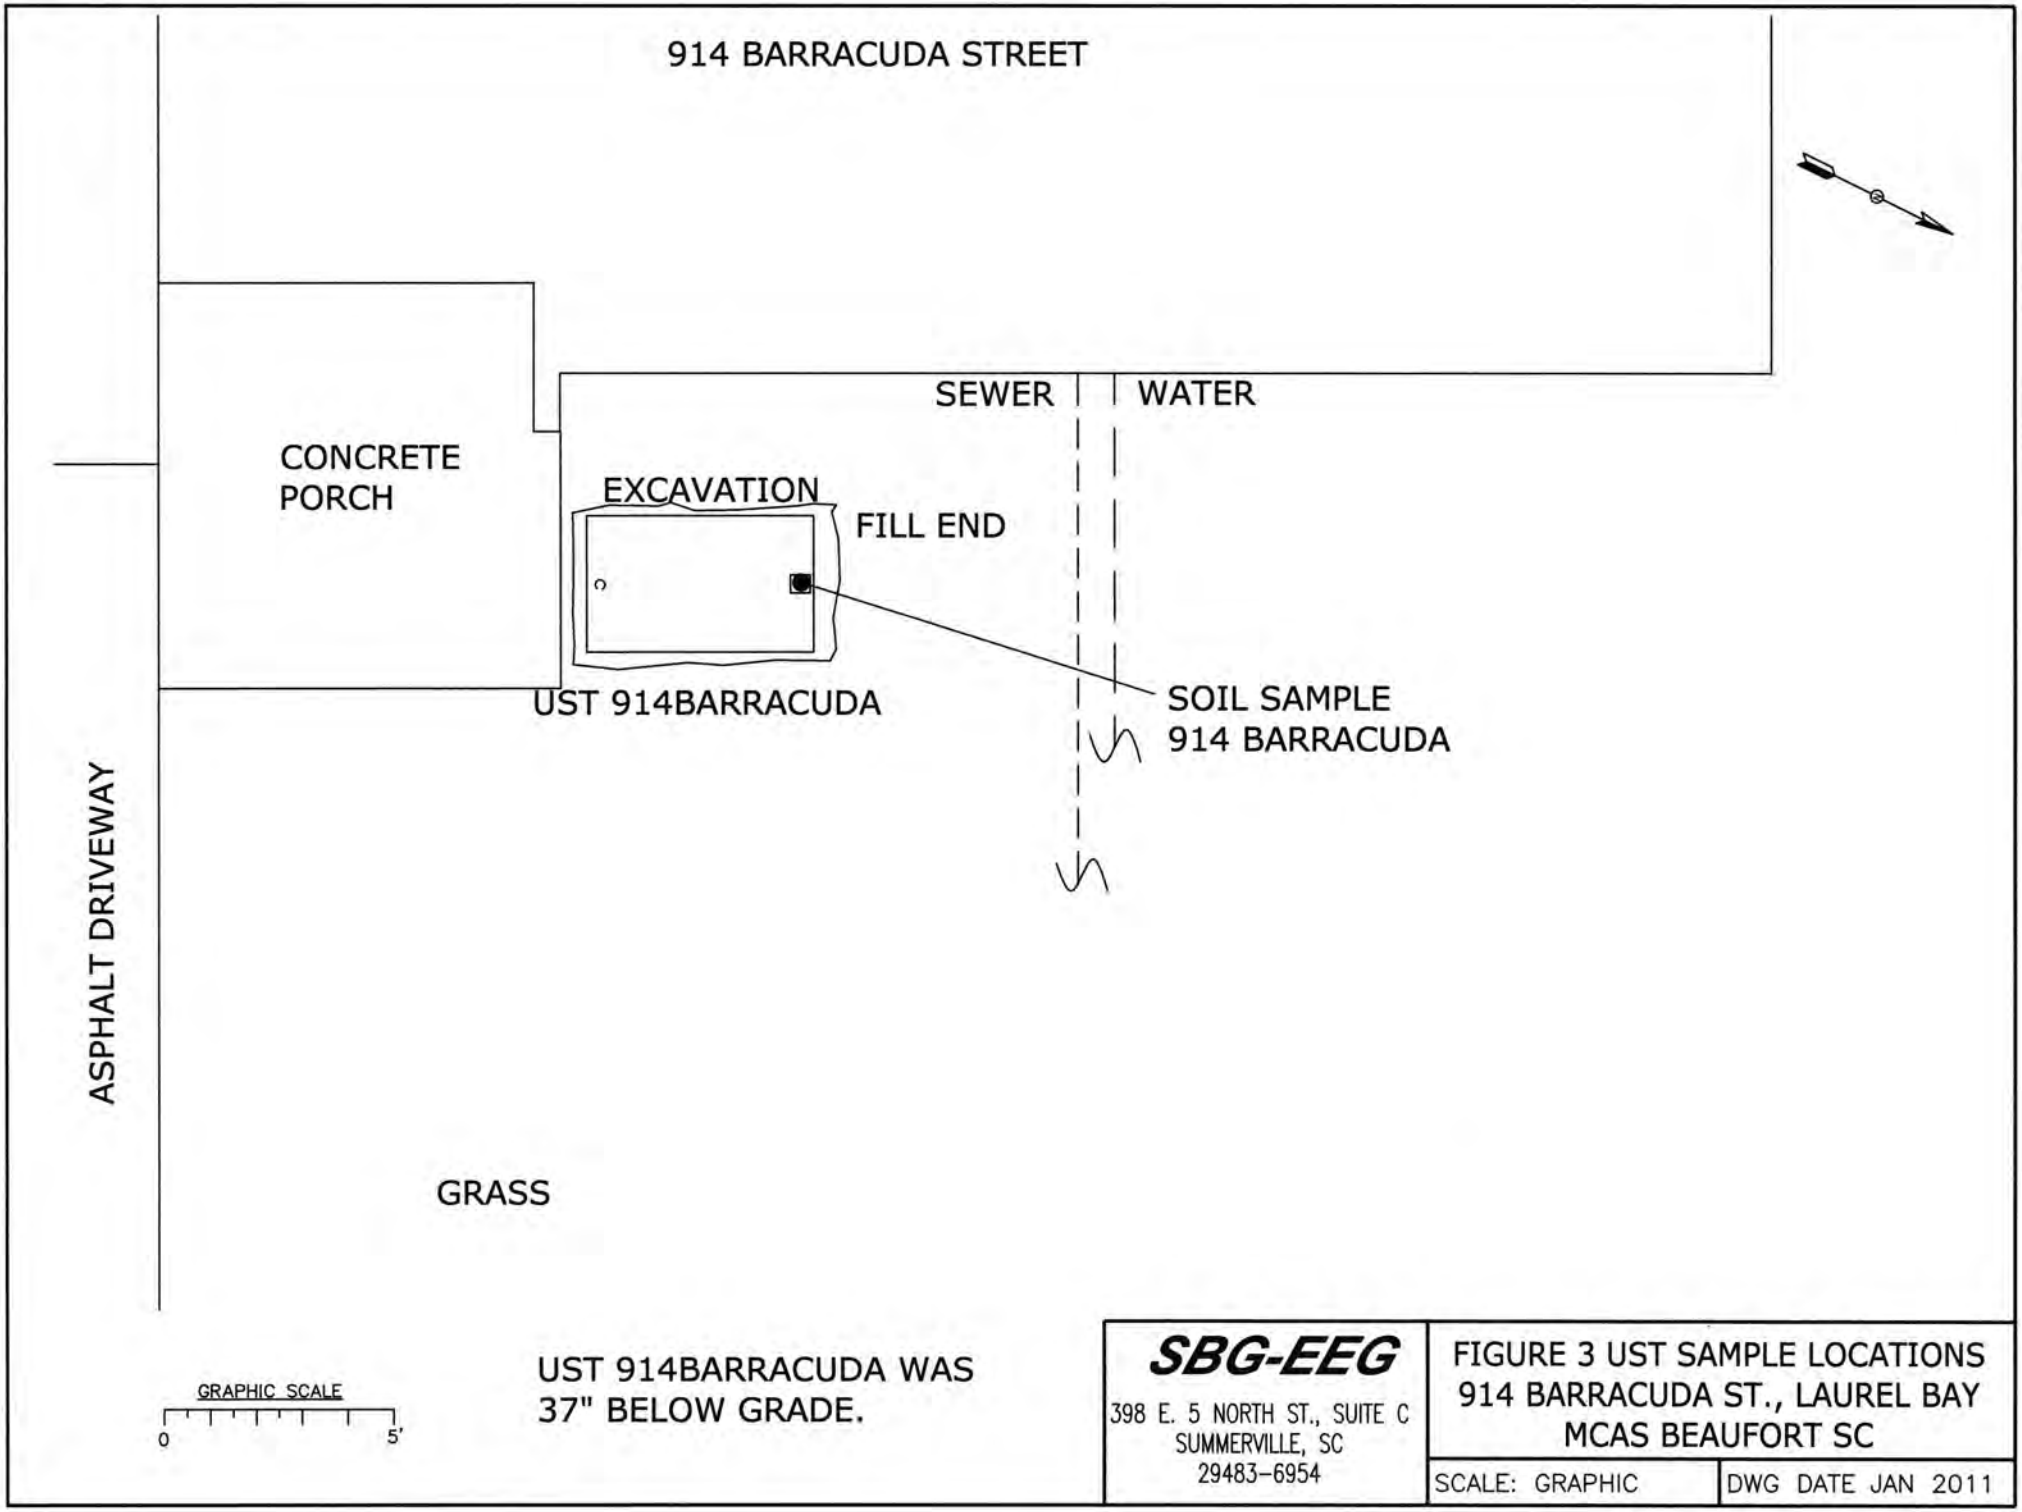
FIGURE 3 UST SAMPLE LOCATIONS
914 BARRACUDA ST., LAUREL BAY
MCAS BEAUFORT SC

UST 914BARRACUDA WAS
37" BELOW GRADE.
