SUMMARY REPORT
172 ALBACORE STREET (FORMERLY 933 ALBACORE STREET)
LAUREL BAY MILITARY HOUSING AREA
MARINE CORPS AIR STATION BEAUFORT
BEAUFORT, SC

JUNE 2021

Contract Number: N62470-14-D-9016
CTO WE52
JUNE 2021

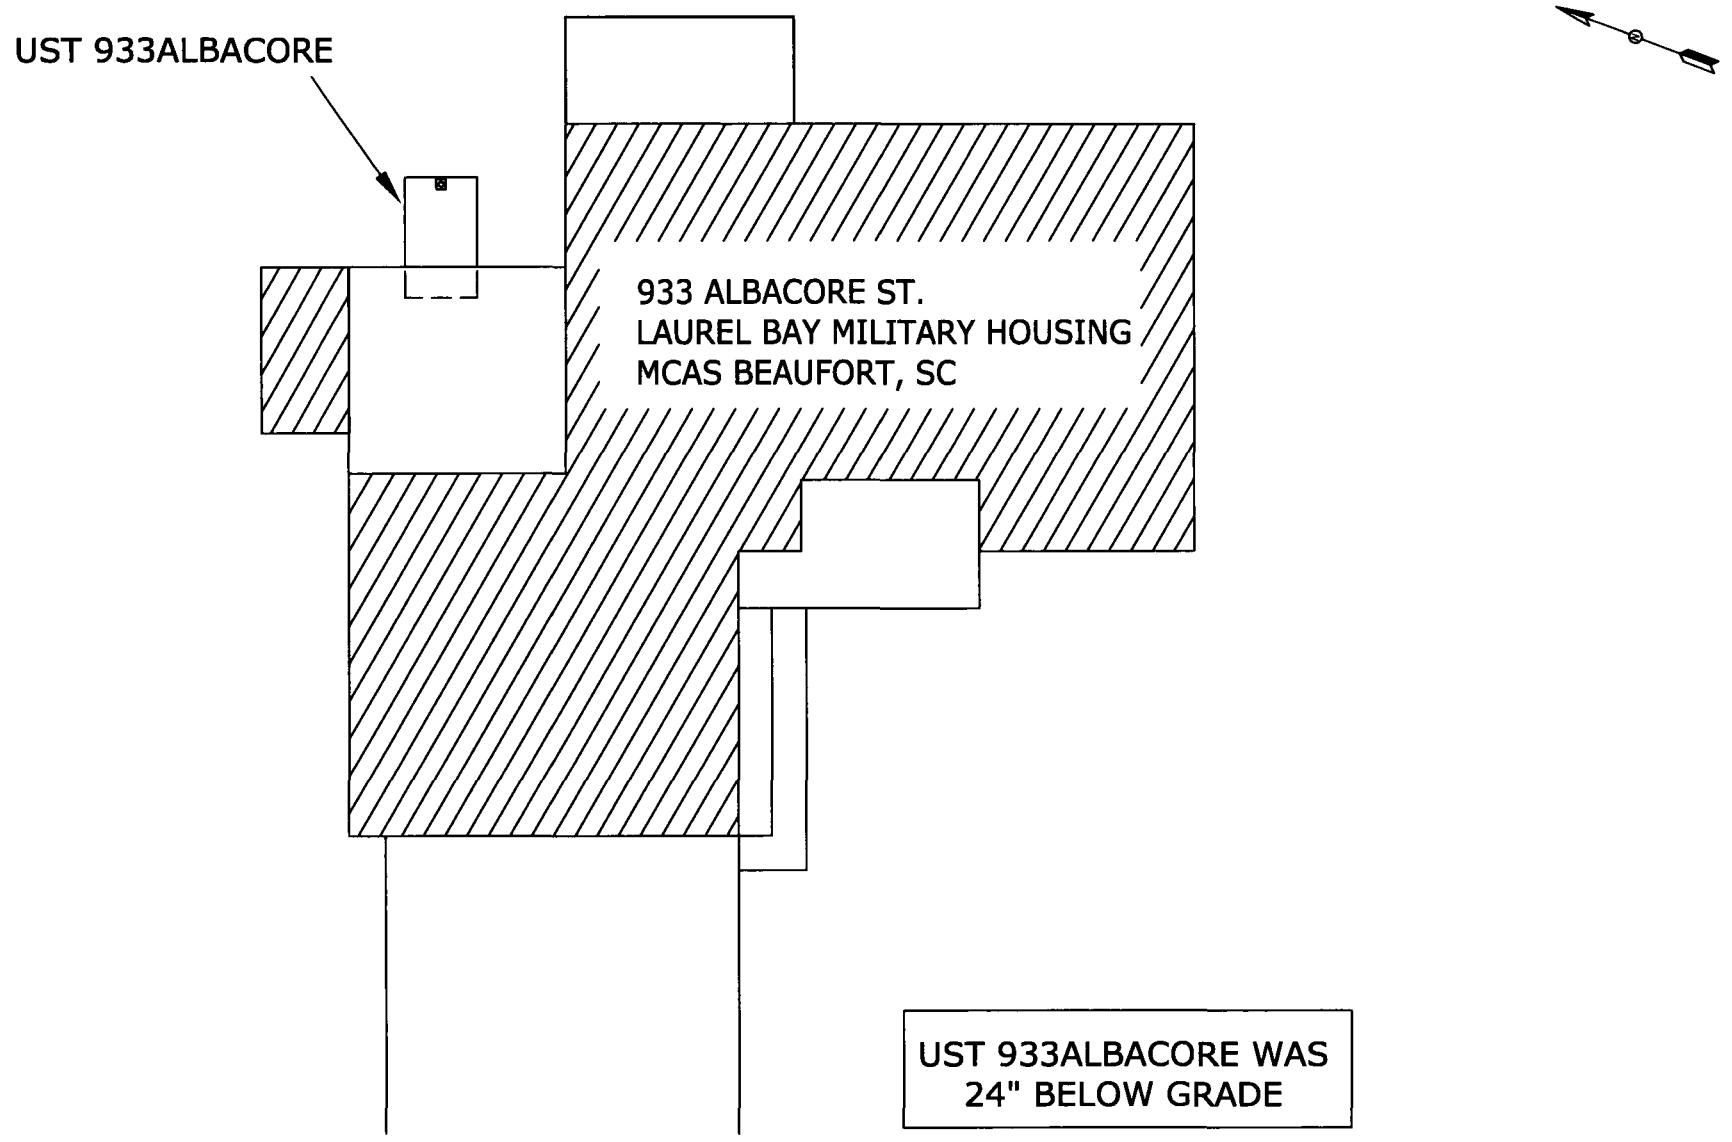
FIGURE 1 SITE MAP
933 ALBACORE ST., LAUREL BAY
MCAS BEAUFORT SC

On January 15, 2015, a single 280 gallon heating oil UST was removed from the back yard adjacent to the patio area at 172 Albacore Street (Formerly 933 Albacore Street). The former UST location is indicated on Figures 1 and 2 of the UST Assessment Report (Appendix B). The UST was removed and properly disposed of (i.e., shipped offsite for recycling or transported to a landfill). There was no visual evidence (i.e., staining or sheen) of petroleum impact at the time of the UST removal. According to the UST Assessment Report (Appendix B), the depth to the base of the UST was 5'0" below ground surface (bgs) and a single soil sample was collected

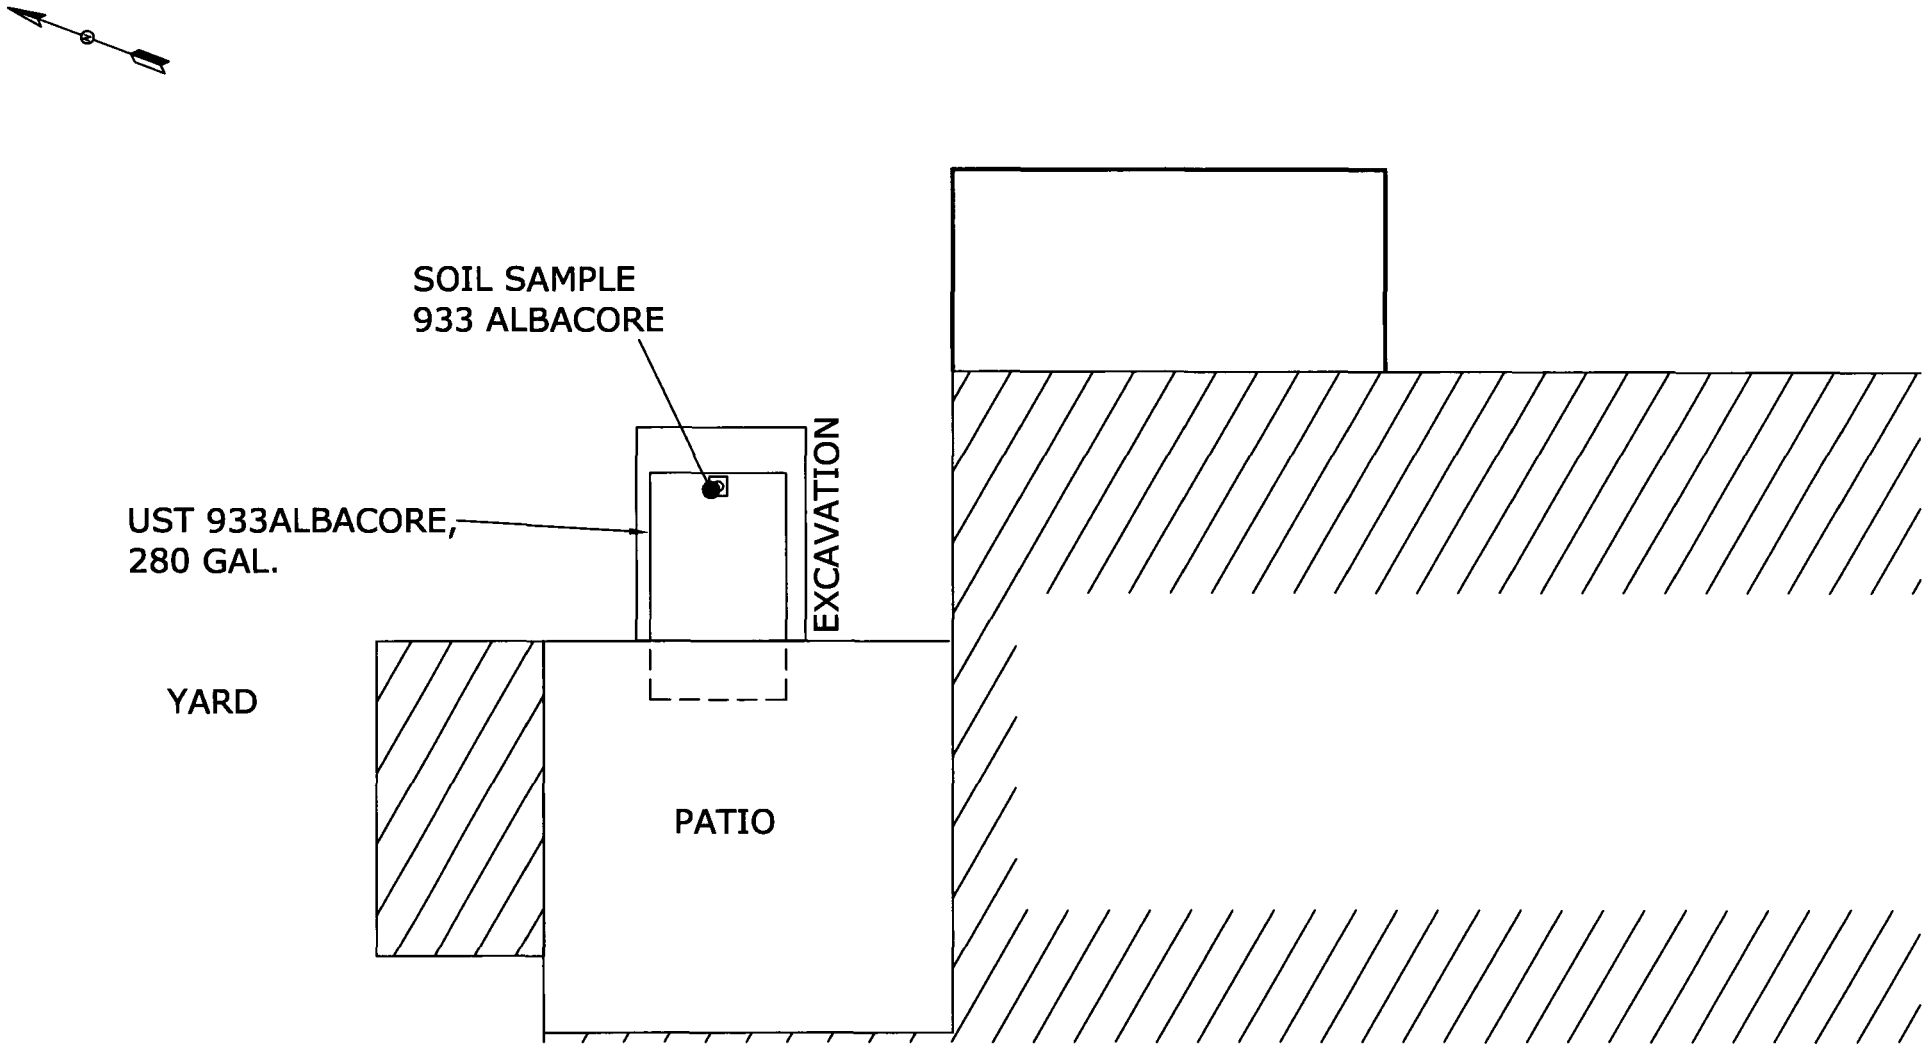
FIGURE 2 UST SAMPLE LOCATION
933 ALBACORE ST., LAUREL BAY
MCAS BEAUFORT SC

Sample #	Location	Sample Type (Soil/Water)	Soil Type (Sand/Clay)	Depth*	Date/Time of Collection	Collected by	OVA #
933 Albacore	Excav at fill end	Soil	Sandy	5'	1/15/15 1045 hrs	P. Shaw	
8							
9							
10							
11							
12							
13							
14							
15							
16							
17							
18							
19							
20

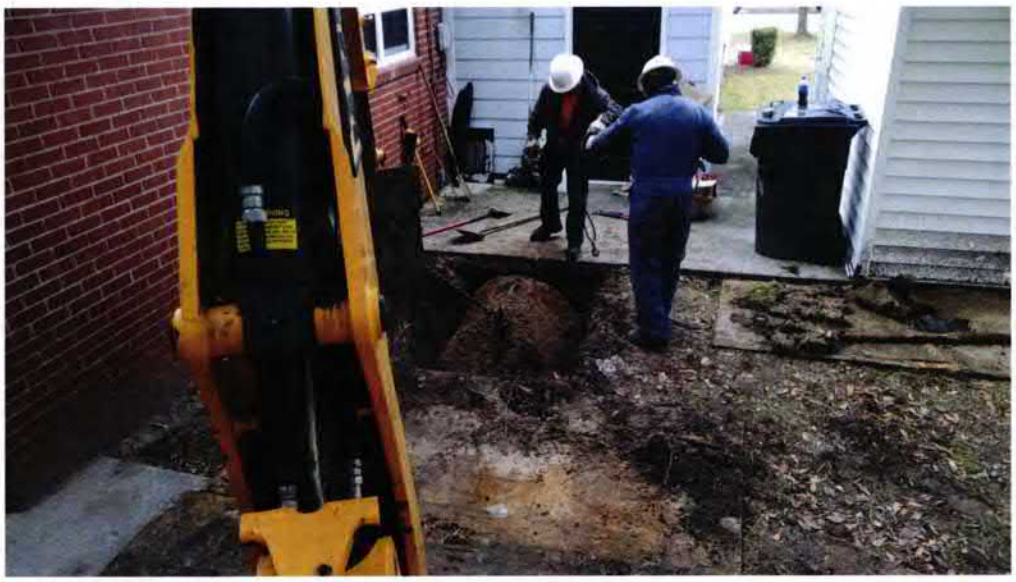
Picture 2: UST 933Albacore being hoisted from the excavation.
