SUMMARY REPORT 192 FOXGLOVE STREET (FORMERLY 1025 FOXGLOVE STREET) LAUREL BAY MILITARY HOUSING AREA MARINE CORPS AIR STATION BEAUFORT BEAUFORT, SC

Contract Number: N62470-14-D-9016 CTO WE52 JUNE 2021

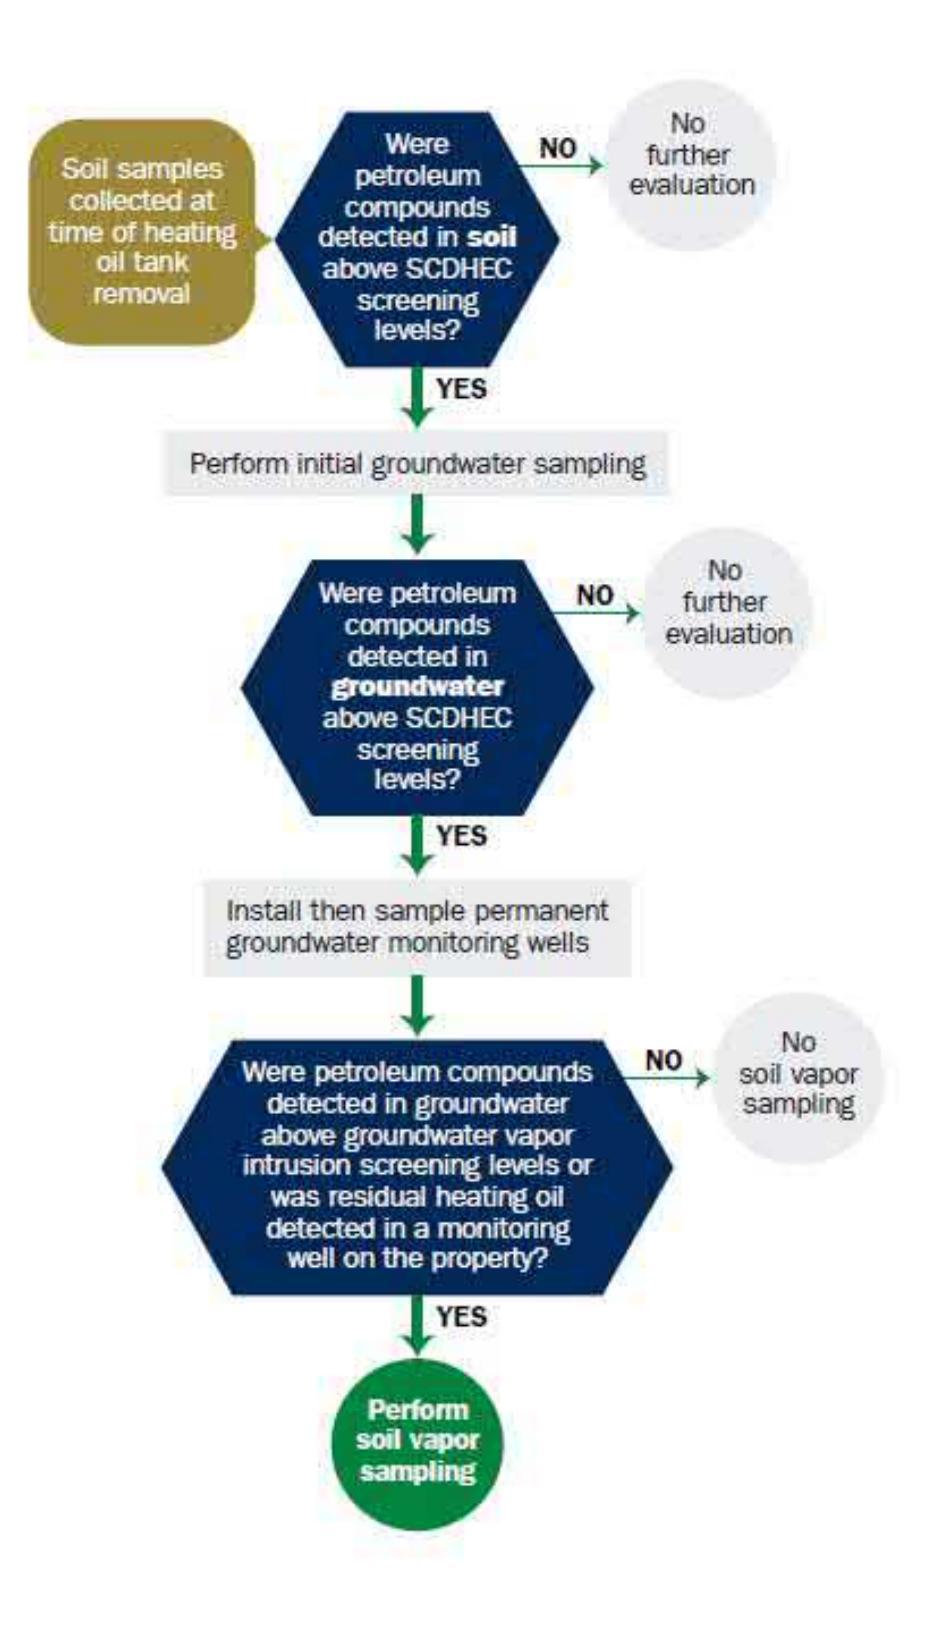
Appendix A - Multi-Media Selection Process for LBMH

The results of the soil sampling at each former UST location were used to determine if a potential for groundwater contamination exists (i.e., soil results greater than RBSLs) and subsequently to select properties for follow-up initial groundwater assessment (IGWA) sampling. The results of the IGWA sampling (if necessary) are used to determine the presence or absence of the aforementioned COPCs in groundwater and identify whether former UST locations will require additional delineation of COPCs in groundwater. In order to delineate the extent of impact to groundwater, permanent wells are installed and a sampling program is established for those former UST locations where IGWA sampling has indicated the presence of COPCs in excess of the SCDHEC RBSLs for groundwater. Groundwater analytical results are also compared to the site specific groundwater vapor intrusion screening levels (VISLs) to evaluate the potential for vapor intrusion and the necessity for an investigation associated with this media. A multi-media investigation selection process tree, applicable to the LBMH UST investigations, is presented as Appendix A.
