SUMMARY REPORT 269 GARDENIA DRIVE (FORMERLY 1045 GARDENIA DRIVE) LAUREL BAY MILITARY HOUSING AREA MARINE CORPS AIR STATION BEAUFORT BEAUFORT, SC

Contract Number: N62470-14-D-9016 CTO WE52 JUNE 2021

Attachment 1 South Carolina Department of Health and Environmental Control (SCDHEC) Underground Storage Tank (UST) Assessment Report

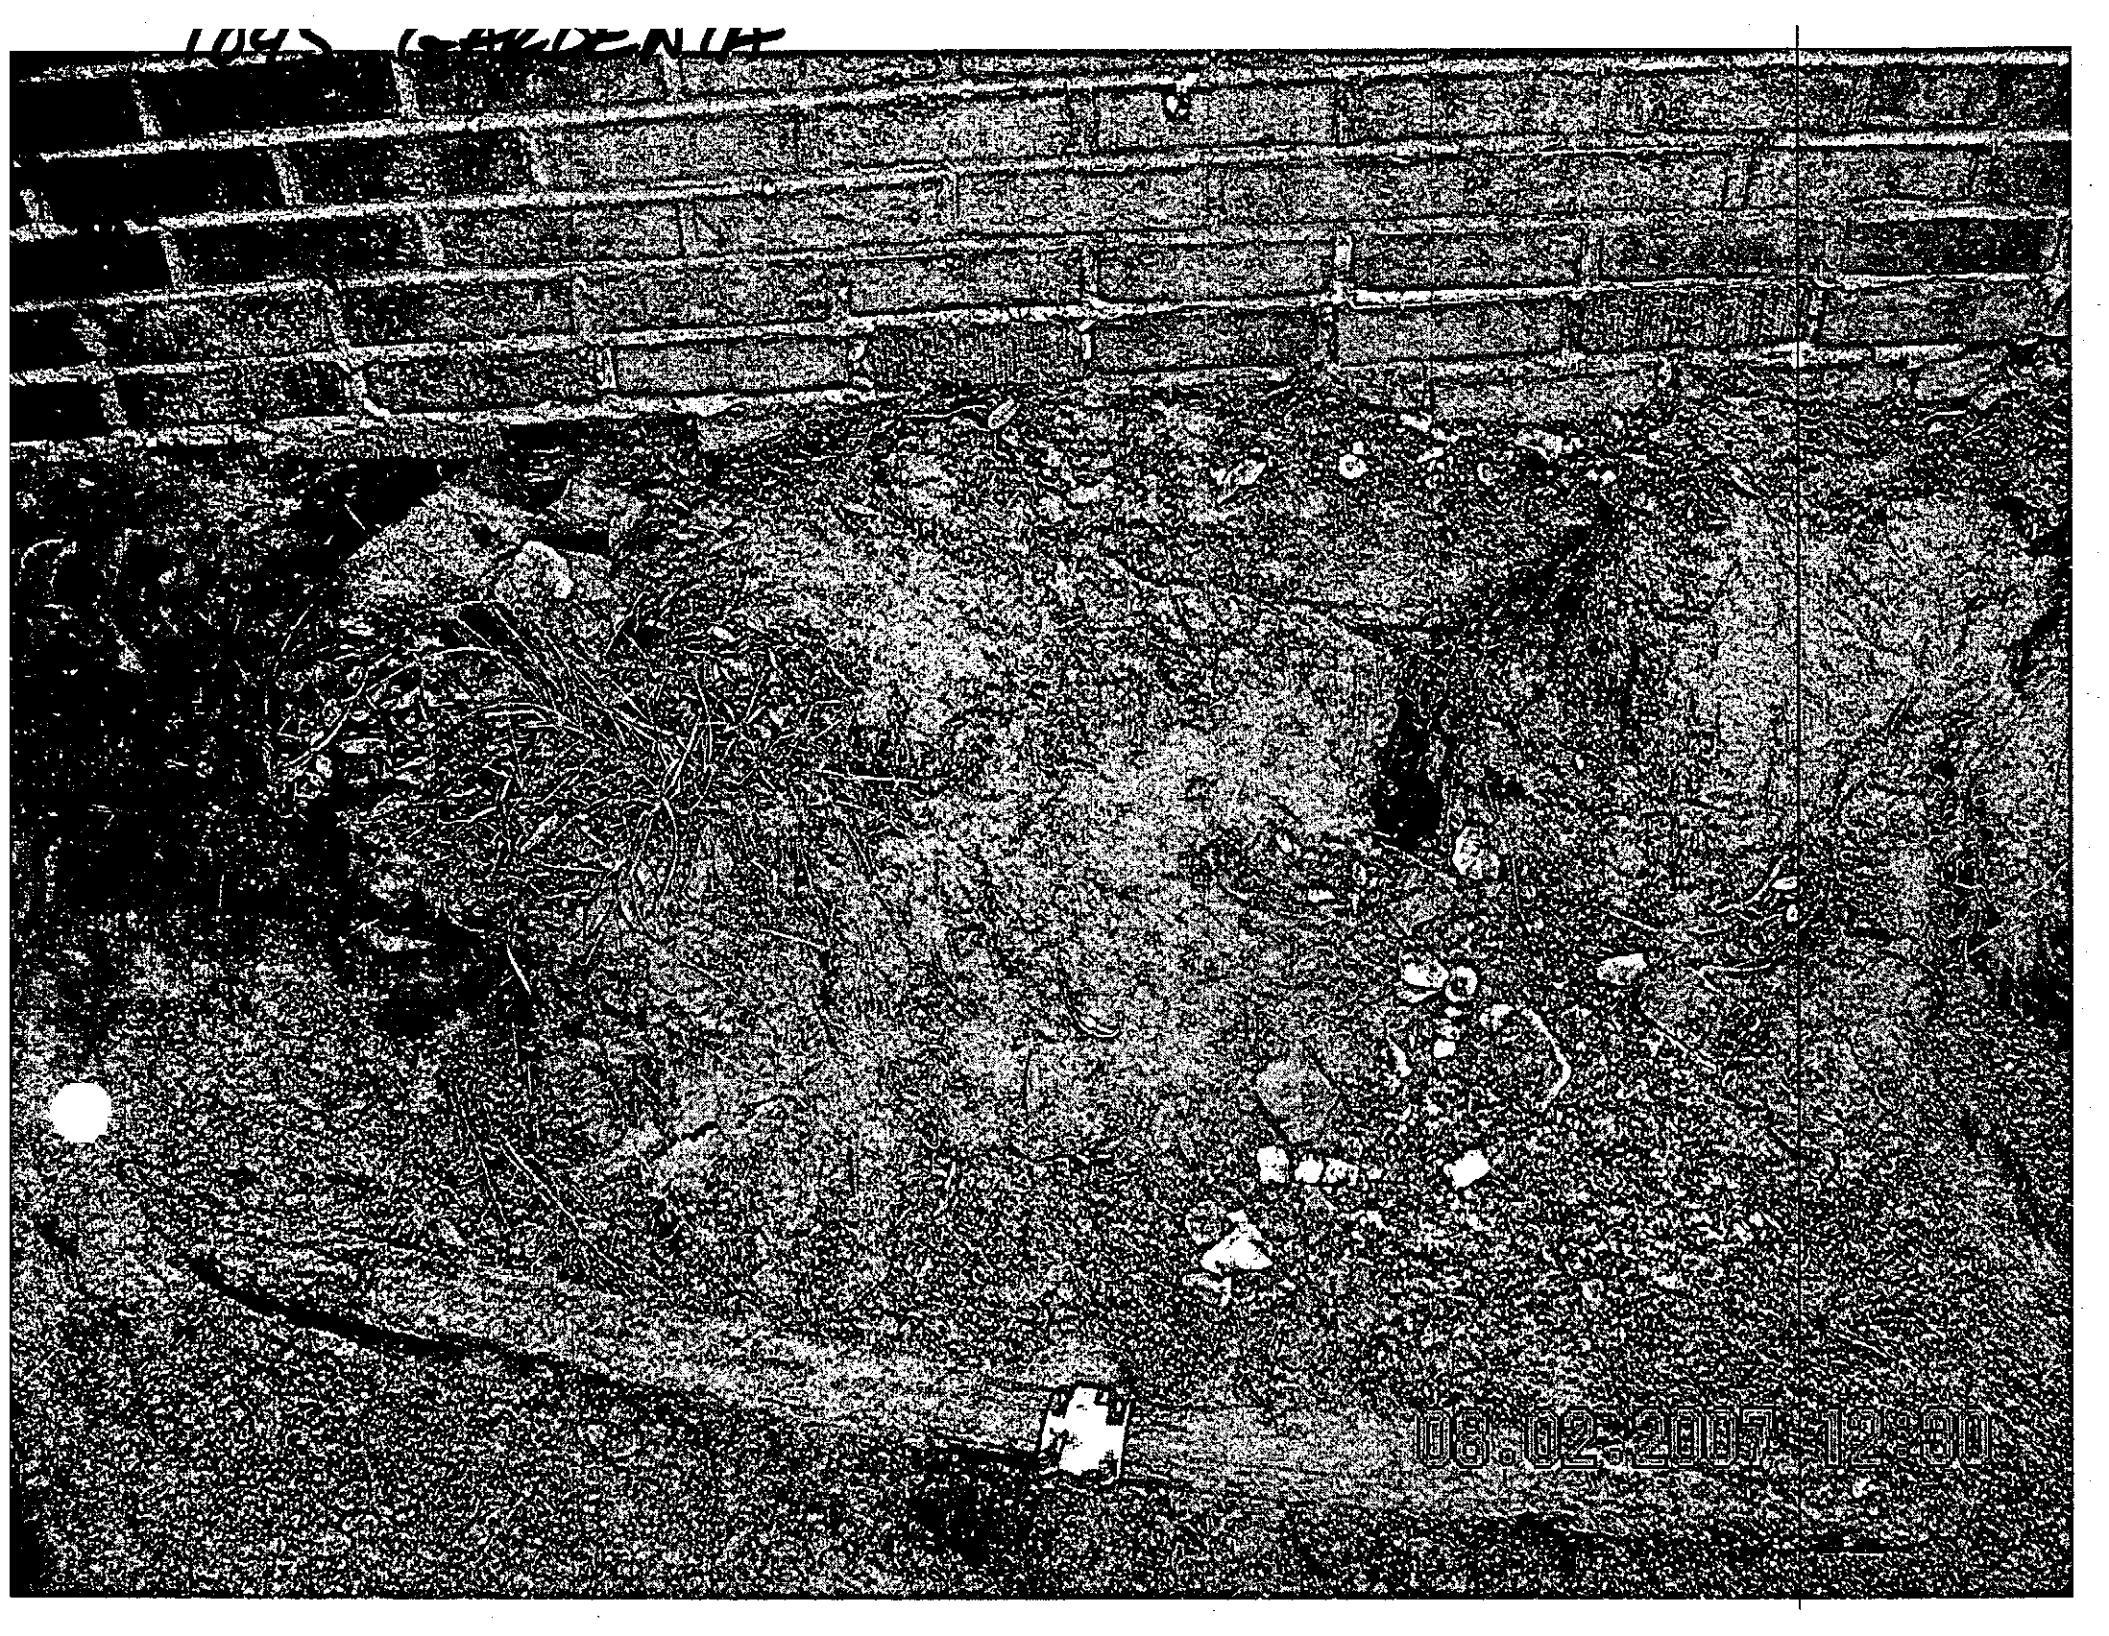
1045	
L	/	A B
	T/	ANK I
	B	ASE 68"
<u></u>		
	GARDENIA DI	RIVE N
		\mathbf{N}
TANK EXCAVATI	<u>ON</u>	
A-SOIL TEST SID B-SOIL TEST BO	E SAMPLE @ 46'' TTOM SAMPLE @ 6.R	···
		\mathbf{X}
J\$TOMER :	SCALE:	
USTOMER : BEAUFORT MILITARY COMPLEX FAMILY HOUSING	SCALE : 1/16"= 1'-0" SUPPLIER :	EPG INC.
