SUMMARY REPORT 72 HEATHER STREET (FORMERLY 1081 HEATHER STREET) LAUREL BAY MILITARY HOUSING AREA MARINE CORPS AIR STATION BEAUFORT BEAUFORT, SC

JUNE 2021

Contract Number: N62470-14-D-9016 CTO WE52 JUNE 2021

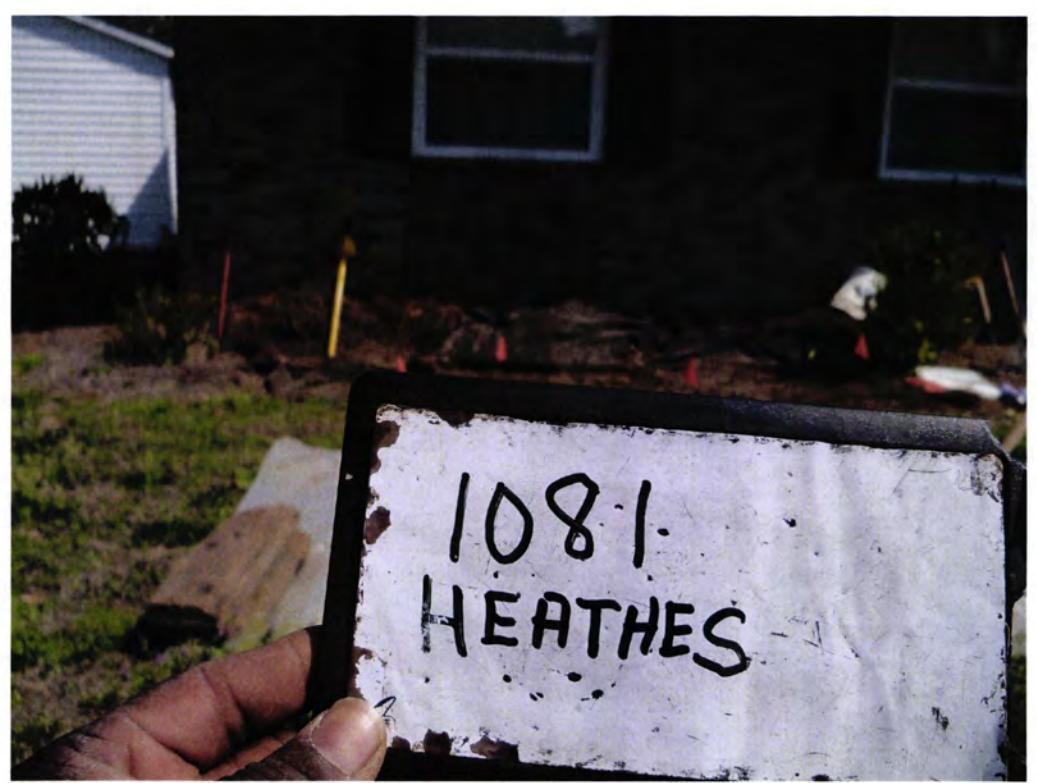
Picture 1: Location of UST 1081Heather. "Heathes" is an accidental misspelling.

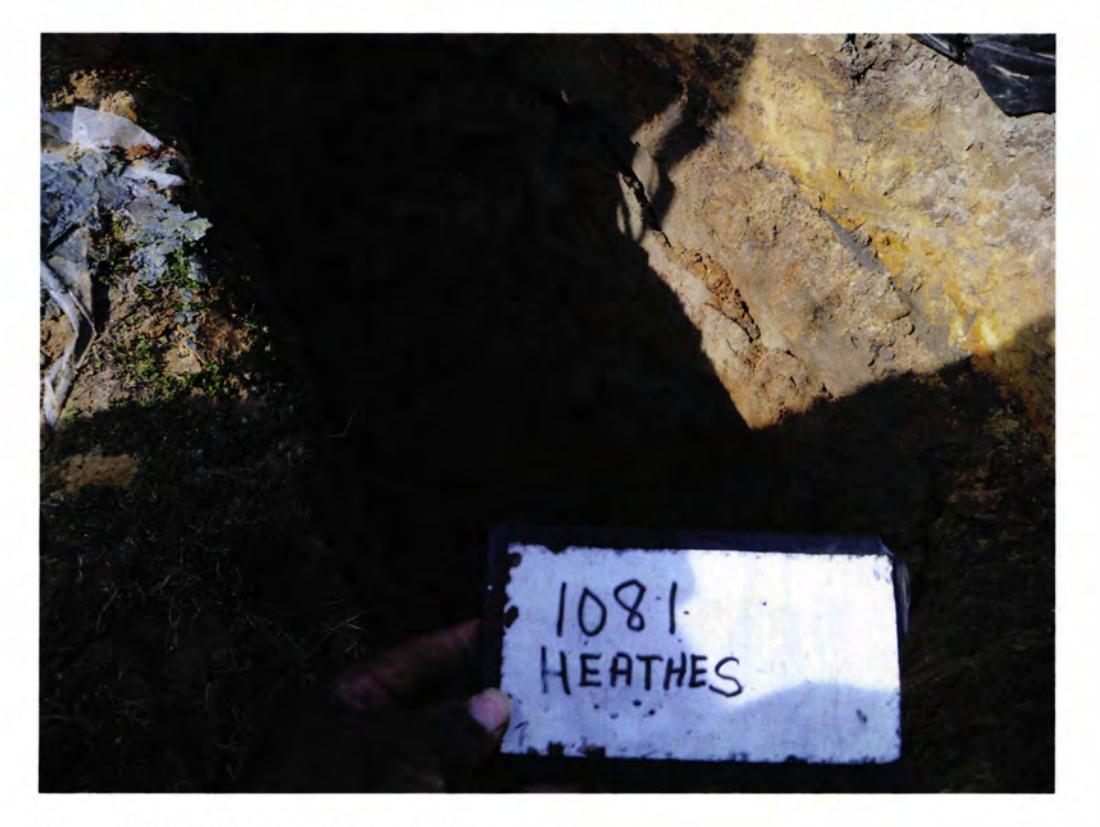
Heather
A٠	Product(ex. Gas, Kerosene)	Heating oil
B.	Capacity(ex. 1k, 2k)	280 gal
C.	Age	Late 1950s
D.	Construction Material(ex. Steel, FRP)	Steel
Е·	Month/Year of Last Use	Mid 1980s
F.	Depth (ft.) To Base of Tank	6'2"
G.	Spill Prevention Equipment Y/N	No
Н·	Overfill Prevention Equipment Y/N	No
I.	Method of Closure Removed/Filled	Removed
J _.	Date Tanks Removed/Filled	3/14/2011
K.	Visible Corrosion or Pitting Y/N	Yes
L.	Visible Holes Y/N	Yes

O. If any corrosion, pitting, or holes were observed, describe the location and extent for each UST Corrosion, pitting and holes were found throughout the tank.

Picture 2: UST 1081Heather tank pit.
