Public Health Review Report

29 September 2017

Marine Corps Air Station (MCAS) Beaufort
Marine Corps Recruit Depot (MCRD) Parris Island
Laurel Bay Military Housing

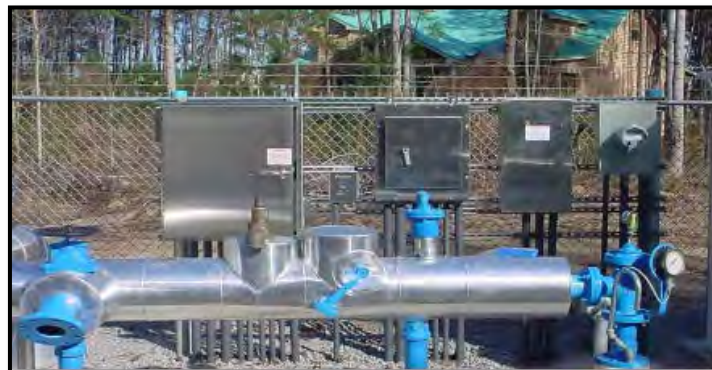
Figure 1: Port Royal Island Water Reclamation Facility

"As part of a merger, utilities on the military installations have undergone significant maintenance and upgrades. In addition, due to more restrictive Beaufort River discharge requirements, the military wastewater plants at the Air Station and Parris Island have been eliminated, with wastewater flows diverted to our state-of-the-art Port Royal Island Water Reclamation Facility.

Eight pump stations were constructed at Marine Corps Air Station Beaufort and Marine Corps Recruit Depot Parris Island. Several pump stations were eliminated and replaced with gravity sewer pipes, and pipelines were connected to the Port Royal Island Water Reclamation Facility. A two and a half million gallon equalization tank was added on Parris Island. The pipeline from Parris Island has been installed under Archer's Creek, using horizontal directional drilling to ensure minimal impact on the creek and surrounding marsh area. The consolidation project and upgrades to utilities have been completed."

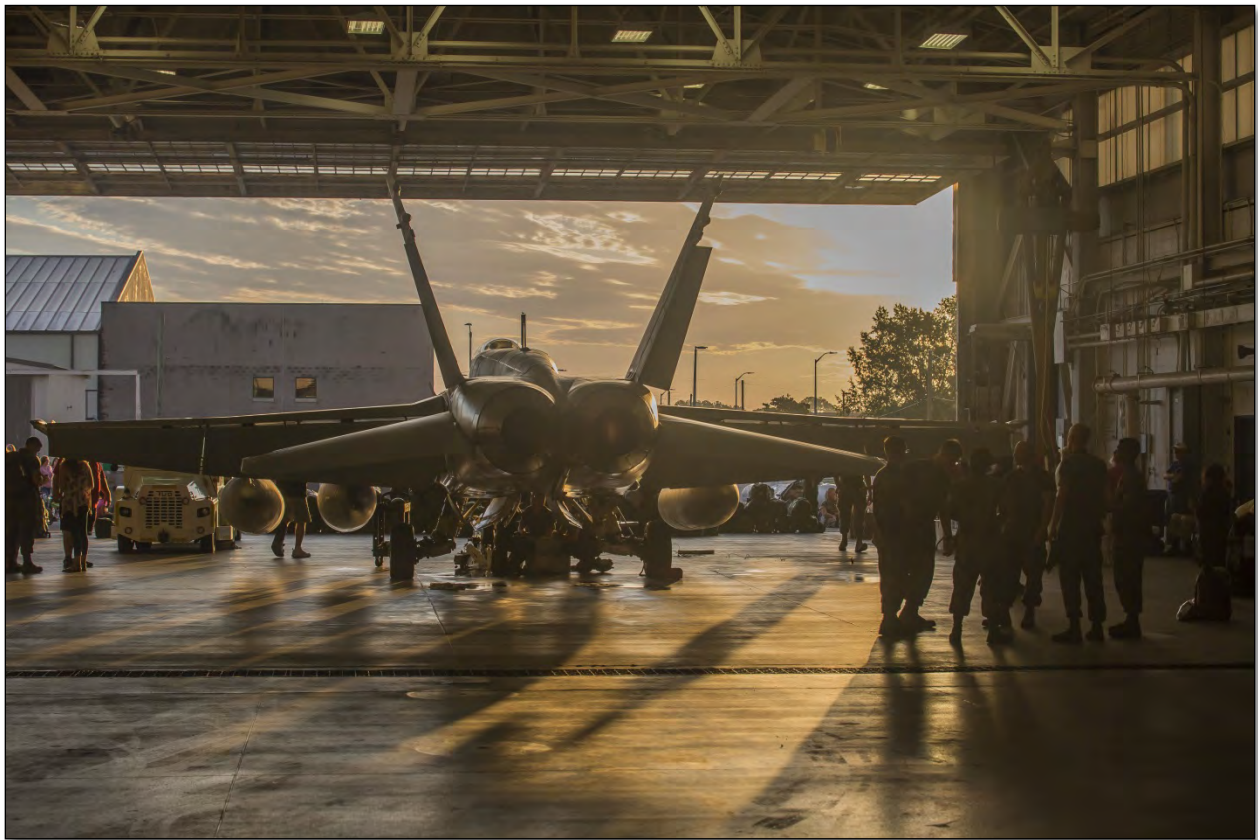
housing (e.g., senior officer's quarters, bachelor's quarters, and temporary lodging facilities) are presented on Figure 4. The majority of the sites are concentrated in areas where people work at MCAS Beaufort including the airfield and operational facilities (see Figure 4). Family housing units were located east of the airfield, but were demolished and all family housing for MCAS Beaufort is currently located off-base at LBMH. There is a child development center located south of the runway on Geiger Boulevard that provides day-care. The closest site to the child development center (SWMU 72) is approximately 1,200 feet away. SWMU 72 is designated as NFA¹³ and was identified as the base photo lab.

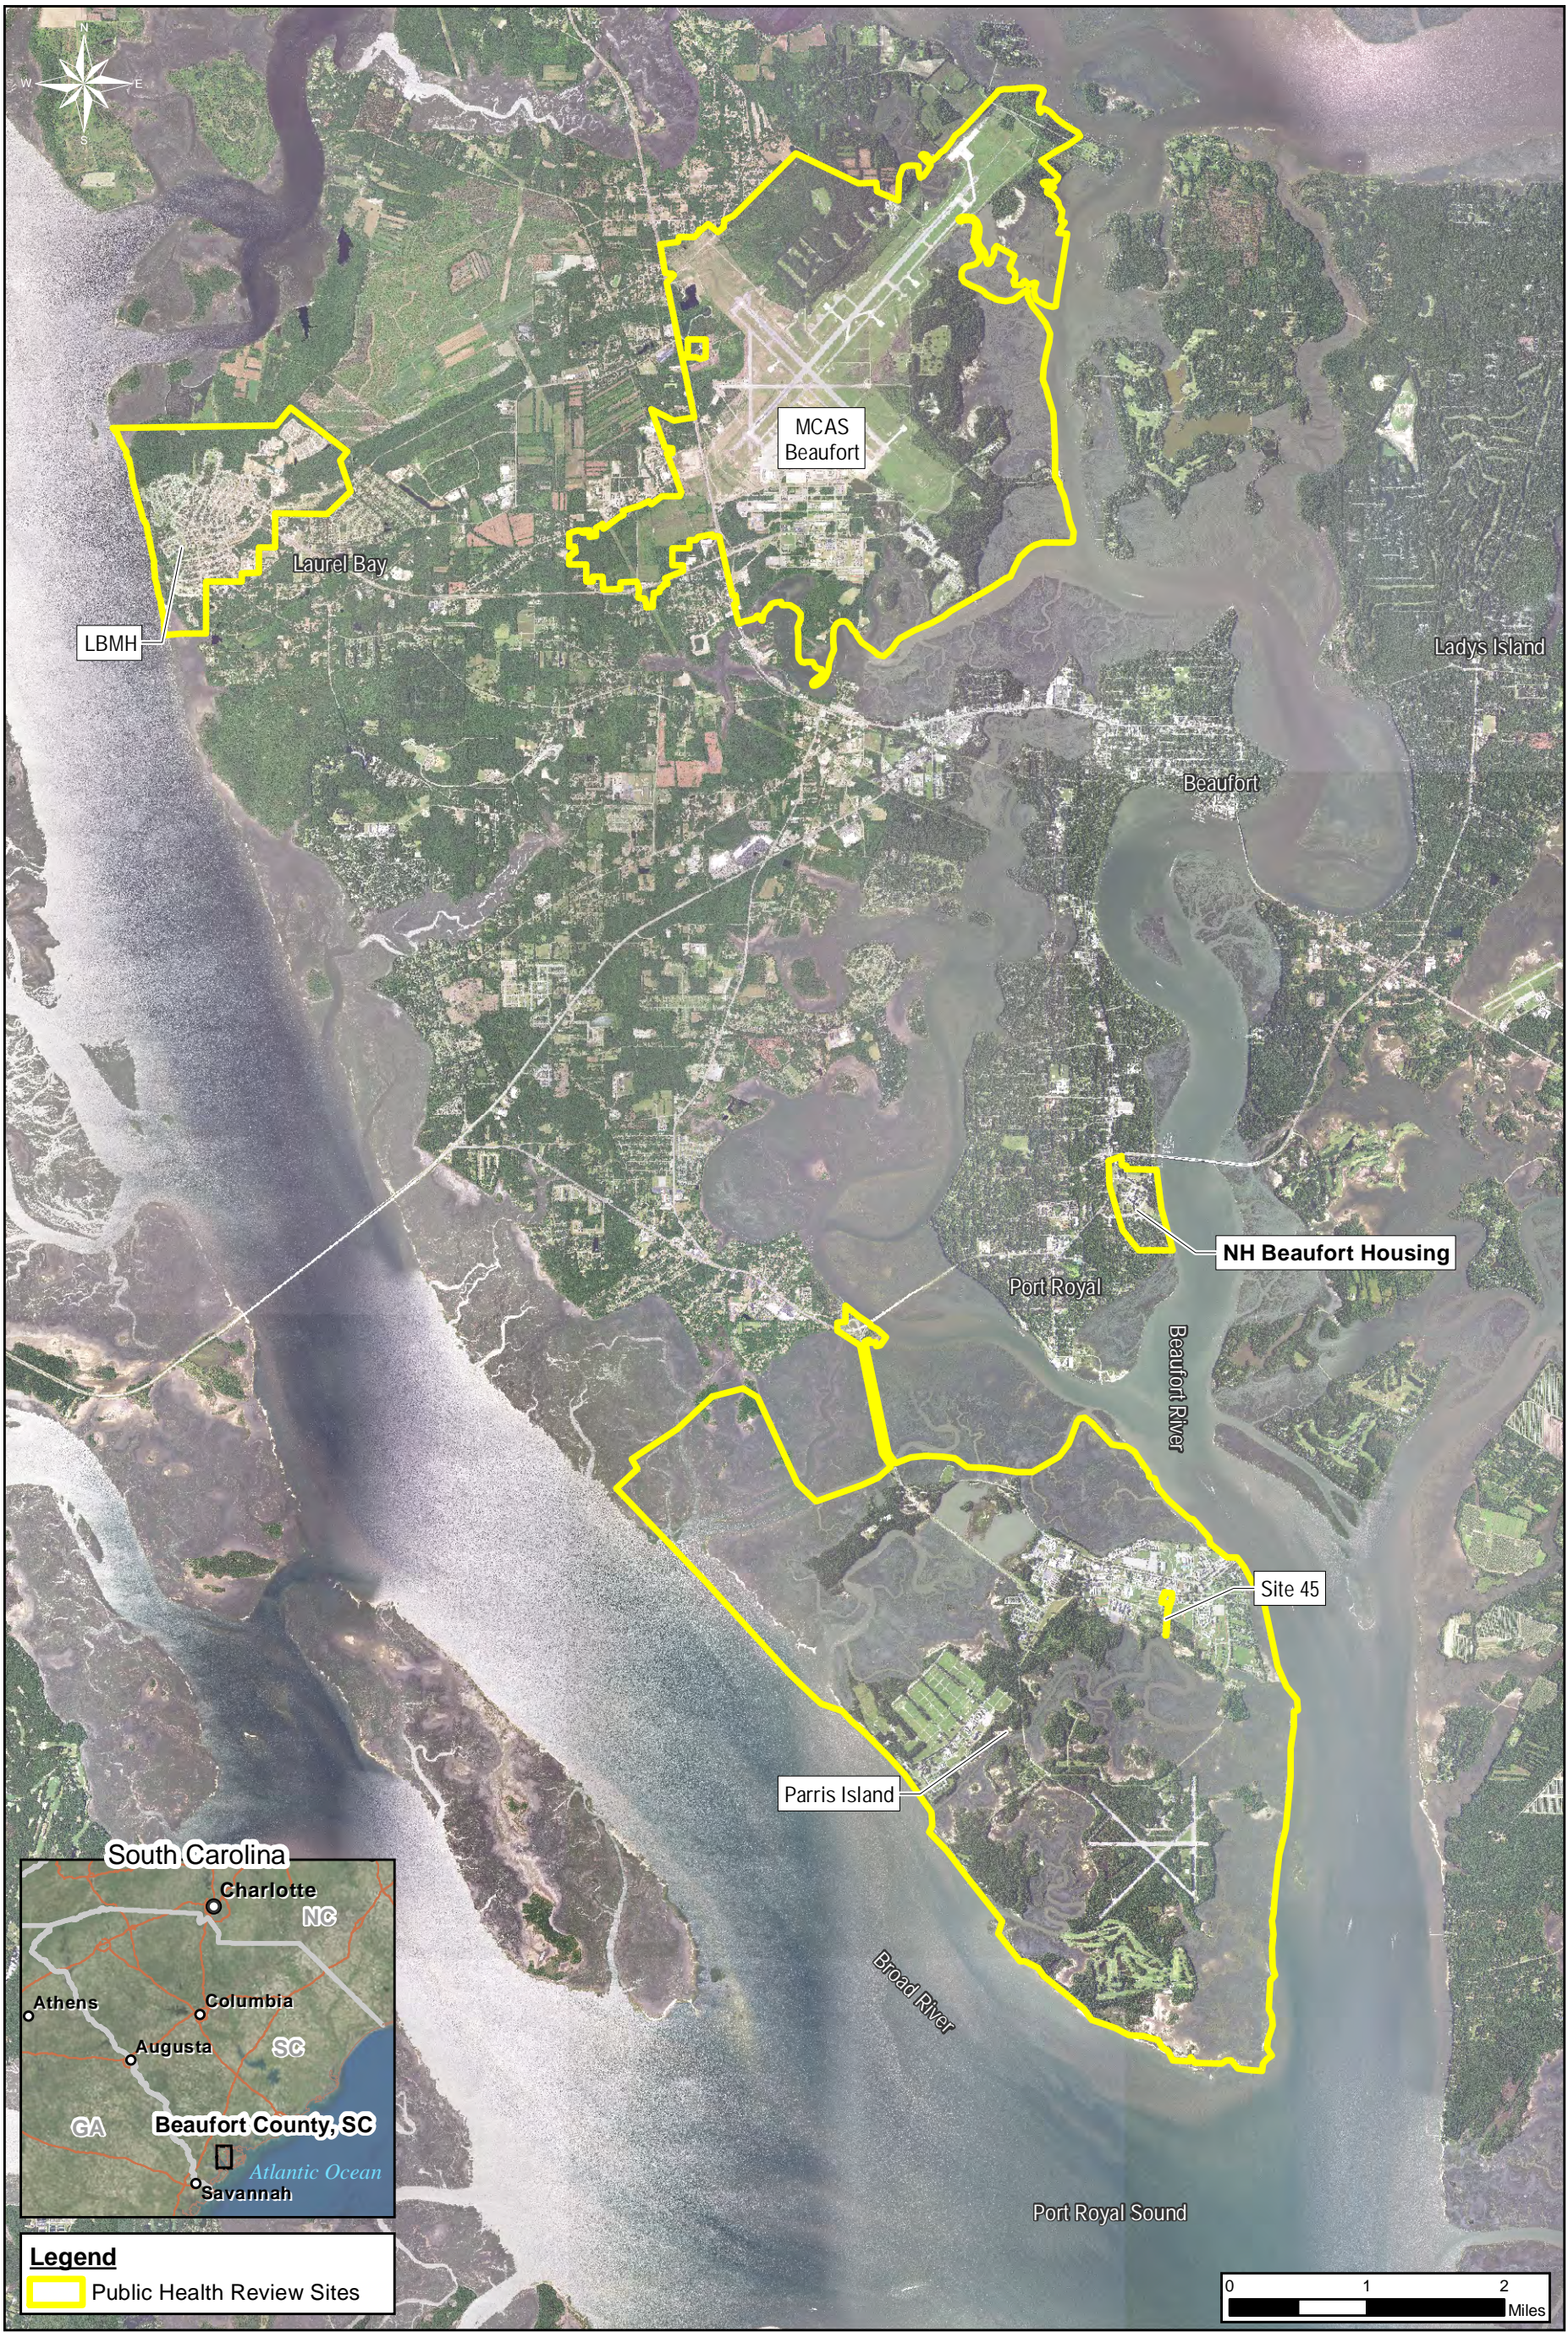
To identify the study population, a list of the postal zip codes for of active duty marines and sailors who lived and worked within approximately 30 miles of LBMH and MCRD Parris Island was created (see Figure 1). The zip codes used to identify the service members are provided in Appendix D. Data from the active duty Defense Manpower Data Center (DMDC) database were obtained for 01 January 2002 to 31 December 2016 using the identified zip codes to capture personal identifiers for all possible service members living in the study area. The study population scope was expanded to include active duty personnel from squadrons that deployed through MCAS Beaufort with zip codes outside the study area using the duty location codes in the DMDC database. The study start date was January 2002 because this is the first month the EDC began archiving medical and personnel records data. The study end date was December 2016 because this allowed sufficient time for medical claims data to be submitted and entered into the medical data systems. Latency was not used as a factor in this analysis because the latency of most pediatric cancers is unknown.

Epidemiological Investigation Study Area
Public Health Report
Beaufort County, South Carolina

- **Study Area:** Children (including those conceived) of active duty Marine Corps and Navy service members assigned to work at MCAS Beaufort and MCRD Parris Island from January 2002 to December 2016. These dates were chosen because medical data was not available prior to 2002. The study was based on sponsor zip codes within a 30-mile radius of the study area including LBMH (See Figure 1 – Epidemiological Investigation Study Area).

In June of 2015, in response to residents' concerns, the United States Marine Corps (USMC) requested that the Navy and Marine Corps Public Health Center (NMCPHC) investigate the incidence of pediatric cancers in current and former residents of Laurel Bay Military Housing (LBMH) in Beaufort, South Carolina, which residents believe may be associated with environmental exposures (see Figure 1). In response to this request, NMCPHC initiated a Public Health Review (PHR).

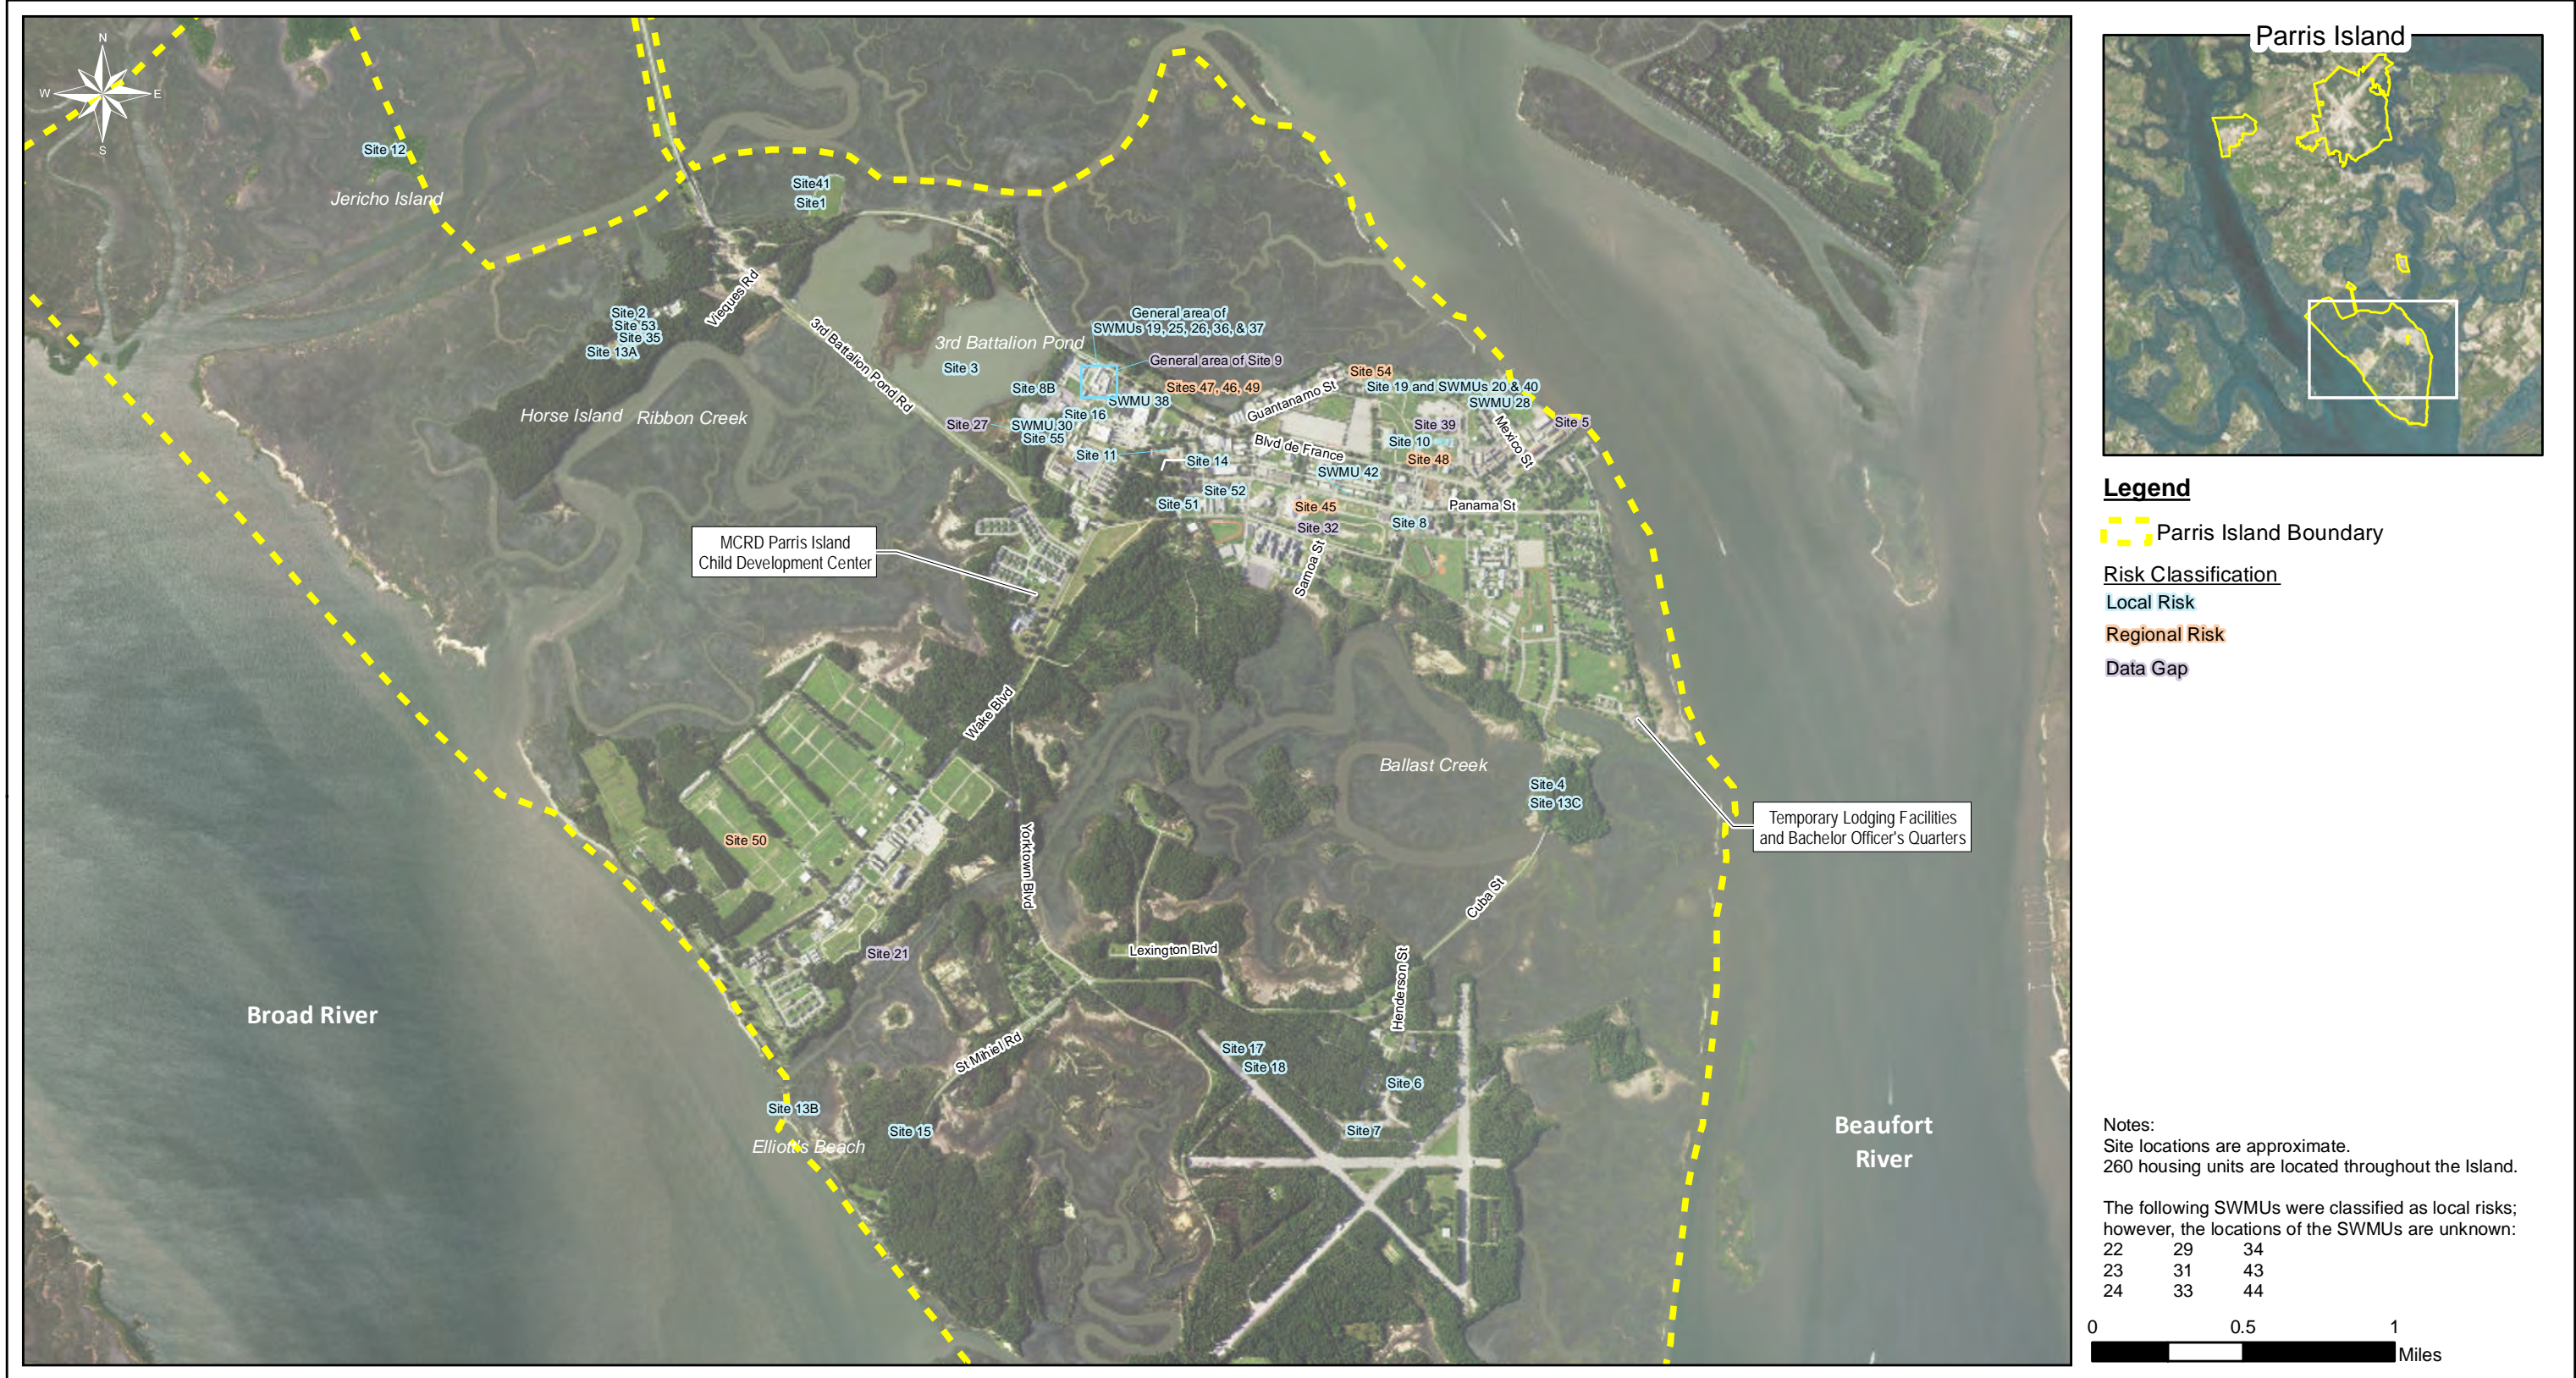
The majority of the sites are concentrated in areas where people work on MCRD Parris Island. Available information indicated that there are approximately 260 housing units including Unaccompanied Housing (UH), Officer Housing (OH), and Bachelor Officer's Quarters (BOQ). The UH and BOQ are located near the Beaufort River on the eastern perimeter of MCRD Parris Island. Enlisted housing is on the Broad River. The child development center is located on Wake Boulevard and is approximately 2,500 feet from the nearest site (Site 55 – Fiber Optic Vault). Location information was not available for some sites and therefore could not be identified on the figure. A list of sites for which the locations are unknown is presented in the legend notes on Figure 5.

MCRD Parris Island Overview
Public Health Review
Beaufort County, South Carolina

Additional information collected for this review included the identification of site locations relative to other buildings and existing features on MCRD Parris Island. This information was collected to identify where potential for wide-spread human exposures and potential populations at risk exist (e.g., residents, recreationists, commercial/industrial worker, and construction worker). The identified sites, lodging facilities, bachelor officer's quarters, child development center, and other existing features for MCRD Parris Island are presented on Figure 5.

Of the 58 sites reviewed, 45 sites were determined to have potential local impacts, seven sites were determined to have potential regional impacts, and six sites were determined to have data gaps that precluded categorization of potential impacts. In the table below, sites are listed by impact category with a short description of each site identified at MCRD Parris Island. A more detailed summary of site information including contaminants of concern, current status or recommended actions, and impact category rationale is presented on Table 2. The site locations are presented on Figure 5.

Note: Due to the extensive documentation of the Site 45 investigation, Site 45 is presented in a separate section in order to facilitate summary of the information/findings. Site 45 is located on MCRD Parris Island (see Figure 5 and Figure 6).
