SUMMARY REPORT
60 EAST CYPRESS STREET (FORMERLY 224 EAST CYPRESS STREET)
LAUREL BAY MILITARY HOUSING AREA
MARINE CORPS AIR STATION BEAUFORT
BEAUFORT, SC

JUNE 2021

CDM - AECOM
Multimedia Joint Venture

Contract Number: N62470-14-D-9016
CTO WE52
JUNE 2021

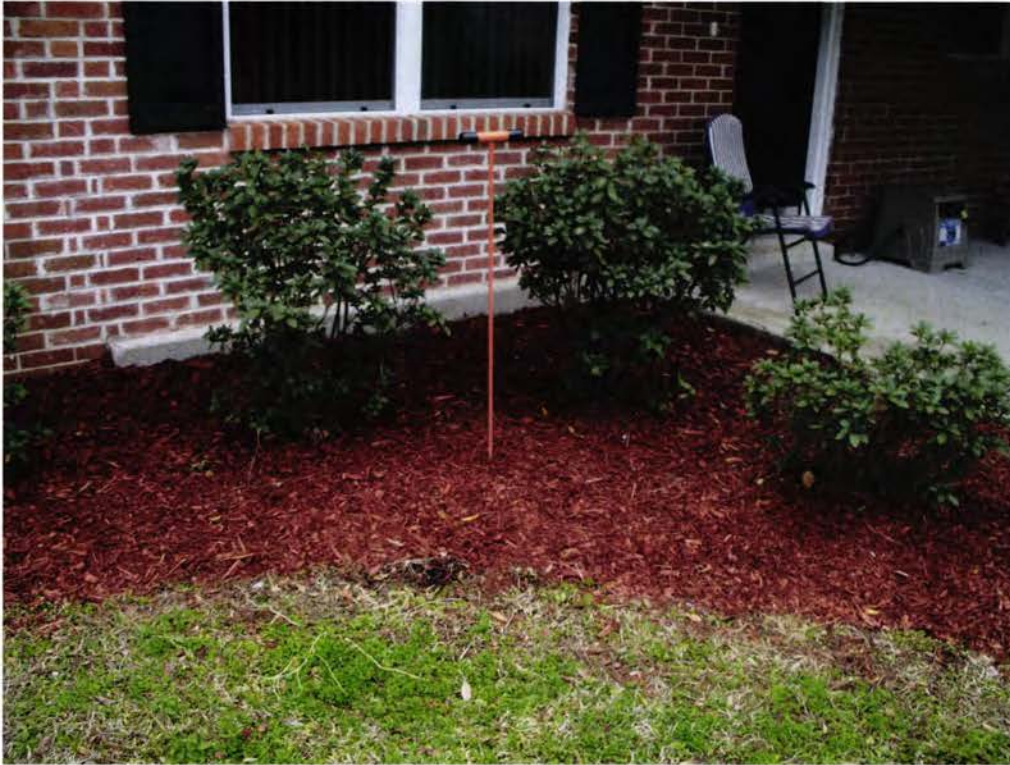
Picture 1: Location of UST 224Cypress.

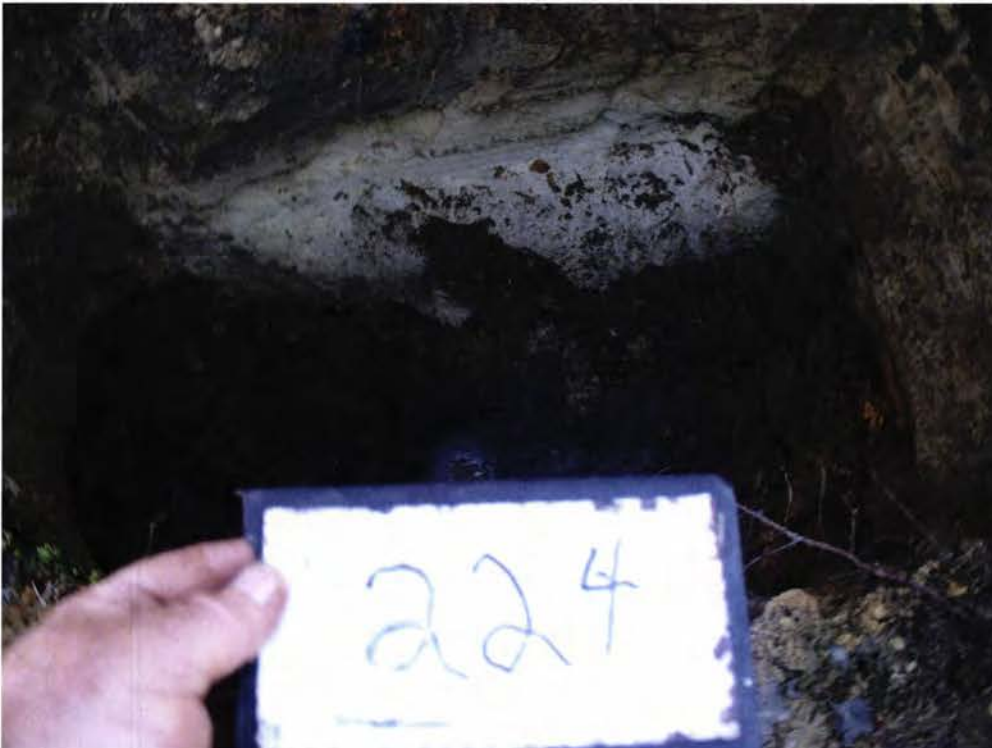
O. If any corrosion, pitting, or holes were observed, describe the location and extent for each UST
Corrosion and pitting were found throughout the tank.

Picture 2: UST 224Cypress tank pit.
