SUMMARY REPORT
FORMER 295 BIRCH ROAD (CURRENT EMPTY LOT)
LAUREL BAY MILITARY HOUSING AREA
MARINE CORPS AIR STATION BEAUFORT
BEAUFORT, SC

CDM - AECOM Multimedia Joint Venture 10560 Arrowhead Drive, Suite 500 Fairfax, Virginia 22030

JUNE 2021

South Carolina Department of Health and Environmental Control (SCDHEC) Underground Storage Tank (UST) Assessment Report

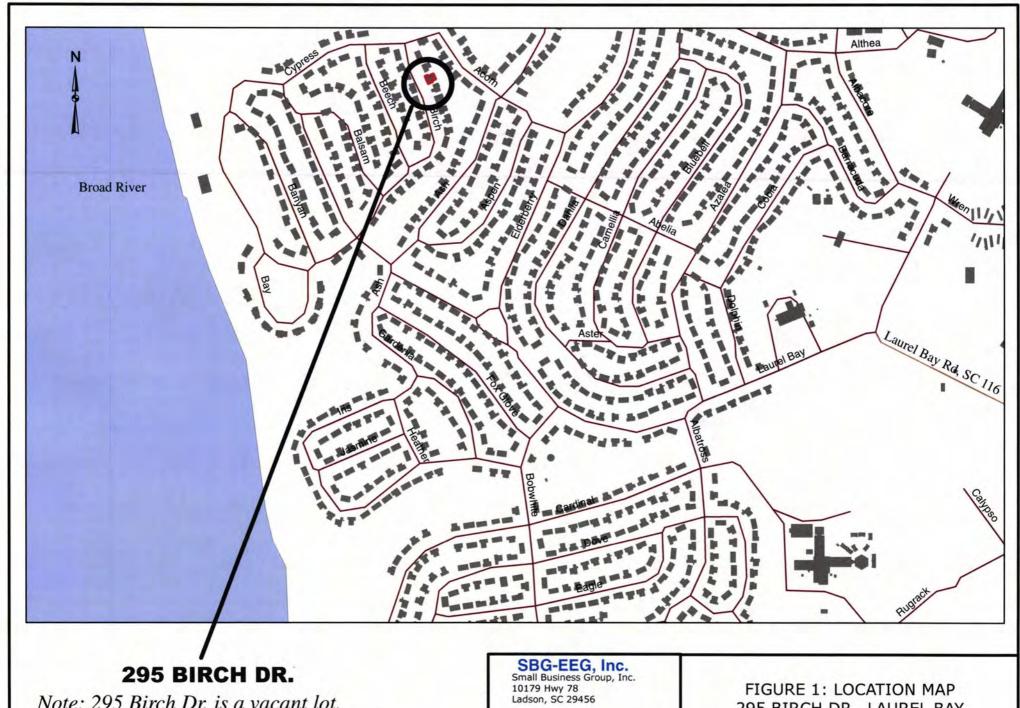
295 BIRCH DR., LAUREL BAY MCAS BEAUFORT SC

Note: 295 Birch Dr. is a vacant lot.

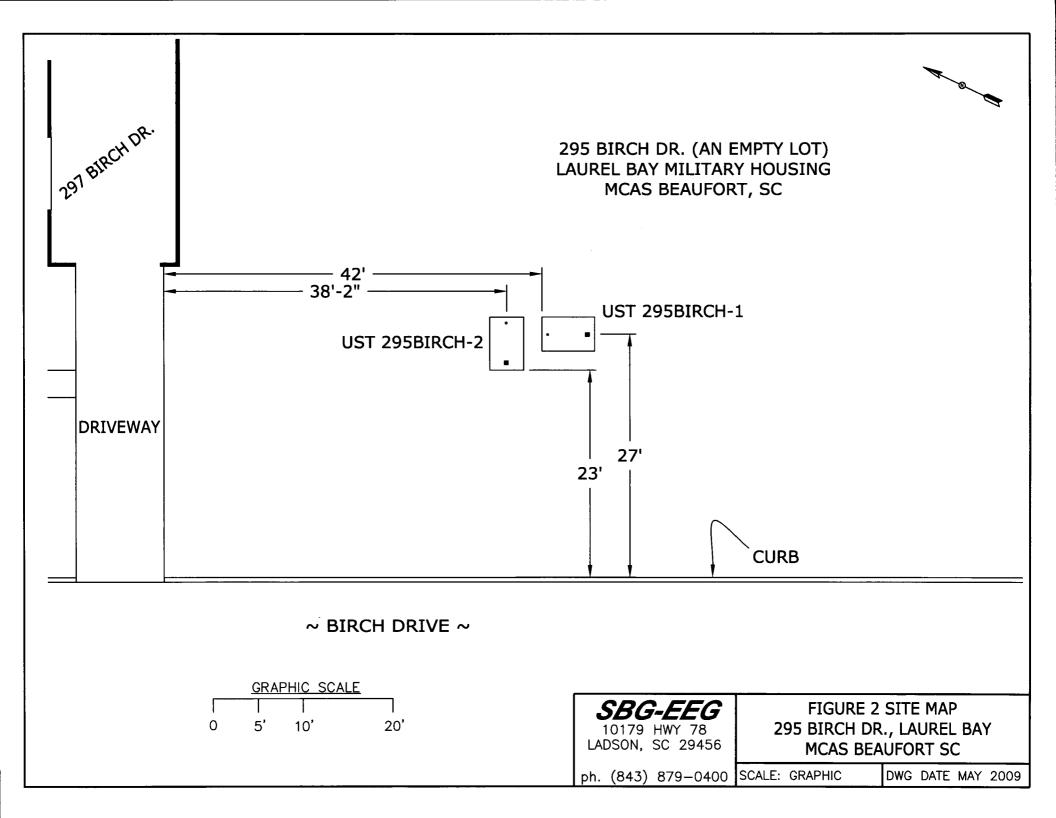
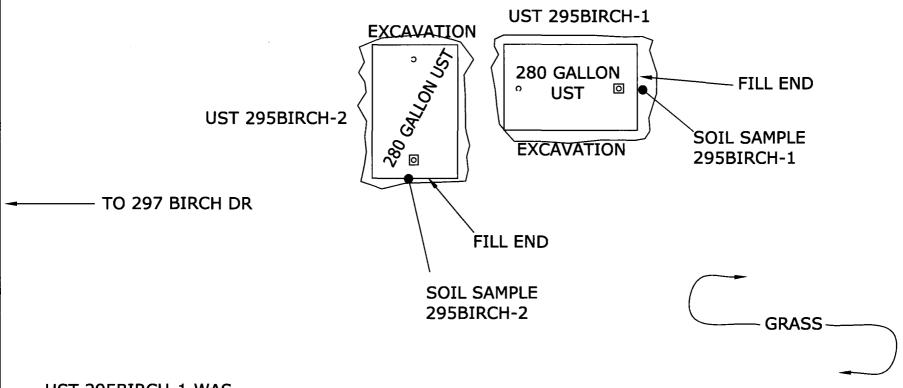
SBG-EEG 10179 HWY 78 LADSON, SC 29456 FIGURE 3 UST SAMPLE LOCATIONS 295 BIRCH DR., LAUREL BAY MCAS BEAUFORT SC

UST 295BIRCH-1 WAS 32" BELOW GRADE.

UST 295BIRCH-2 WAS 23" BELOW GRADE.

On April 27, 2009, two 280 gallon heating oil USTs were removed at former 295 Birch Road. Tank 1 was removed on from the front grassed area, 38'2" south to southwest of the driveway. Tank 2 was removed from the front grassed area, 42' south to southwest of the driveway. The former UST locations are indicated in Figures 2 and 3 of the UST Assessment Report (Appendix

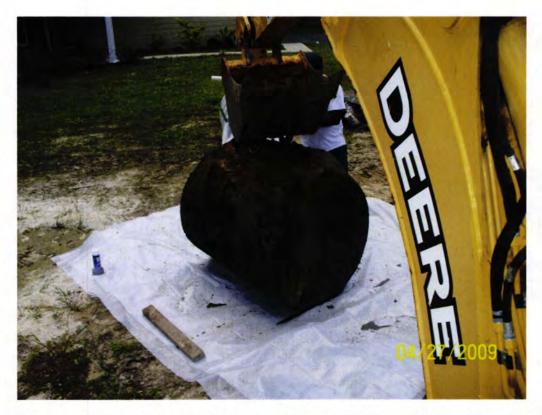
O. If any corrosion, pitting, or holes were observed, describe the location and extent for each UST Corrosion, pitting and holes were found on the entire surface of both tanks.

Picture 1: UST 295Birch-2 immediately after removal. UST 295Birch-1 was identical.

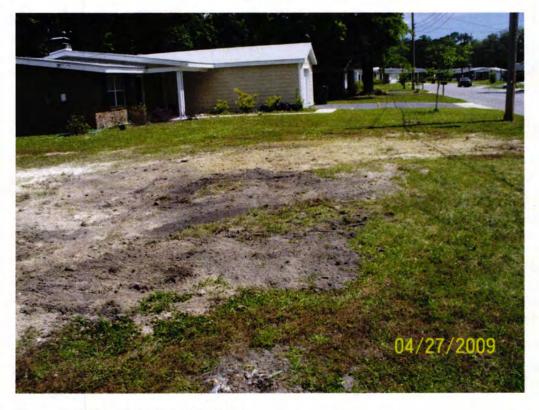
Picture 2: 295 Birch Dr. excavation site.
