**SUMMARY REPORT  
156 BANYAN DRIVE (FORMERLY 128 BANYAN DRIVE)  
LAUREL BAY MILITARY HOUSING AREA  
MARINE CORPS AIR STATION BEAUFORT  
BEAUFORT, SC**

**JUNE 2021**

**Contract Number: N62470-14-D-9016  
CTO WE52  
JUNE 2021**

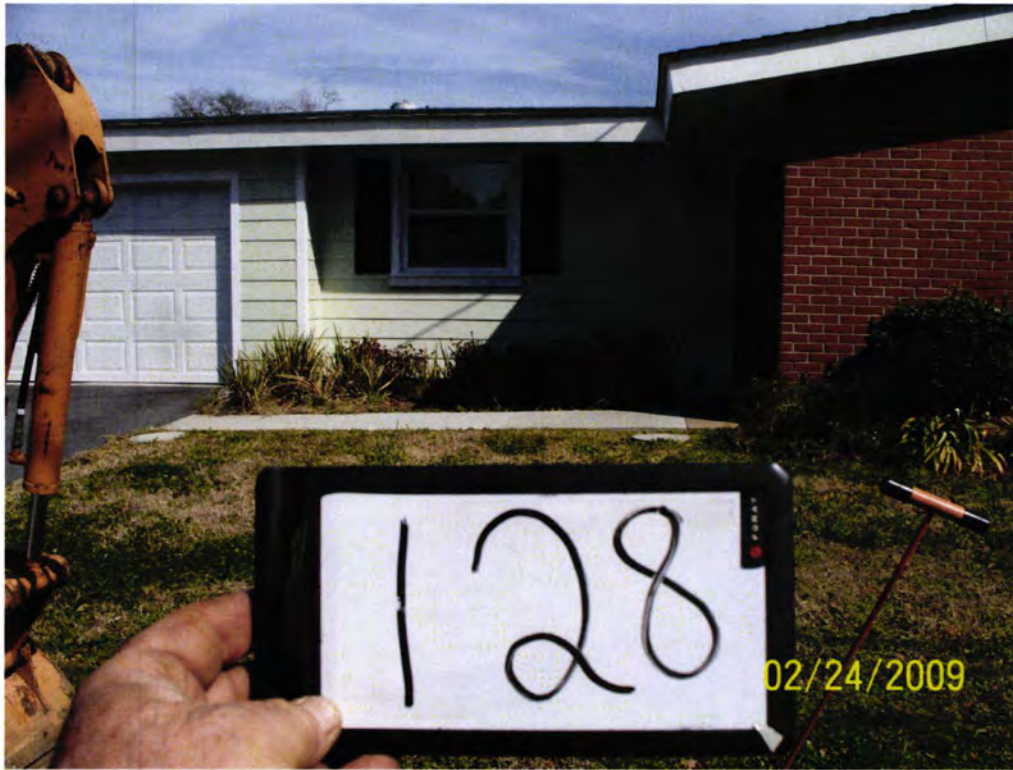
Picture 1: 128 Banyan Street, site of UST 128Banyan-1 and USTBanyan-2.

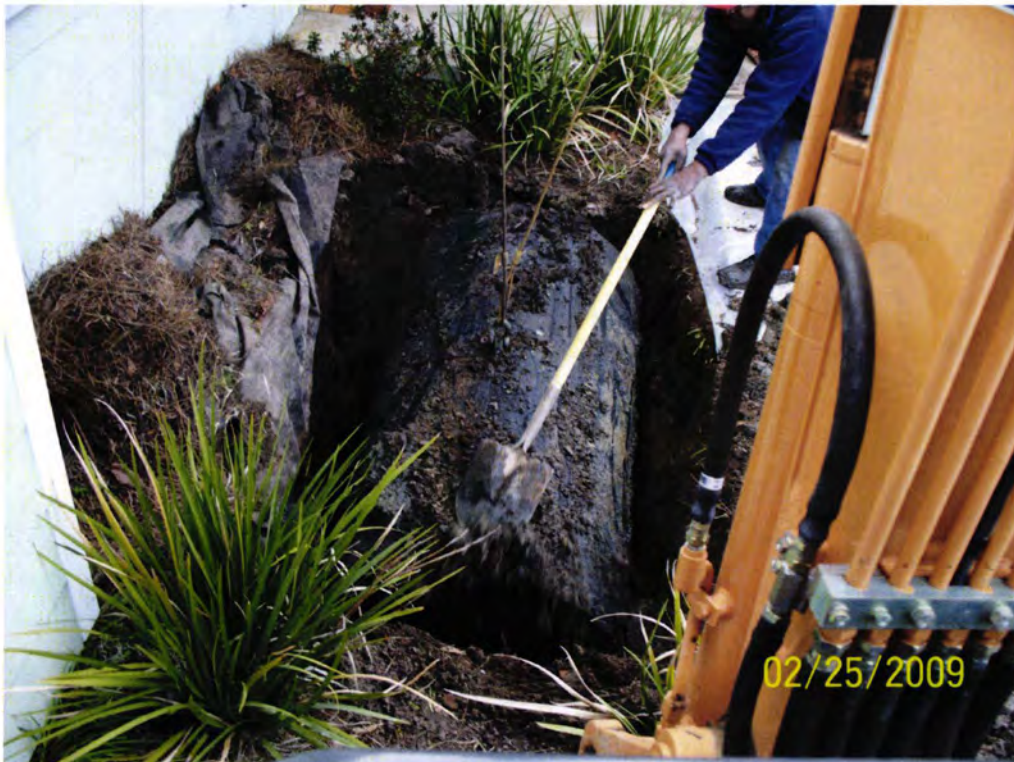
- M. Method of disposal for any USTs removed from the ground (attach disposal manifests)  
USTs 128Banyan-1 and 128Banyan-2 were removed and disposed of at a Subtitle D landfill.
- N. Method of disposal for any liquid petroleum, sludges, or wastewaters removed from the USTs (attach disposal manifests)  
Tanks were filled with contaminated sand. See attachment A for manifest
- O. If any corrosion, pitting, or holes were observed, describe the location and extent for each UST  
Holes due to corrosion were found on seams at ends of the tank.

Picture 2: UST 128Banyan-1 during removal.

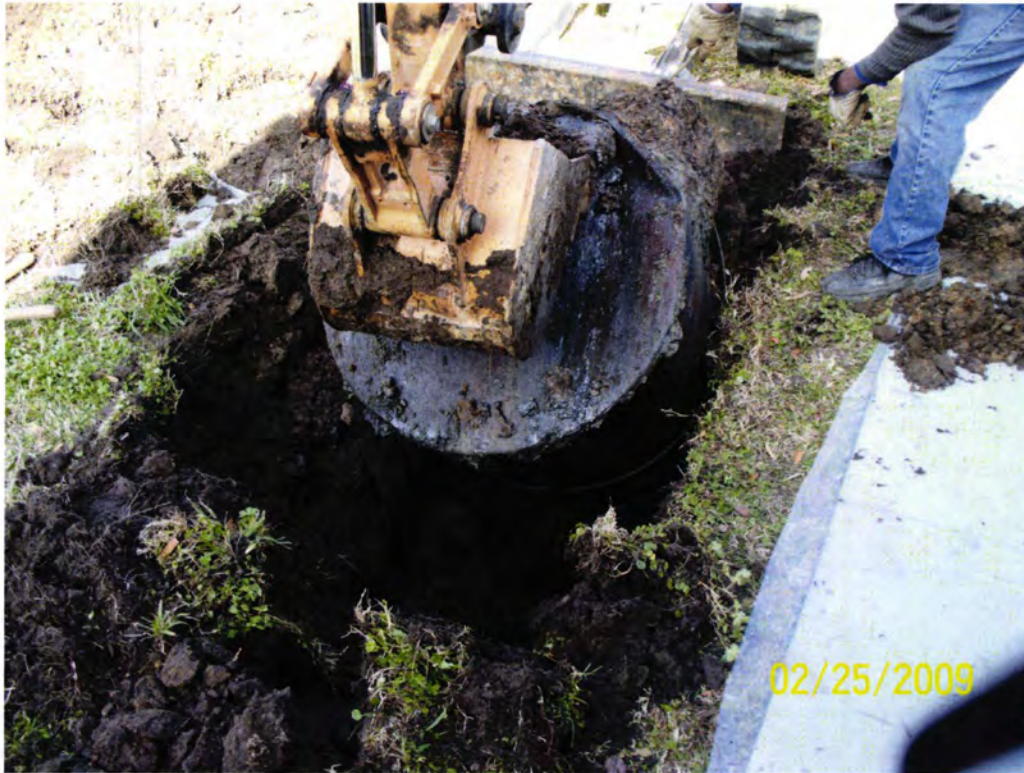
Corrosion was found on the exterior steel piping of both USTs.

Picture 3: UST 128Banyan-2 being removed from the excavation.
