**SUMMARY REPORT
100 ASH STREET (FORMERLY 307 ASH STREET)
LAUREL BAY MILITARY HOUSING AREA
MARINE CORPS AIR STATION BEAUFORT
BEAUFORT, SC**

CDM - AECOM
Multimedia Joint Venture

**Contract Number: N62470-14-D-9016
CTO WE52
JUNE 2021**

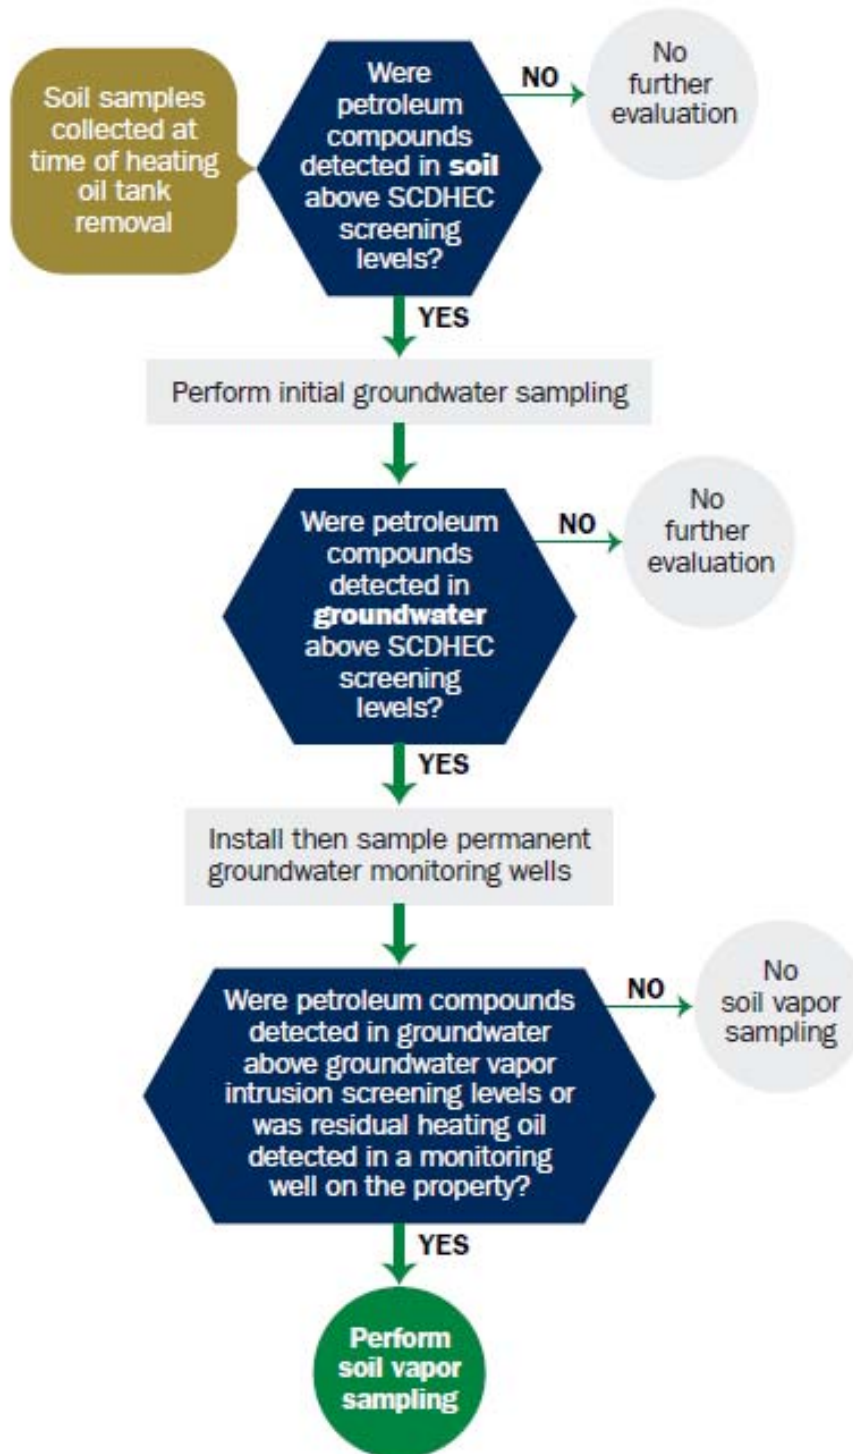
Appendix A
Multi-Media Selection Process for LBMH

Appendix A - Multi-Media Selection Process for LBMH

MCAS Beaufort does not have documentation of the UST removal activities at 34 properties where it was discovered that a structure (i.e., home addition, garage, porch, or shed) had been historically constructed on top of the suspected former UST locations. The results of a historical document review and ground penetrating radar (GPR) survey at the 34 properties indicated there was no evidence that any of the former USTs remained in place beneath the structures and it was likely that the USTs were removed prior to 2007. The LBMH UST removal and assessment process is described below in Section 1.2. The LBMH multi-media investigation selection process tree, used to evaluate the environmental impact of USTs for most sites at LBMH, is presented in Appendix A. It should be noted that because soil and groundwater were not sampled following the UST removal and analytical results were not available for evaluation, the subject property of this report did not follow the typical multi-media investigation selection process presented in Appendix A.

As stated above, the assessment process at this property did not follow the typical process presented in Appendix A. Instead the process consisted first of a vapor intrusion (VI)
