SUMMARY REPORT
28 FOXGLOVE STREET (FORMERLY 1005 FOXGLOVE STREET)
LAUREL BAY MILITARY HOUSING AREA
MARINE CORPS AIR STATION BEAUFORT
BEAUFORT, SC

South Carolina Department of Health and Environmental Control (SCDHEC)
Underground Storage Tank (UST) Assessment Report

1005 Foxglove St., Laurel Bay Military Housing Area

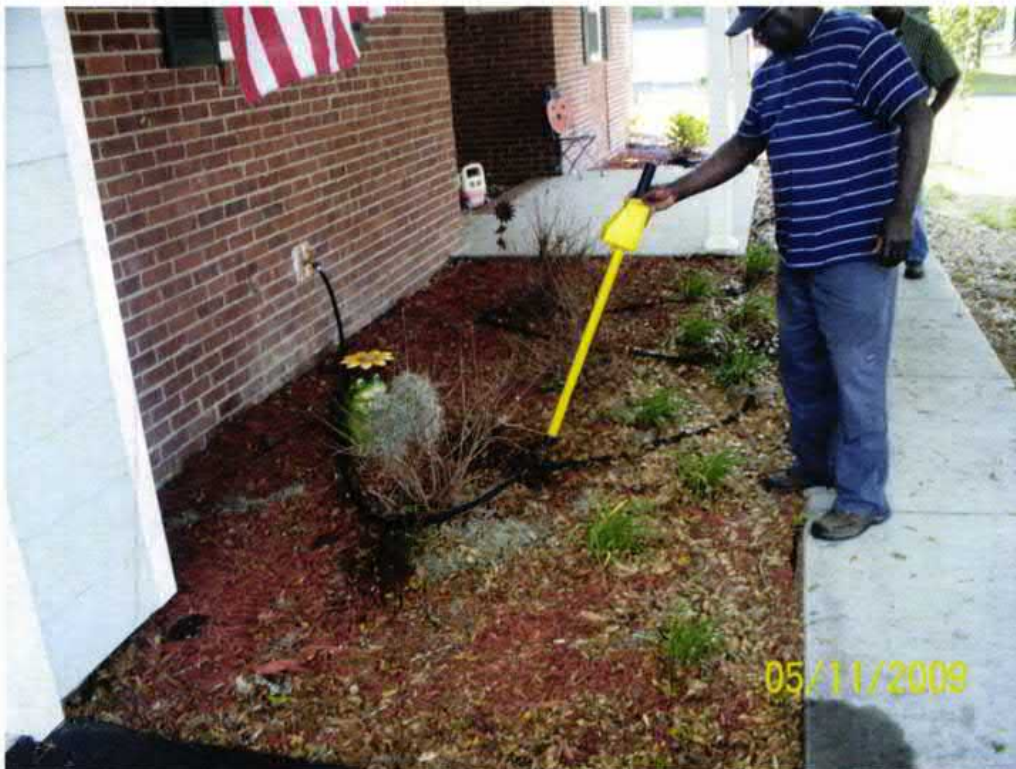
Picture 1: UST 1005Foxglove was located in the foreground of the flowerbed.

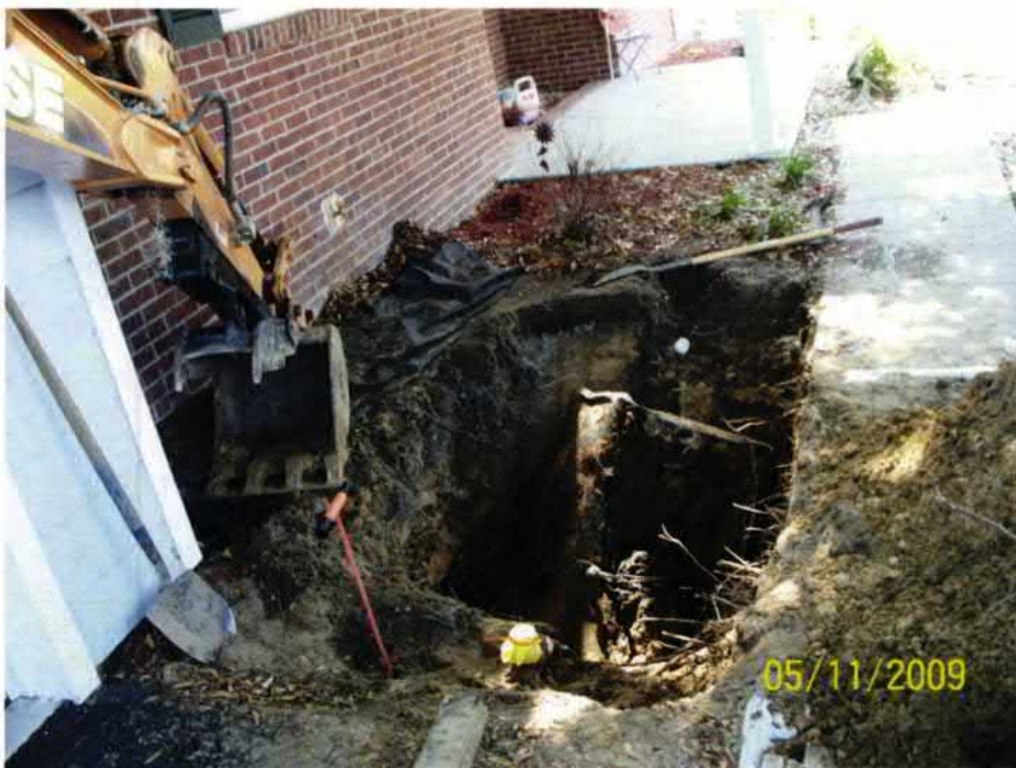
- M. Method of disposal for any USTs removed from the ground (attach disposal manifests)
UST 1005Foxglove was removed from the ground and disposed of at a
Subtitle D landfill. See Attachment "A."
-
- N. Method of disposal for any liquid petroleum, sludges, or wastewaters removed from the USTs (attach disposal manifests)
UST 1005Foxglove had been previously filled with sand by others.
-
- O. If any corrosion, pitting, or holes were observed, describe the location and extent for each UST
Corrosion, pitting and holes were found on the entire surface of the
tank.

Picture 2: UST 1005Foxglove being removed from the excavation.
