**SUMMARY REPORT  
345 IRIS LANE (FORMERLY 1132 IRIS LANE)  
LAUREL BAY MILITARY HOUSING AREA  
MARINE CORPS AIR STATION BEAUFORT  
BEAUFORT, SC**

**JUNE 2021**

**Contract Number: N62470-14-D-9016  
CTO WE52  
JUNE 2021**

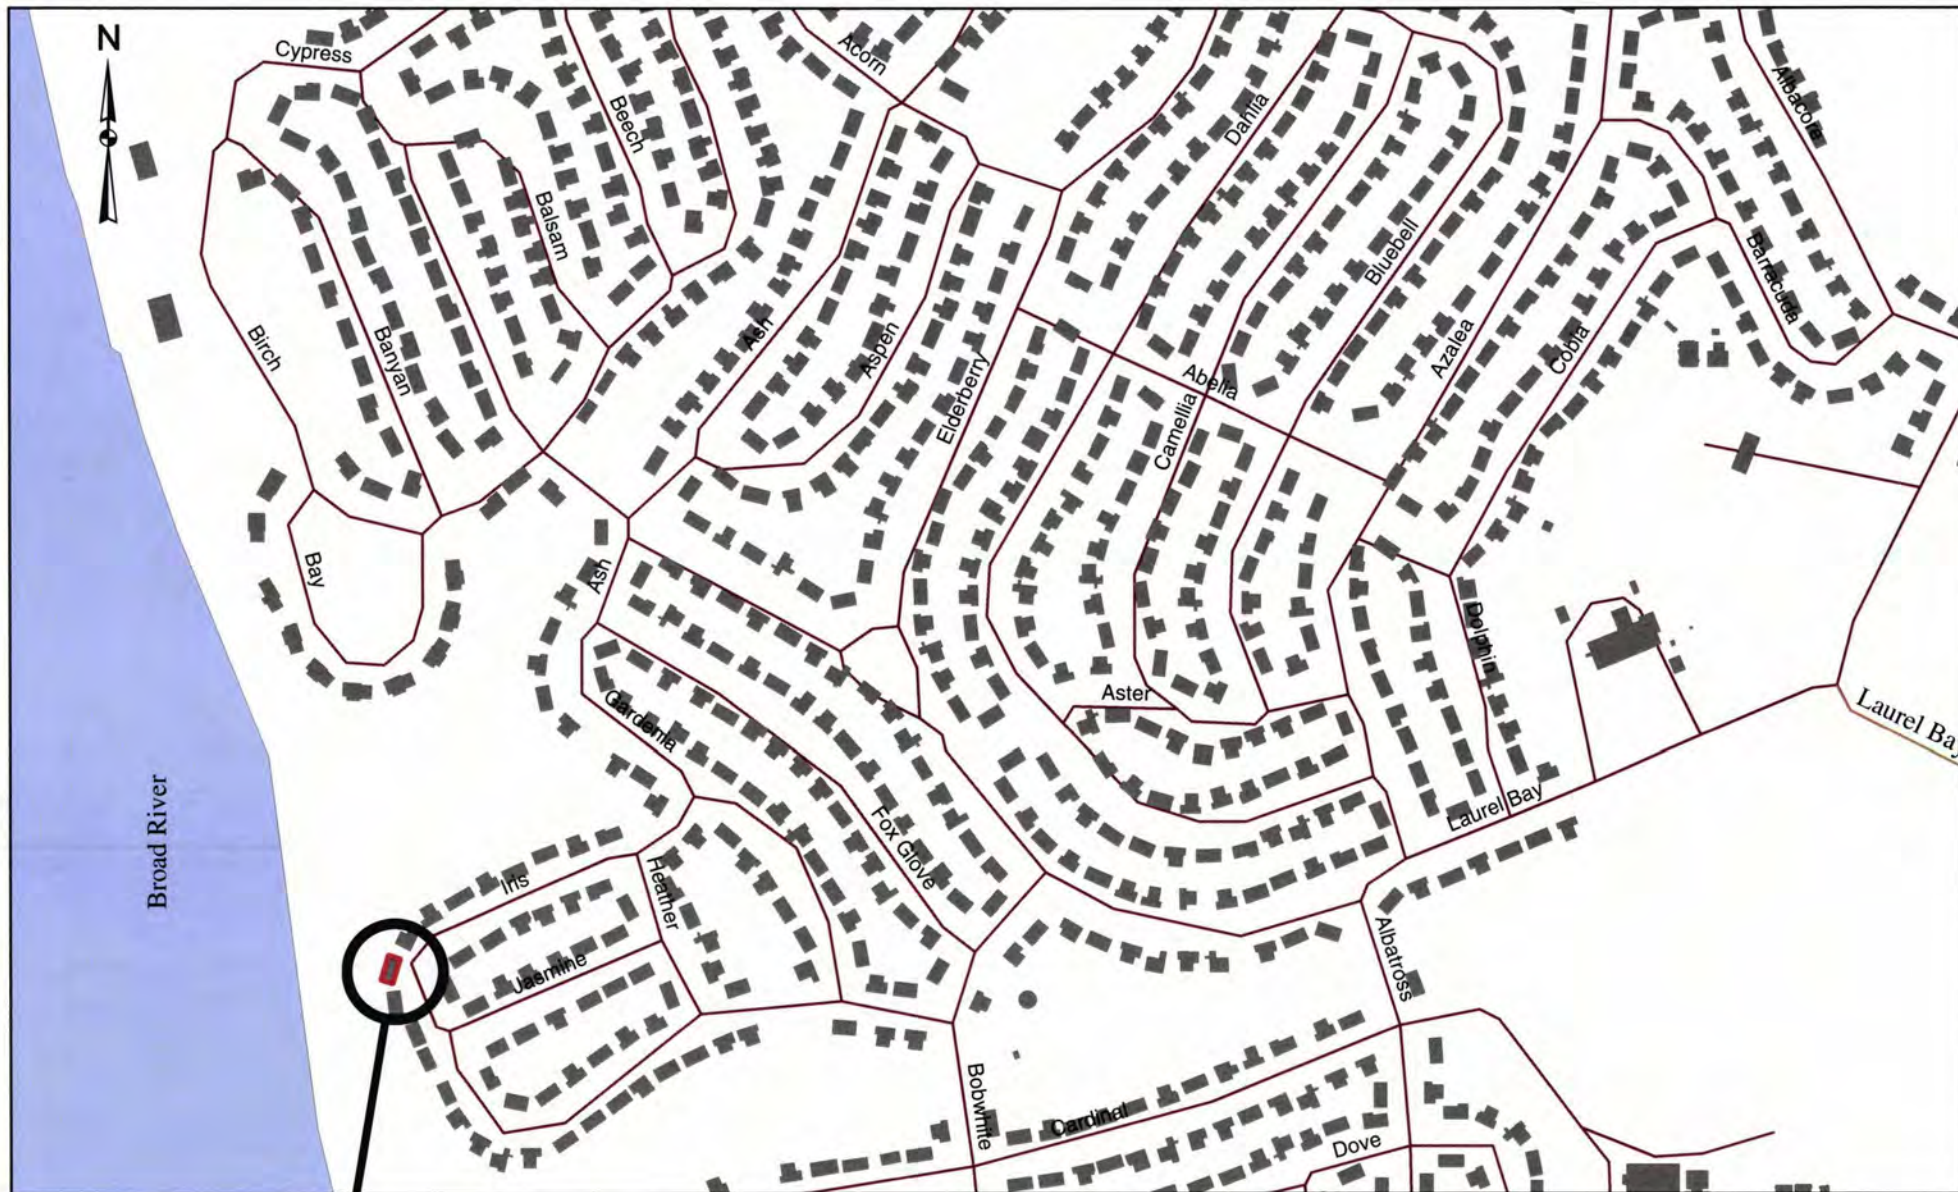
**1132 IRIS LANE**

On June 18, 2009, a single 280 gallon heating oil UST was removed from the front landscaped area, adjacent to the porch at 345 Iris Lane (Formerly 1132 Iris Lane). The former UST location is indicated on Figures 2 and 3 of the UST Assessment Report (Appendix B). The UST was removed and properly disposed of (i.e., shipped offsite for recycling or transported to a landfill). There was no visual evidence (i.e., staining or sheen) of petroleum impact at the time of the UST removal. According to the UST Assessment Report (Appendix B), the depth to the base of the UST was 6'4" bgs and a single soil sample was collected from that depth. The sample was collected from the fill port side of the former UST to represent a worst case scenario and shipped to an offsite laboratory for analysis of the petroleum COPCs. Sampling was performed in accordance with applicable South Carolina regulation R.61-92, Part 280 (SCDHEC, 2017) and assessment guidelines.

**You must supply a scaled site map. It should include all buildings, road names, utilities, tank and dispenser island locations, labeled sample locations, extent of excavation, and any other pertinent information.**

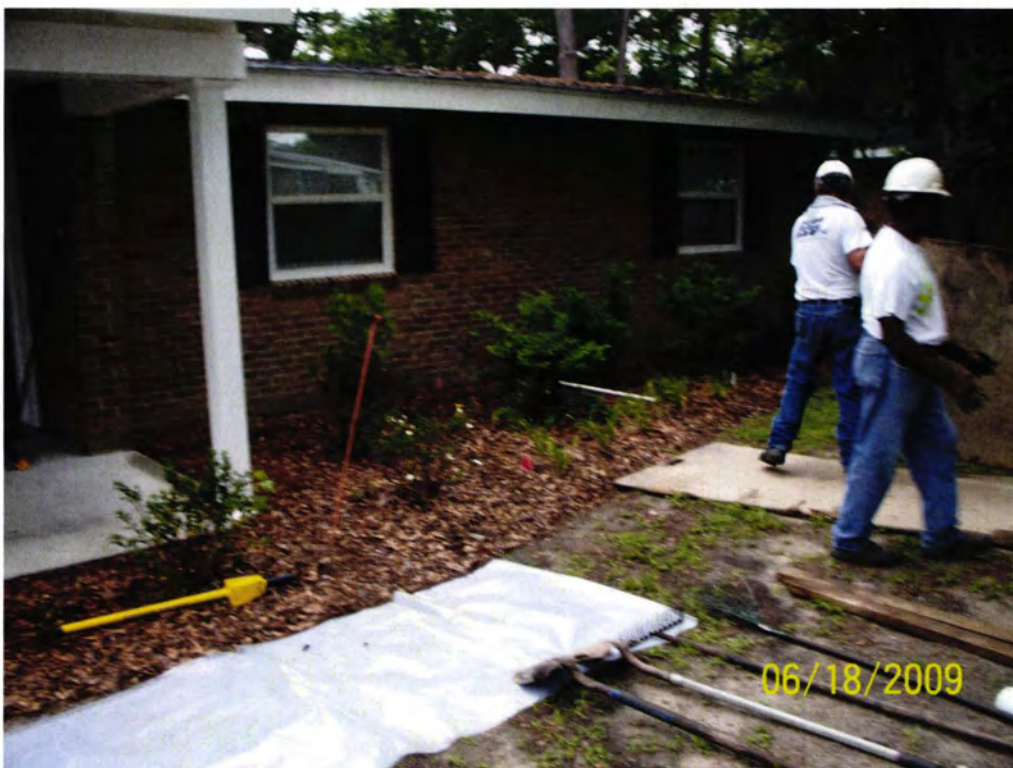
Picture 1: UST 1132Iris's location prior to excavation.
