**SUMMARY REPORT  
433 IRIS LANE (FORMERLY 1144 IRIS LANE)  
LAUREL BAY MILITARY HOUSING AREA  
MARINE CORPS AIR STATION BEAUFORT  
BEAUFORT, SC**

**JUNE 2021**

**Contract Number: N62470-14-D-9016  
CTO WE52  
JUNE 2021**

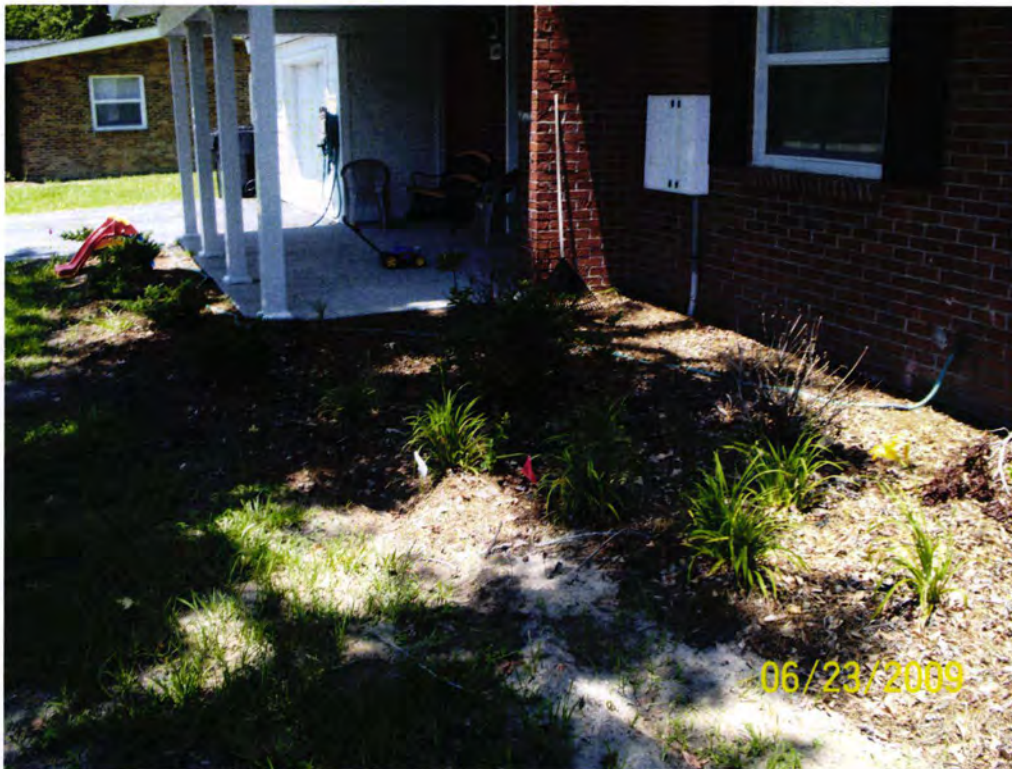
Picture 1: Location of USTs 1144Iris-1 and -2 before removal.

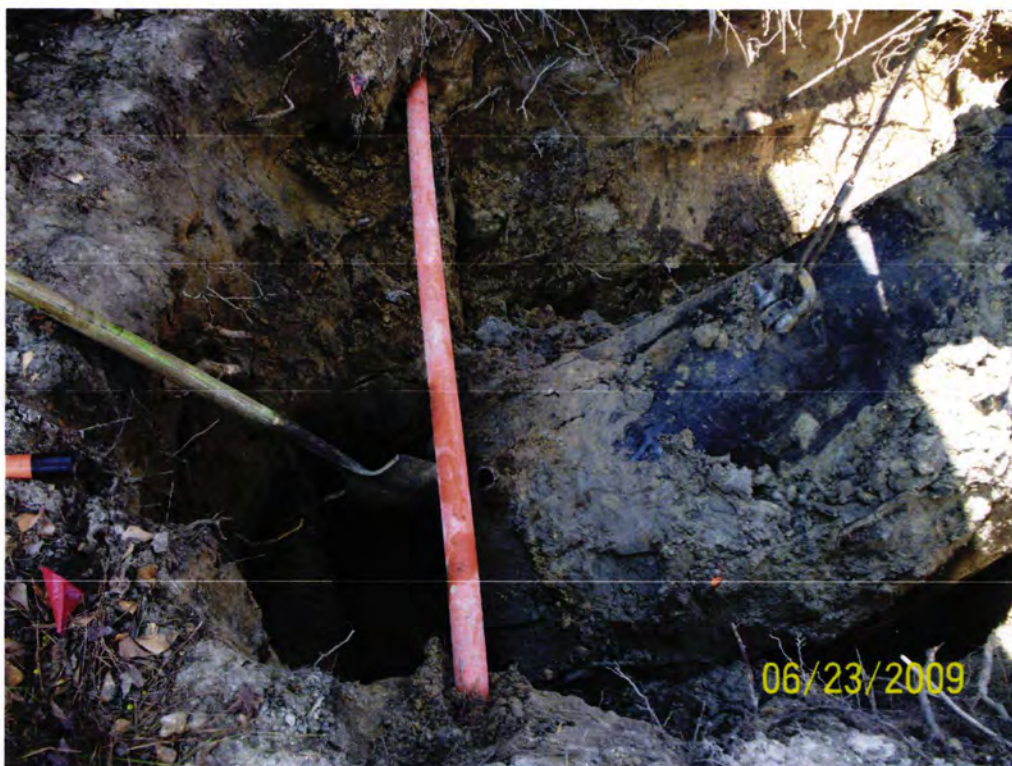
- M. Method of disposal for any USTs removed from the ground (attach disposal manifests)  
UST 1144Iris-1 was removed from the ground, cleaned and recycled.  
UST 1144Iris-2 was removed from the ground and disposed of at a  
~~Subtitle "D" landfill. See Attachment "A."~~
- N. Method of disposal for any liquid petroleum, sludges, or wastewaters removed from the USTs (attach disposal manifests)  
Contaminated water was pumped from UST 1144Iris-1 and disposed of by  
MCAS Beaufort. UST 1144Iris-2 had been previously filled with  
~~sand by others.~~
- O. If any corrosion, pitting, or holes were observed, describe the location and extent for each UST  
Corrosion, pitting and holes were found through out both tanks.

Picture 2: UST 1144Iris-1 during removal.
