SUMMARY REPORT
59 WEST CARDINAL LANE (FORMERLY 1204 WEST CARDINAL LANE)
LAUREL BAY MILITARY HOUSING AREA
MARINE CORPS AIR STATION BEAUFORT
BEAUFORT, SC

7301 RIVERS AVE., SUITE 245 N. CHARLESTON SC 29406-9643 (843) 573-7140 FIGURE 3 UST SAMPLE LOCATIONS 1204 CARDINAL LANE, LAUREL BAY MCAS BEAUFORT SC

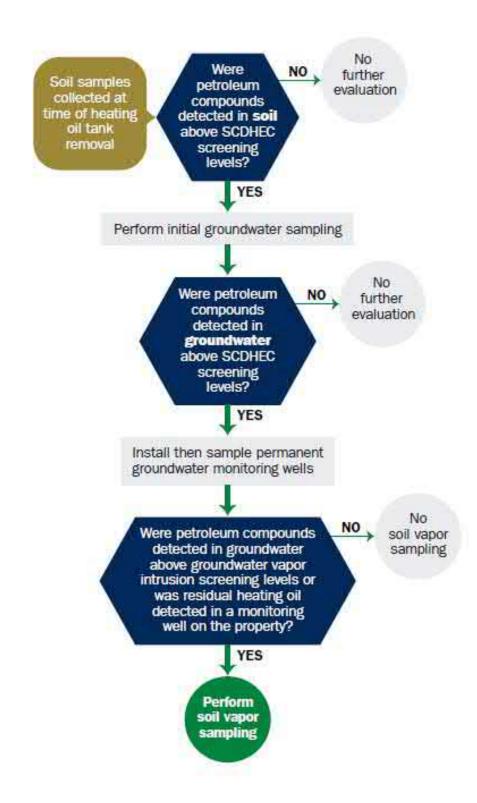
**Appendix A - Multi-Media Selection Process for LBMH**

The results of the soil sampling at each former UST location were used to determine if a potential for groundwater contamination exists (i.e., soil results greater than RBSLs) and subsequently to select properties for follow-up initial groundwater assessment (IGWA) sampling. The results of the IGWA sampling (if necessary) are used to determine the presence or absence of the aforementioned COPCs in groundwater and identify whether former UST locations will require additional delineation of COPCs in groundwater. In order to delineate the extent of impact to groundwater, permanent wells are installed and a sampling program is established for those former UST locations where IGWA sampling has indicated the presence of COPCs in excess of the SCDHEC RBSLs for groundwater. Groundwater analytical results are also compared to the site specific groundwater vapor intrusion screening levels (VISLs) to evaluate the potential for vapor intrusion and the necessity for an investigation associated with this media. A multi-media investigation selection process tree, applicable to the LBMH UST investigations, is presented as Appendix A.

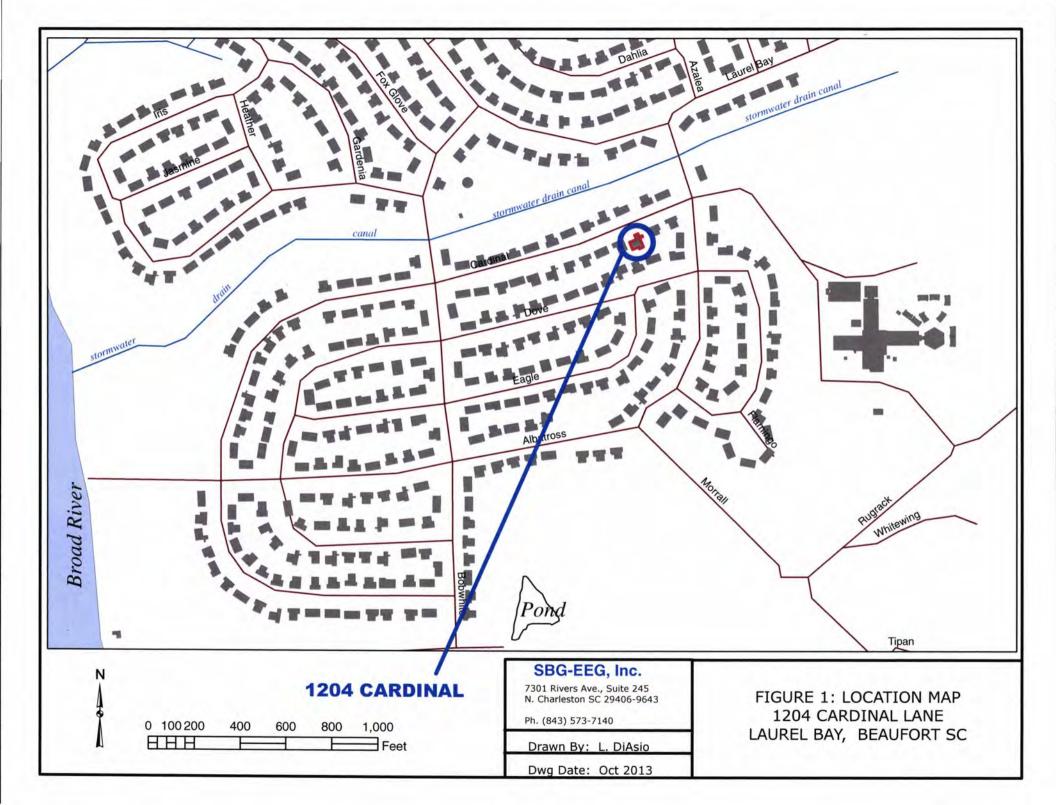
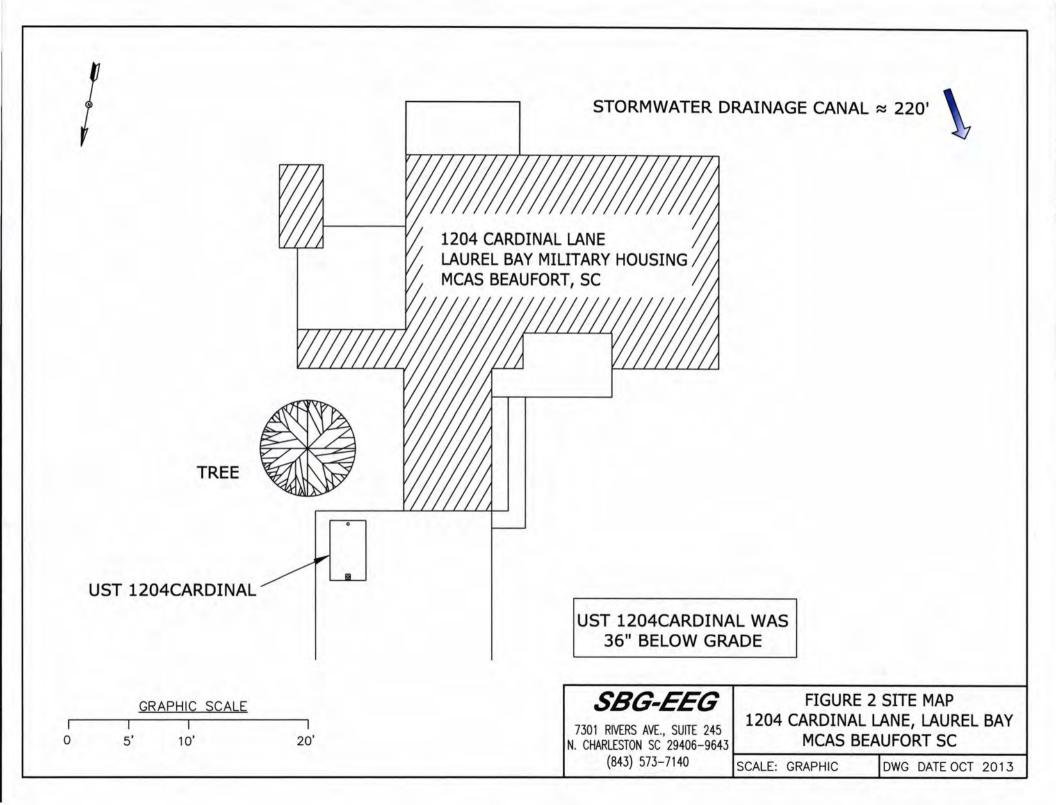
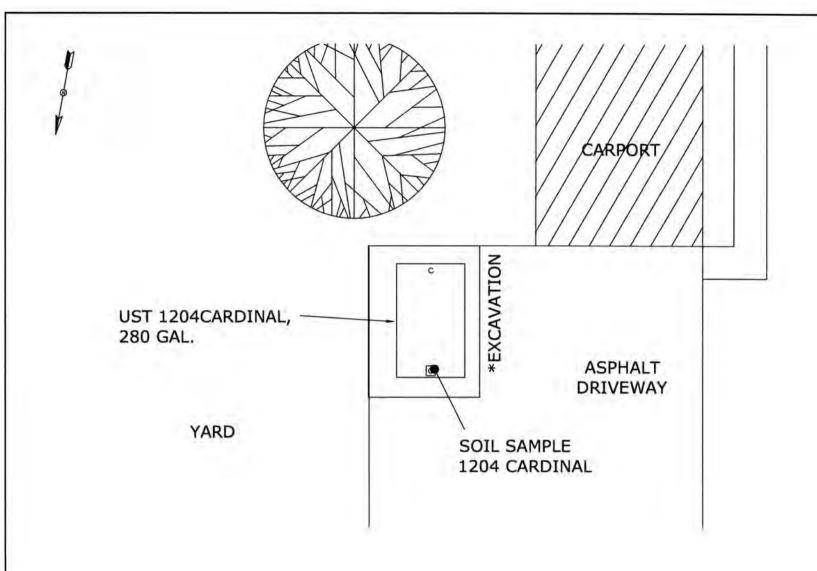
On June 18, 2013, a single 280 gallon heating oil UST was removed from the front yard under the driveway area at 59 West Cardinal Lane (Formerly 1204 West Cardinal Lane). The former UST location is indicated on Figures 2 and 3 of the UST Assessment Report (Appendix B). The UST was removed and properly disposed of (i.e., shipped offsite for recycling or transported to a landfill). There was no visual evidence (i.e., staining or sheen) of petroleum impact at the time of the UST removal. According to the UST Assessment Report (Appendix B), the depth to the

\*A PORTION OF THE ASPHALT DRIVEWAY WAS REMOVED TO FACILITATE TANK EXTRACTION.

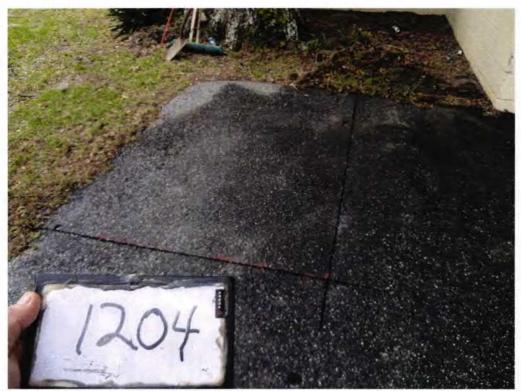
Picture 1: Location of UST 1204Cardinal.

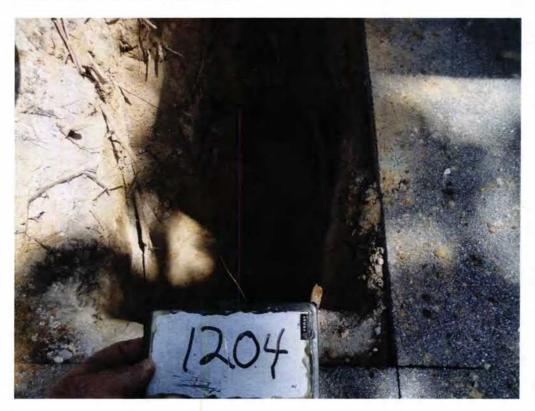
Picture 2: UST 1204Cardinal excavation.
