SUMMARY REPORT  
164 EAST DOVE LANE (FORMERLY 1264 EAST DOVE LANE)  
LAUREL BAY MILITARY HOUSING AREA  
MARINE CORPS AIR STATION BEAUFORT  
BEAUFORT, SC

South Carolina Department of Health and Environmental Control (SCDHEC)  
**Underground Storage Tank (UST) Assessment Report**

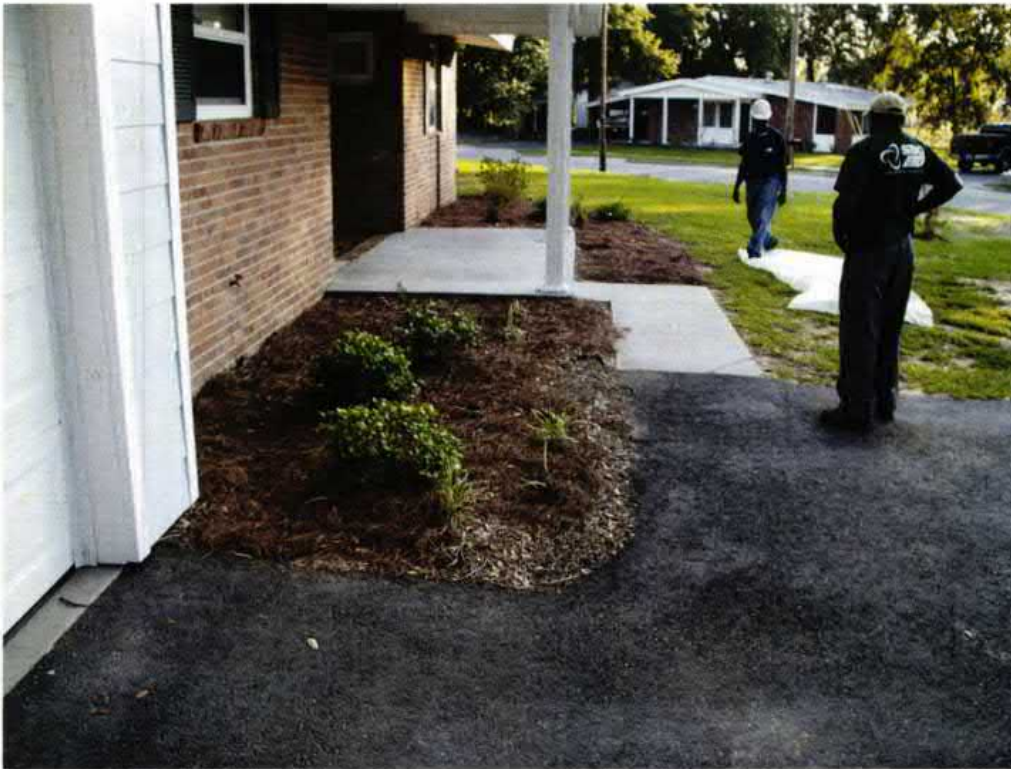
Picture 1: Location of UST 1264Dove.

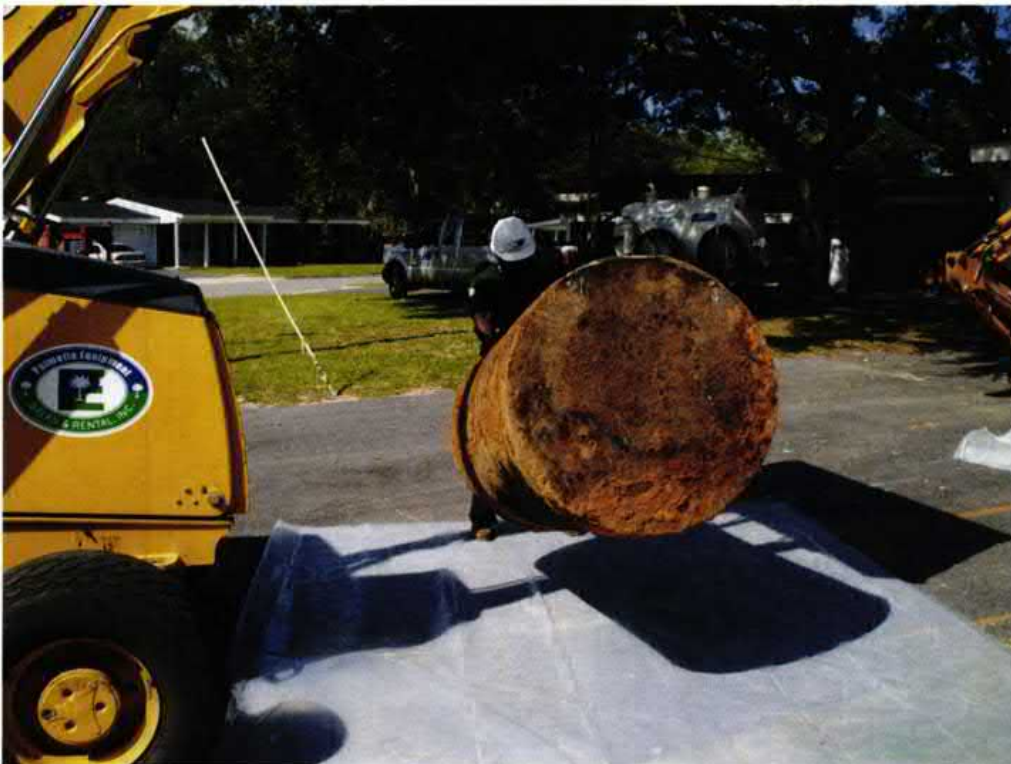
Corrosion, pitting and holes were found throughout the tank.

Picture 2: UST 1264Dove.

UST 1264Dove was removed from the ground and disposed of at a  
Subtitle "D" landfill. See Attachment "A".
