SUMMARY REPORT  
16 FLAMINGO DRIVE (FORMERLY 1281 FLAMINGO DRIVE)  
LAUREL BAY MILITARY HOUSING AREA  
MARINE CORPS AIR STATION BEAUFORT  
BEAUFORT, SC

South Carolina Department of Health and Environmental Control (SCDHEC)  
**Underground Storage Tank (UST) Assessment Report**

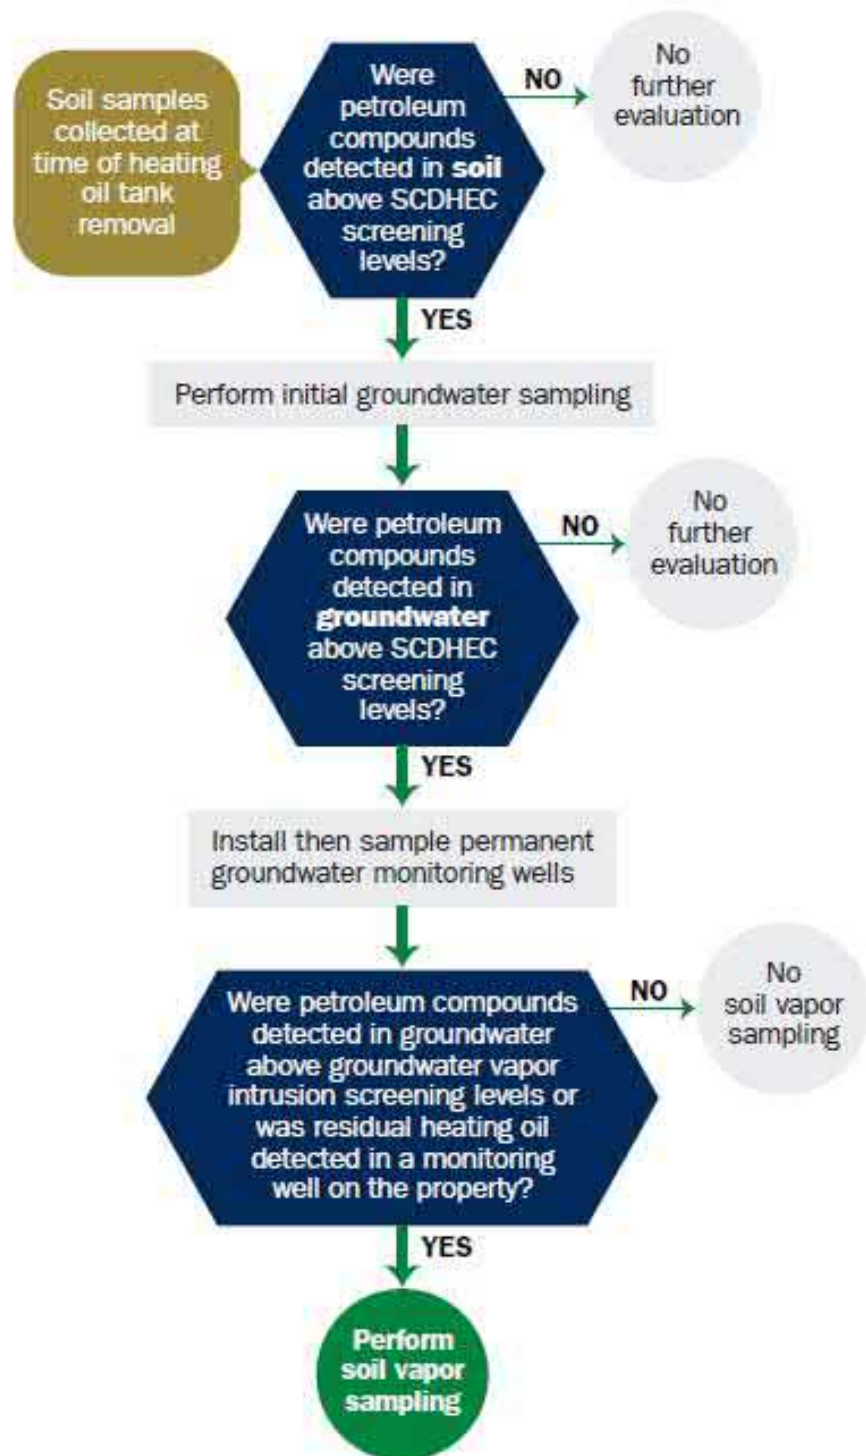
Appendix A - Multi-Media Selection Process for LBMH

The results of the soil sampling at each former UST location were used to determine if a potential for groundwater contamination exists (i.e., soil results greater than RBSLs) and subsequently to select properties for follow-up initial groundwater assessment (IGWA) sampling. The results of the IGWA sampling (if necessary) are used to determine the presence or absence of the aforementioned COPCs in groundwater and identify whether former UST locations will require additional delineation of COPCs in groundwater. In order to delineate the extent of impact to groundwater, permanent wells are installed and a sampling program is established for those former UST locations where IGWA sampling has indicated the presence of COPCs in excess of the SCDHEC RBSLs for groundwater. Groundwater analytical results are also compared to the site specific groundwater vapor intrusion screening levels (VISLs) to evaluate the potential for vapor intrusion and the necessity for an investigation associated with this media. A multi-media investigation selection process tree, applicable to the LBMH UST investigations, is presented as Appendix A.

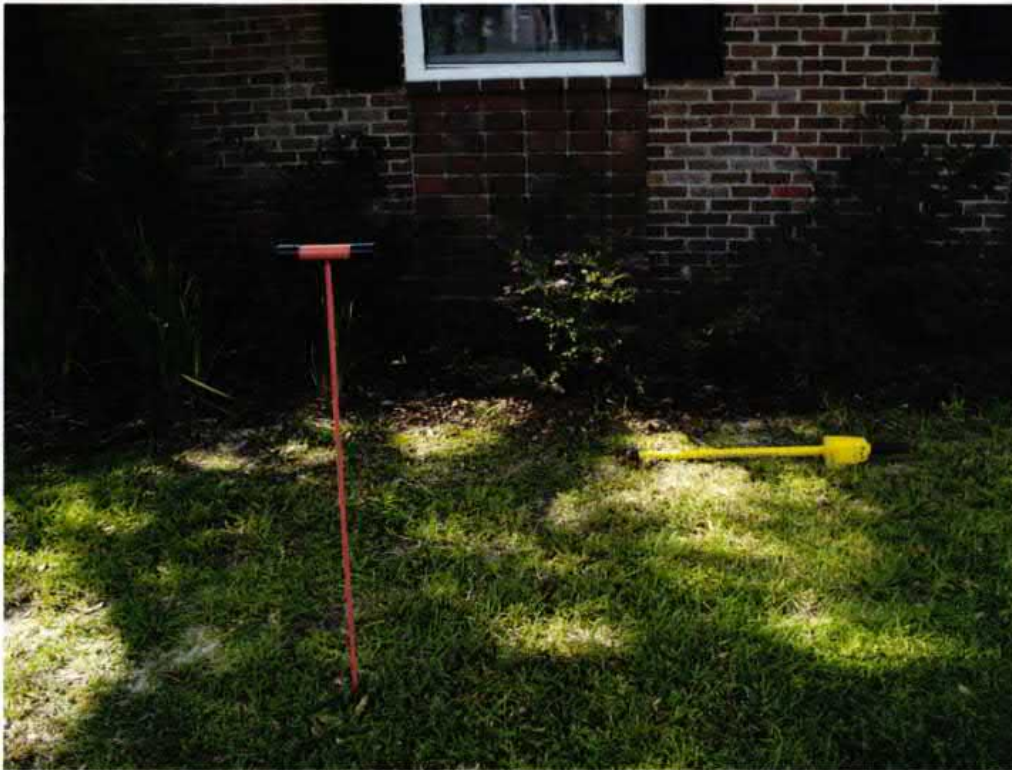
Picture 1: Location of UST 1281 Flamingo.

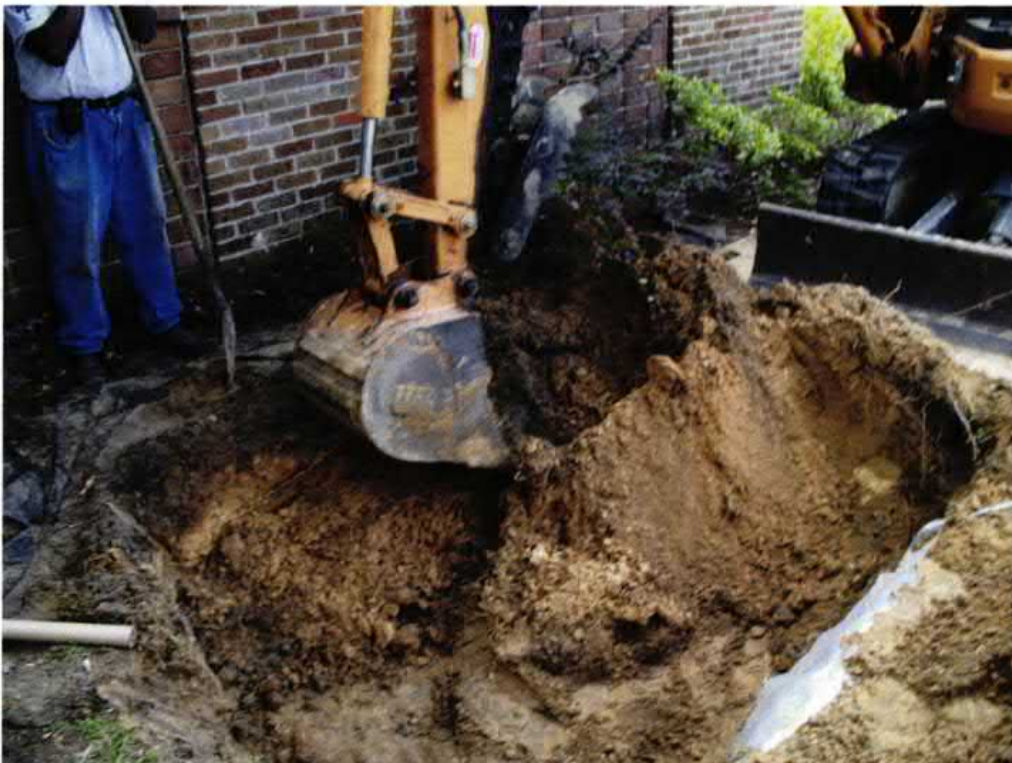
- M. Method of disposal for any USTs removed from the ground (attach disposal manifests)  
UST 1281Flamingo was removed from the ground and disposed of at a  
Subtitle "D" landfill. See Attachment "A".
- 
- N. Method of disposal for any liquid petroleum, sludges, or wastewaters removed from the USTs (attach disposal manifests)  
UST 1281Flamingo had been previously filled with sand by others.
- 
- O. If any corrosion, pitting, or holes were observed, describe the location and extent for each UST  
Corrosion, pitting and holes were found throughout the tank.
-

Picture 2: UST 1281 Flamingo excavation in progress.
