SUMMARY REPORT  
198 EAGLE LANE (FORMERLY 1307 EAGLE LANE)  
LAUREL BAY MILITARY HOUSING AREA  
MARINE CORPS AIR STATION BEAUFORT  
BEAUFORT, SC

Contract Number: N62470-14-D-9016

CTO WE52

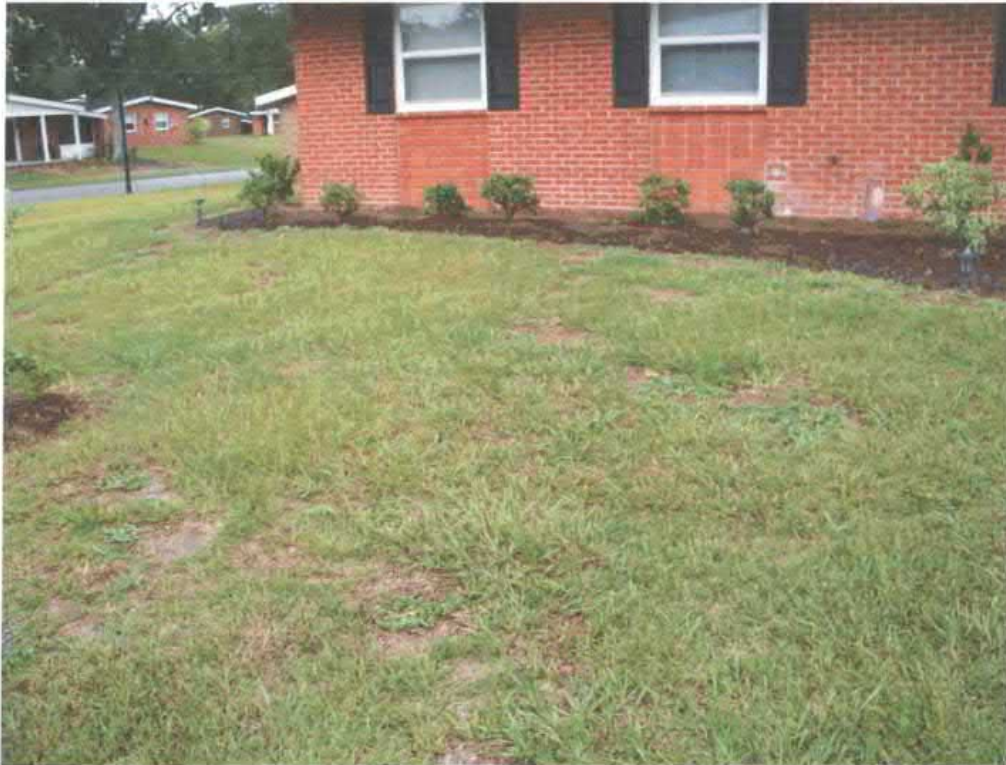
Picture 1: Location of UST 1307Eagle.

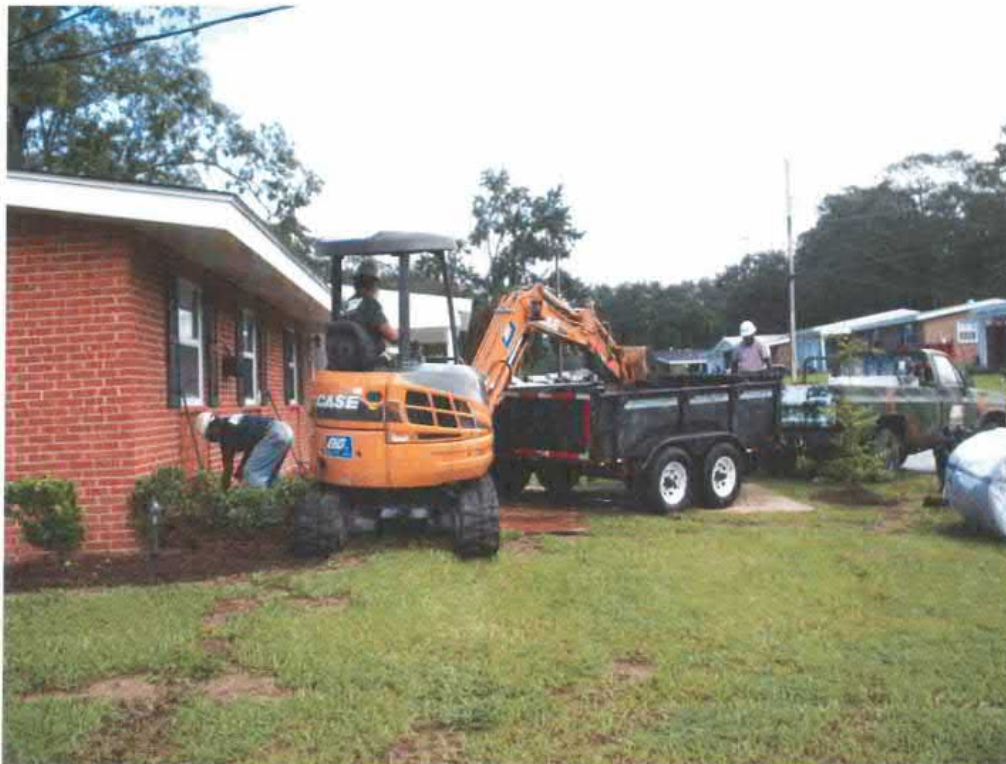
- M. Method of disposal for any USTs removed from the ground (attach disposal manifests)  
UST 1307Eagle was removed from the ground and disposed of at a  
Subtitle "D" landfill. See Attachment "A".
- 
- N. Method of disposal for any liquid petroleum, sludges, or wastewaters removed from the USTs (attach disposal manifests)  
UST 1307Eagle had been previously filled with sand by others.
- 
- O. If any corrosion, pitting, or holes were observed, describe the location and extent for each UST  
Corrosion, pitting and holes were found throughout the tank.

Picture 2: UST 1307Eagle removal in progress.
