SUMMARY REPORT
183 EAGLE LANE (FORMERLY 1310 EAGLE LANE)
LAUREL BAY MILITARY HOUSING AREA
MARINE CORPS AIR STATION BEAUFORT
BEAUFORT, SC

JUNE 2021

CDM - AECOM Multimedia Joint Venture
10560 Arrowhead Drive, Suite 500
Fairfax, Virginia 22030

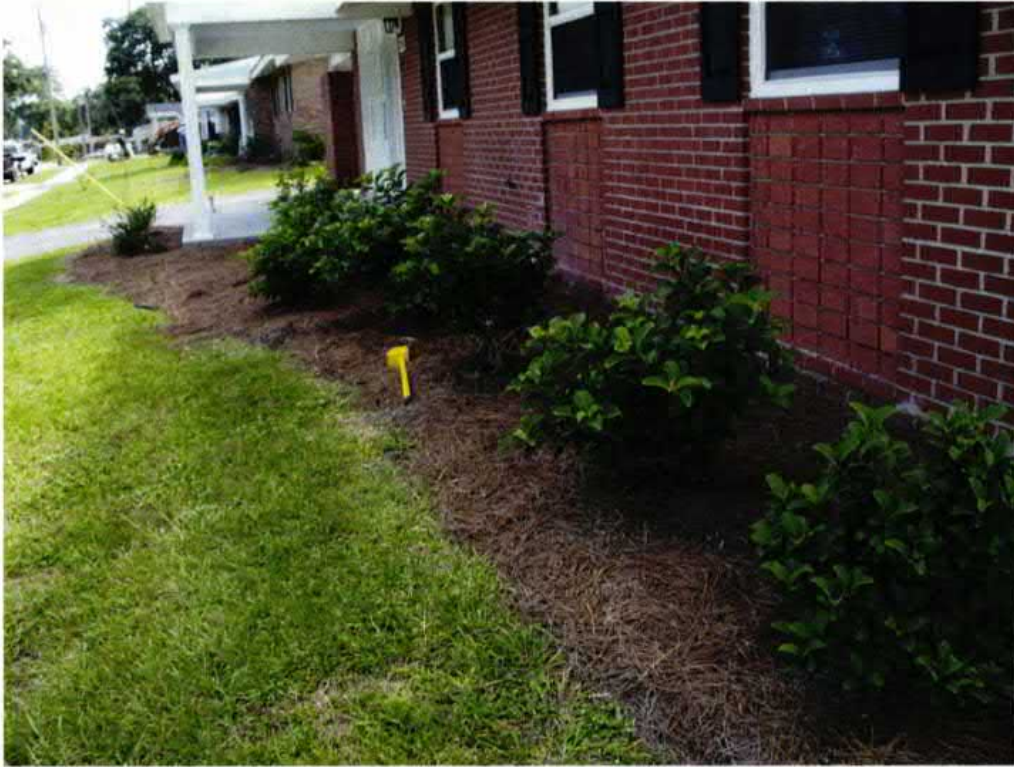
Picture 1: Location of UST 1310Eagle.

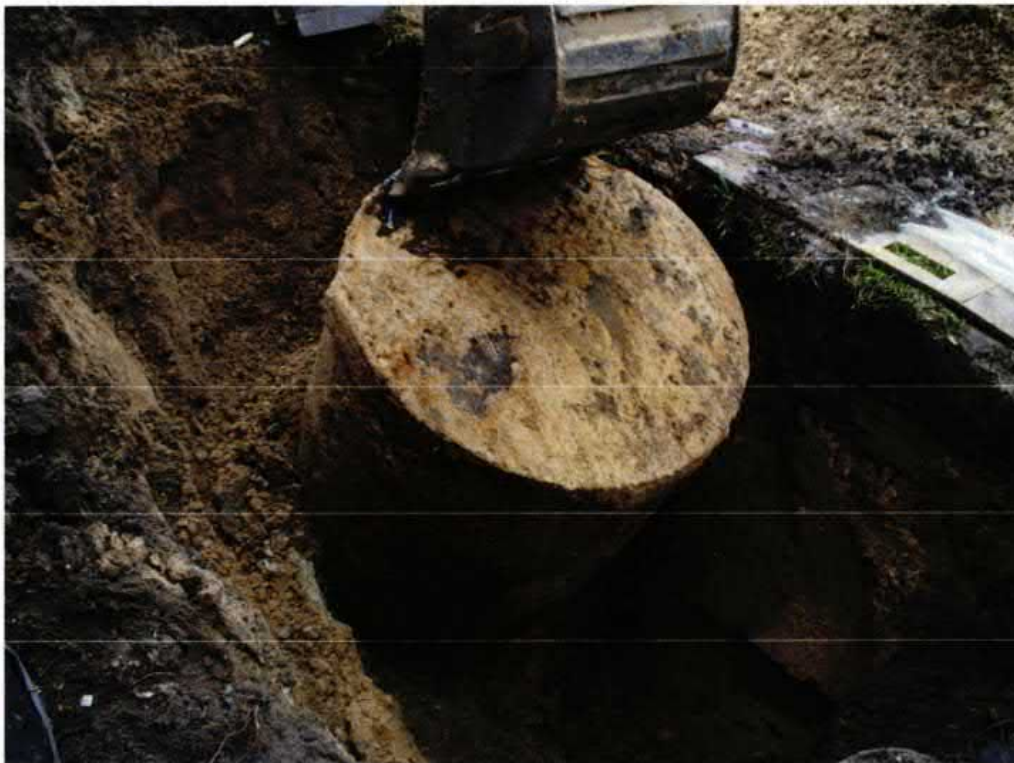
Corrosion, pitting and holes were found throughout the tank.

Picture 2: UST 1310Eagle.
