**SUMMARY REPORT**  
**423 WEST CARDINAL LANE (FORMERLY 1360 WEST CARDINAL LANE)**  
**LAUREL BAY MILITARY HOUSING AREA**  
**MARINE CORPS AIR STATION BEAUFORT**  
**BEAUFORT, SC**

**Contract Number: N62470-14-D-9016**  
**CTO WE52**  
**JUNE 2021**

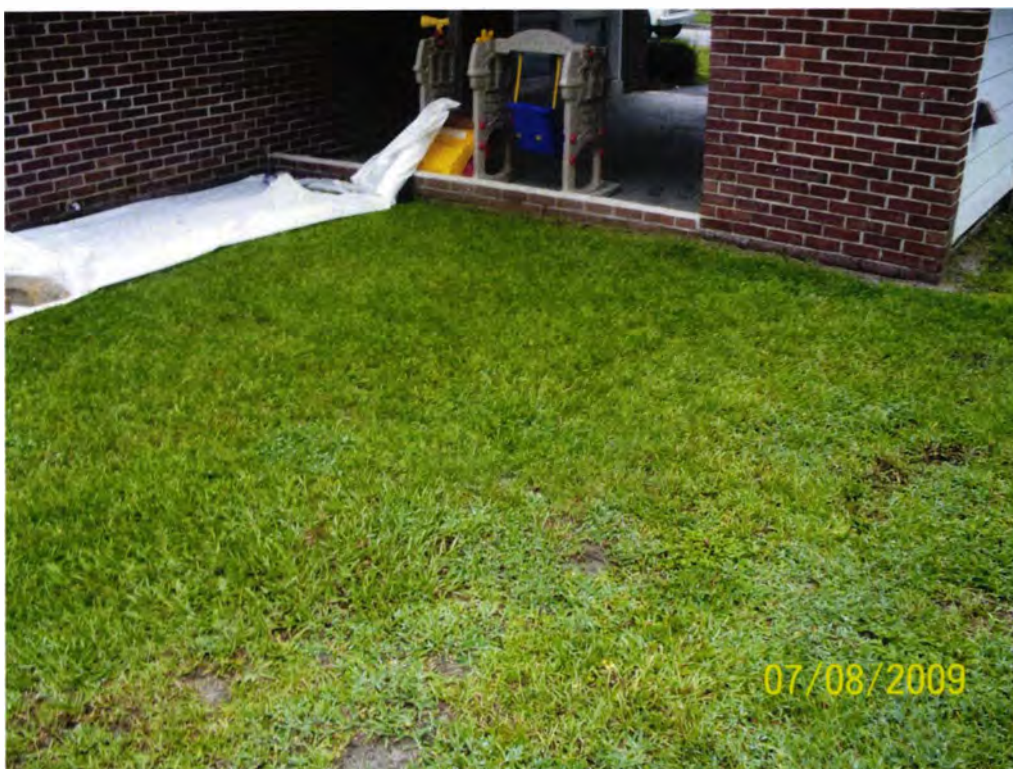
Picture 1: Location of UST 1360Cardinal.

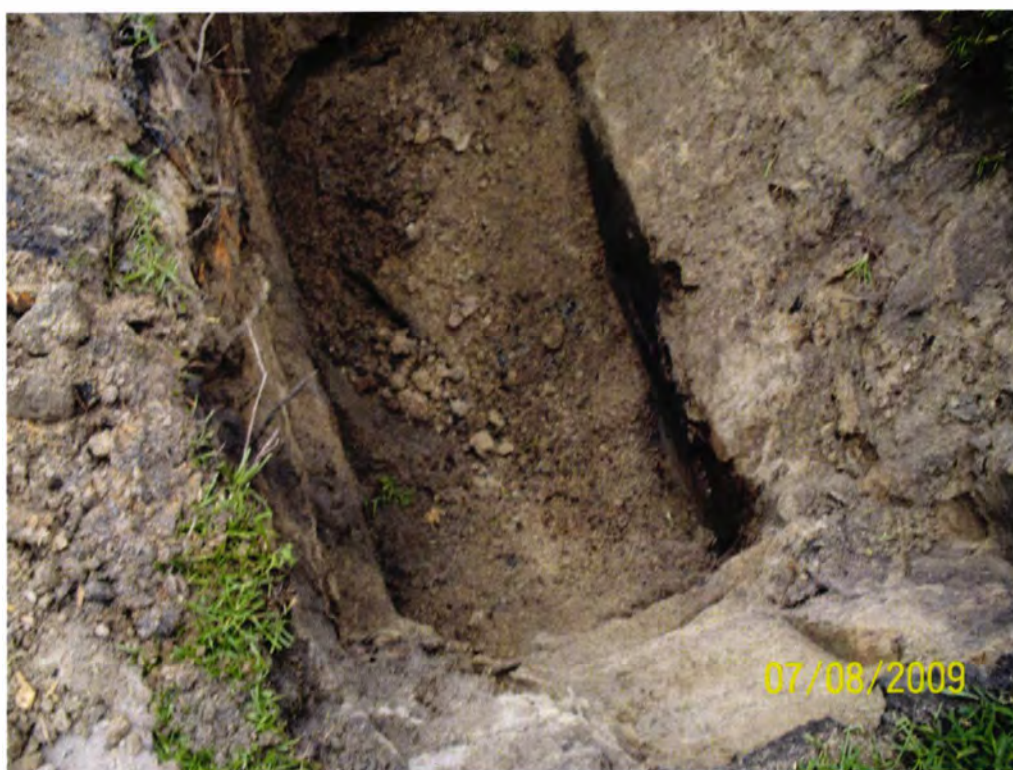
- M. Method of disposal for any USTs removed from the ground (attach disposal manifests)  
UST 1360Cardinal was removed from the ground and disposed of at a  
Subtitle "D" landfill. See Attachment "A."
- 
- N. Method of disposal for any liquid petroleum, sludges, or wastewaters removed from the USTs (attach disposal manifests)  
UST 1360Cardinal had been previously filled with sand by others.
- 
- O. If any corrosion, pitting, or holes were observed, describe the location and extent for each UST  
Corrosion, pitting and holes were found through out the tank.
-

Corrosion and pitting were found on the surface of the steel vent pipe. Copper supply and return lines were sound.

Picture 2: Excavation of UST 1360Cardinal.
