SUMMARY REPORT
441 WEST CARDINAL LANE (FORMERLY 1362 WEST CARDINAL LANE)
LAUREL BAY MILITARY HOUSING AREA
MARINE CORPS AIR STATION BEAUFORT
BEAUFORT, SC

JUNE 2021

Contract Number: N62470-14-D-9016
CTO WE52
JUNE 2021

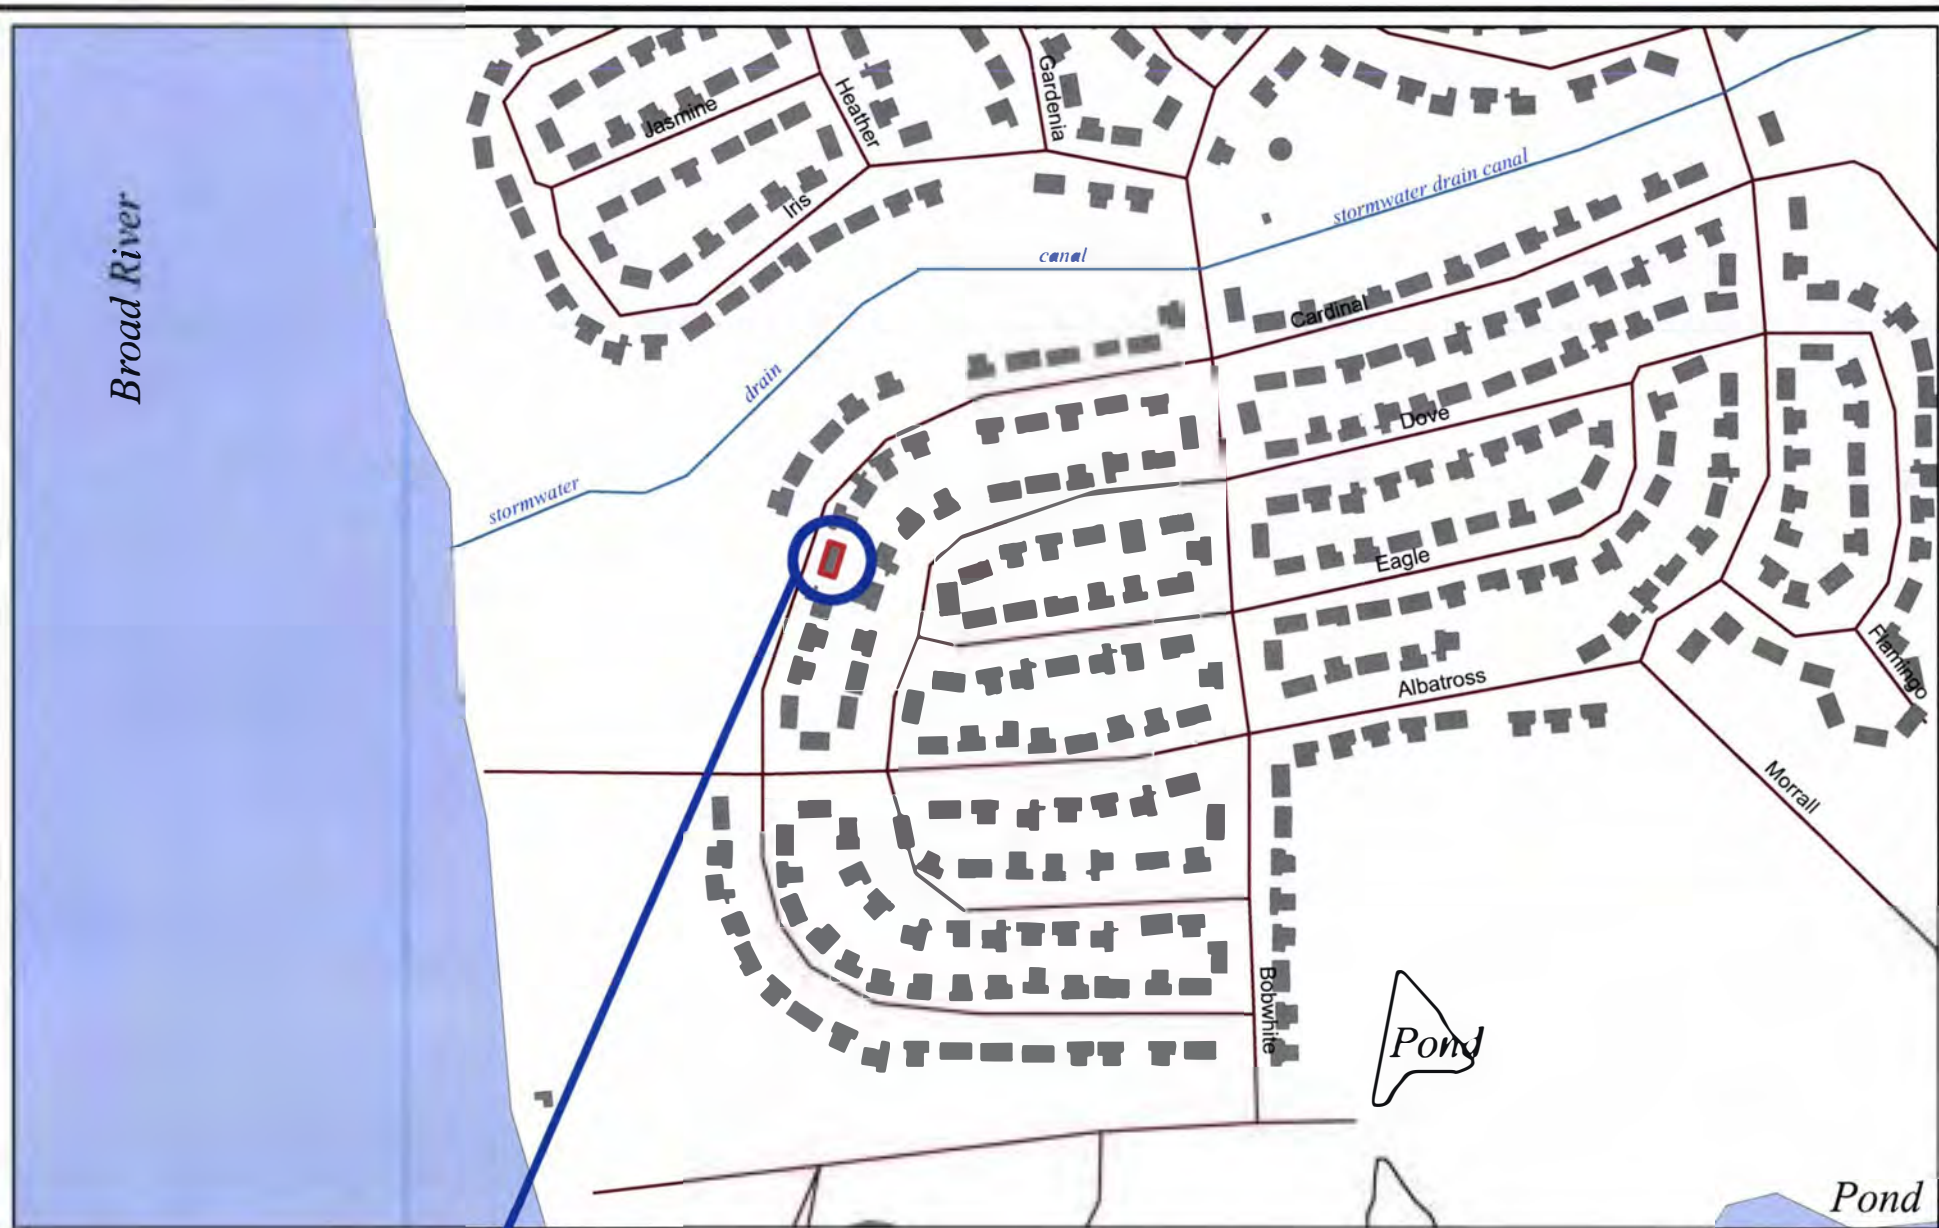
1362 CARDINAL LANE

You must supply a scaled site map. It should include all buildings, road names, utilities, tank and dispenser island locations, labeled sample locations, extent of excavation, and any other pertinent information.

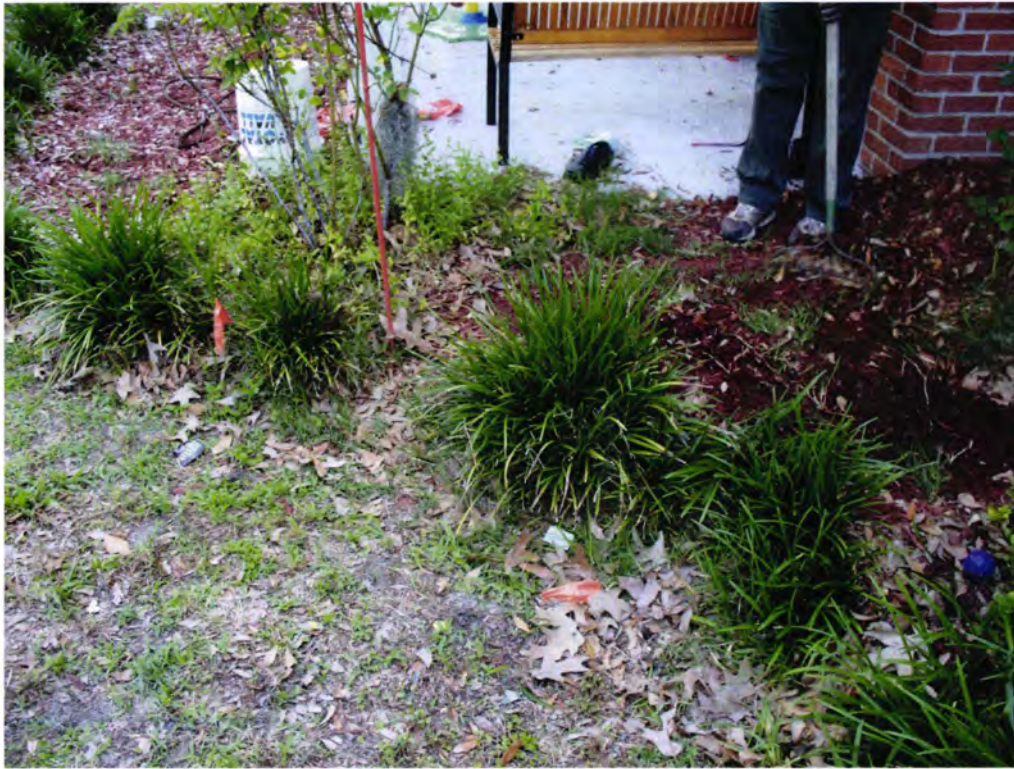
Picture 1: Location of UST 1362 Cardinal.

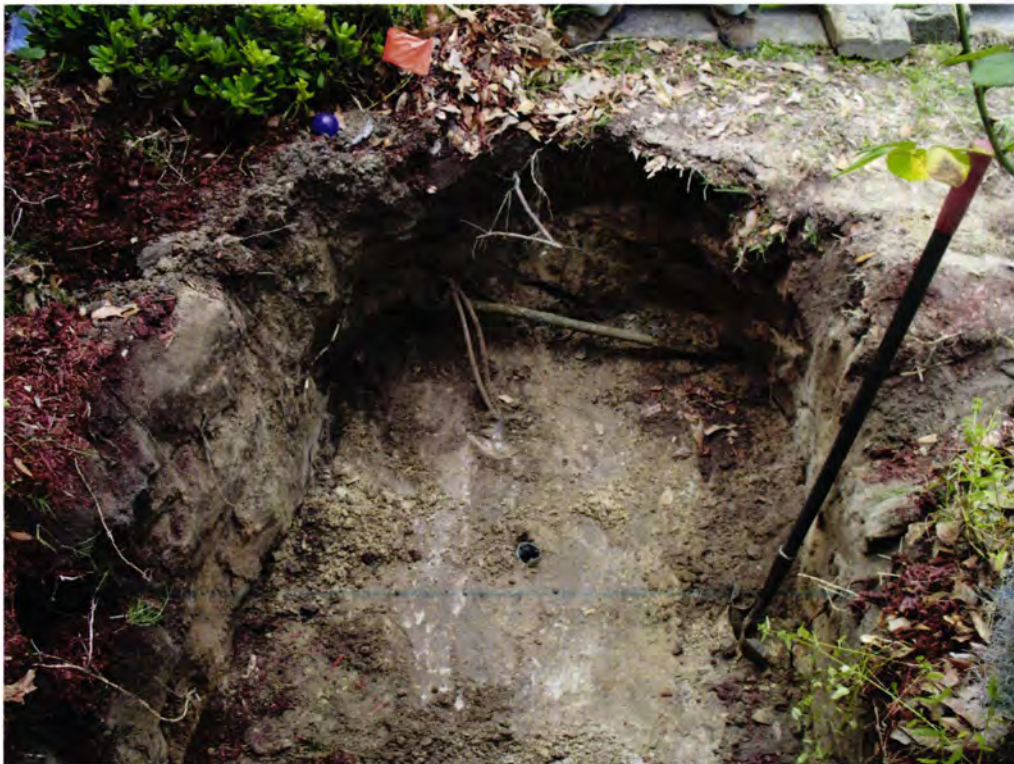
Picture 2: UST 1362 Cardinal excavation in progress.
