SUMMARY REPORT
322 WEST DOVE LANE (FORMERLY 1379 WEST DOVE LANE)
LAUREL BAY MILITARY HOUSING AREA
MARINE CORPS AIR STATION BEAUFORT
BEAUFORT, SC

South Carolina Department of Health and Environmental Control (SCDHEC)
Underground Storage Tank (UST) Assessment Report

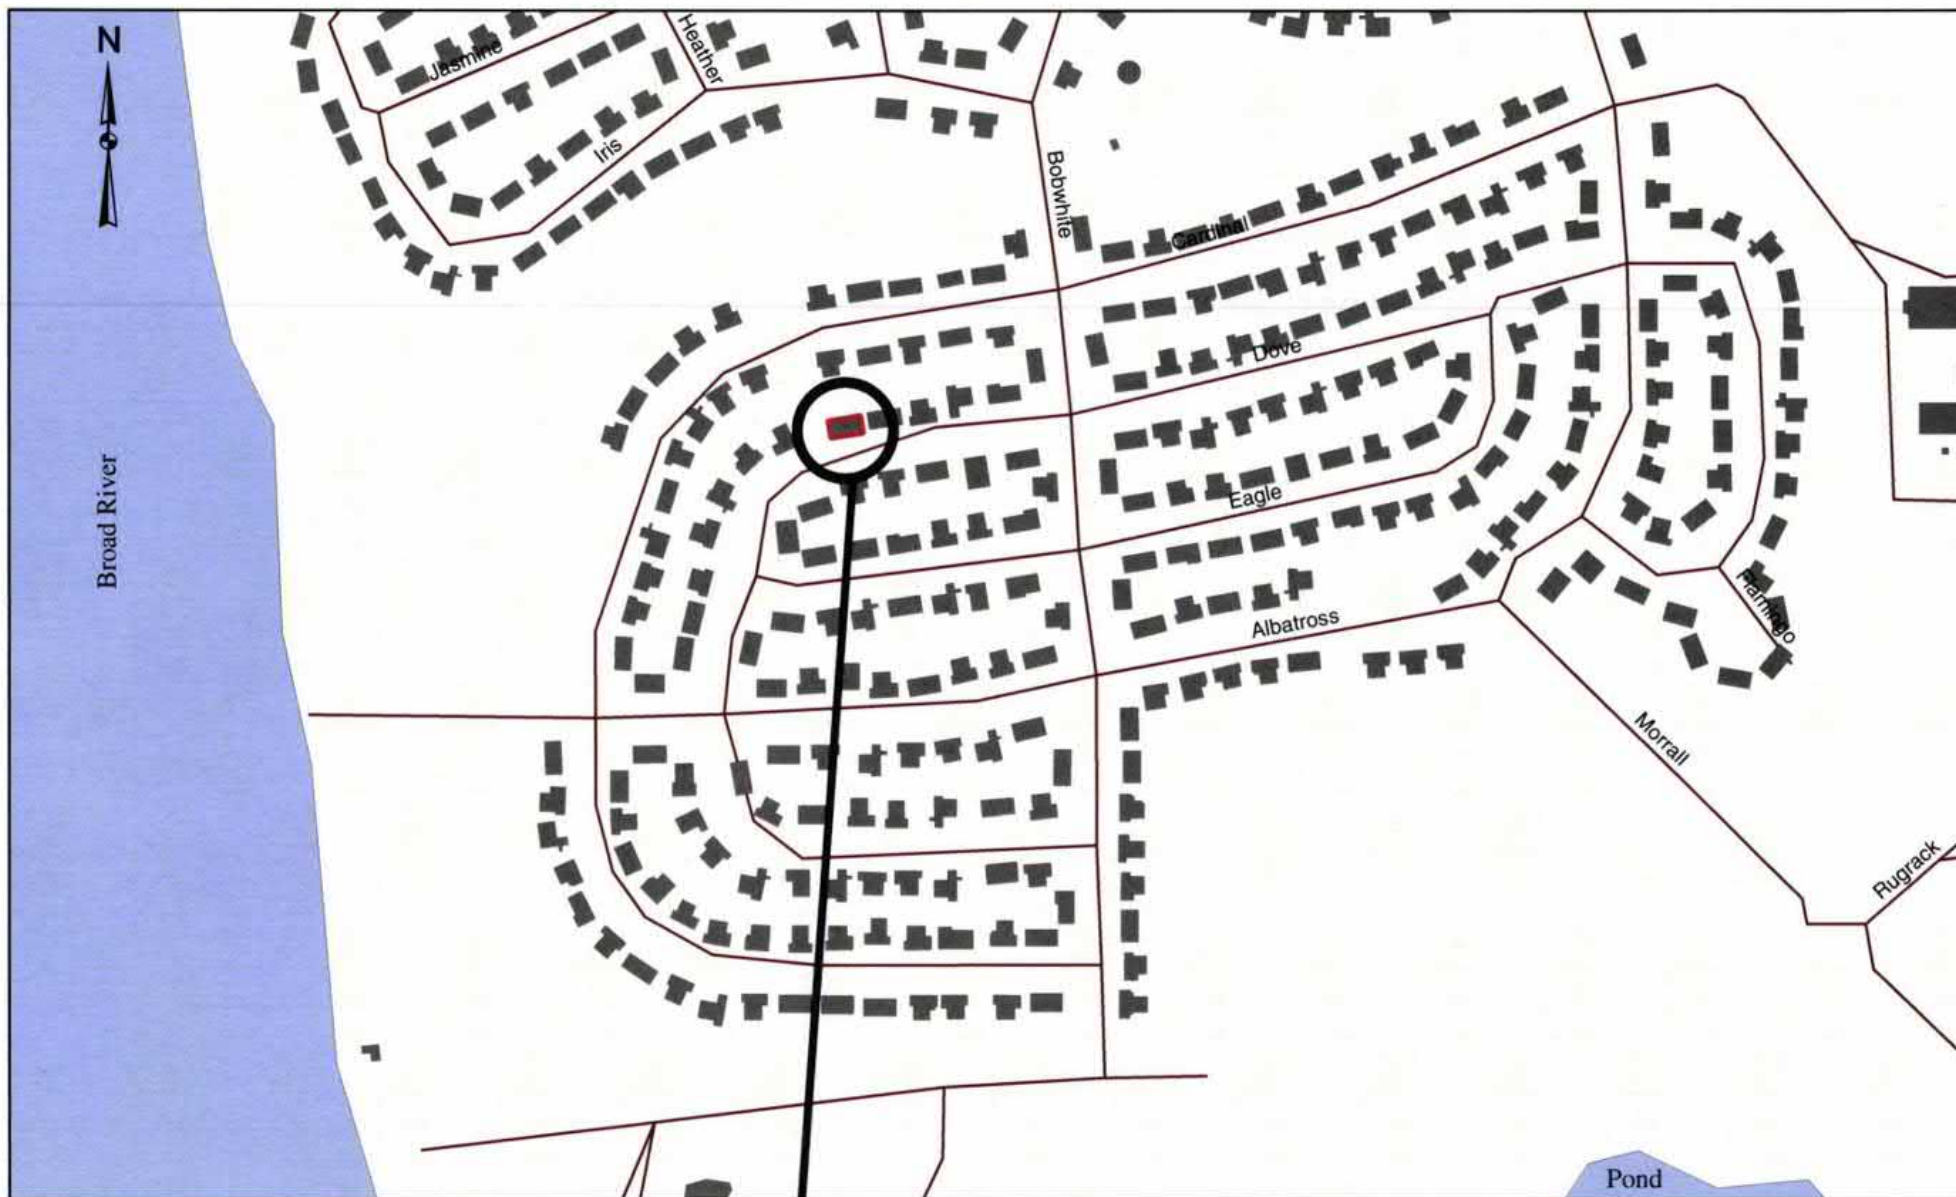
1379 DOVE LANE

You must supply a scaled site map. It should include all buildings, road names, utilities, tank and dispenser island locations, labeled sample locations, extent of excavation, and any other pertinent information.

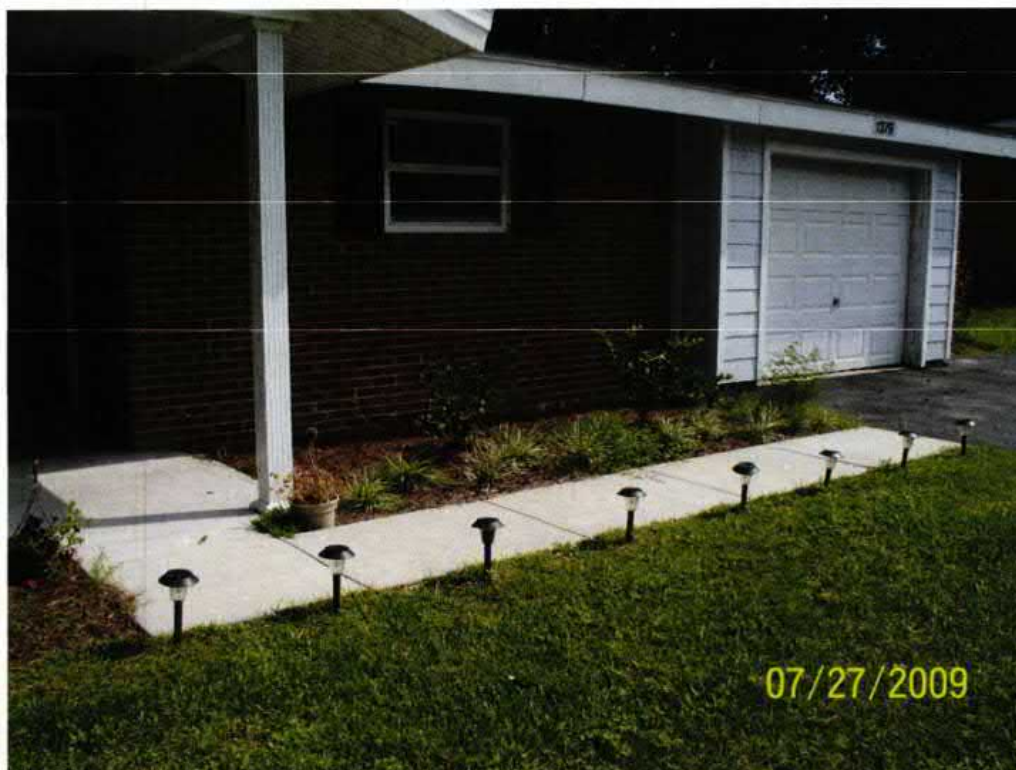
Picture 1: Location of UST 1379Dove prior to removal.

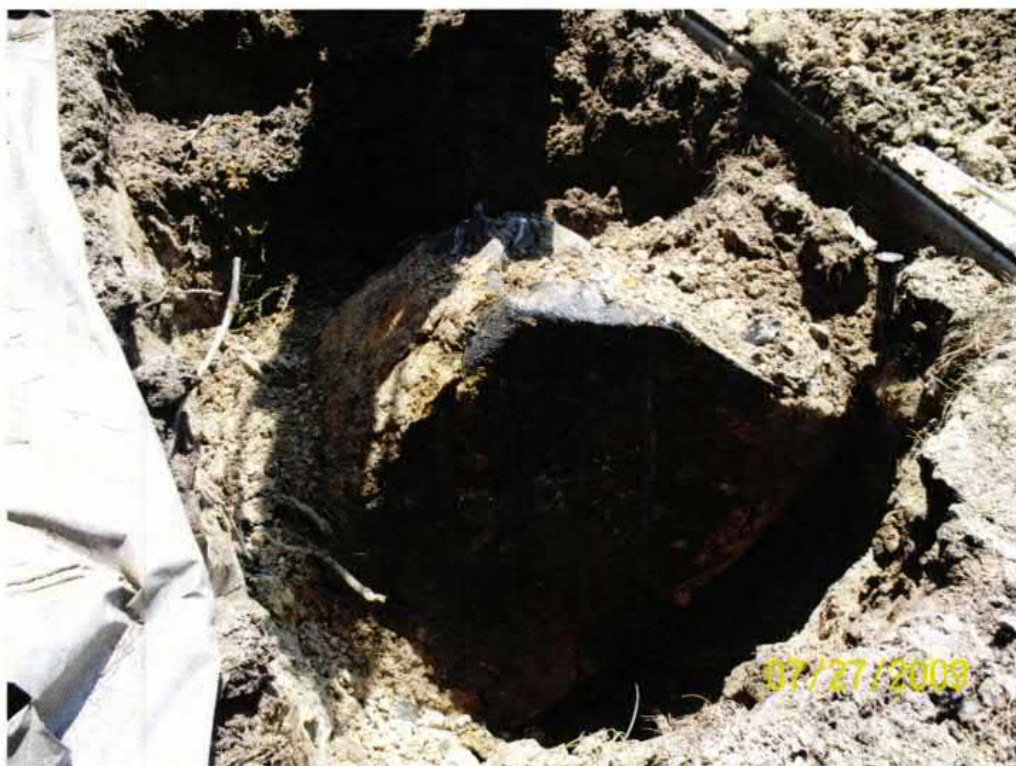
- M. Method of disposal for any USTs removed from the ground (attach disposal manifests)
UST 1379Dove was removed from the ground and disposed of at a
Subtitle "D" landfill. See Attachment "A."
-
- N. Method of disposal for any liquid petroleum, sludges, or wastewaters removed from the USTs (attach disposal manifests)
UST 1379Dove had been previously filled with sand by others.
-
- O. If any corrosion, pitting, or holes were observed, describe the location and extent for each UST
Corrosion, pitting and holes were found through out the tank.

Picture 2: UST 1379Dove during removal.
