**SUMMARY REPORT**  
**421 WEST DOVE LANE (FORMERLY 1392 WEST DOVE LANE)**  
**LAUREL BAY MILITARY HOUSING AREA**  
**MARINE CORPS AIR STATION BEAUFORT**  
**BEAUFORT, SC**

**Contract Number: N62470-14-D-9016**  
**CTO WE52**  
**JUNE 2021**

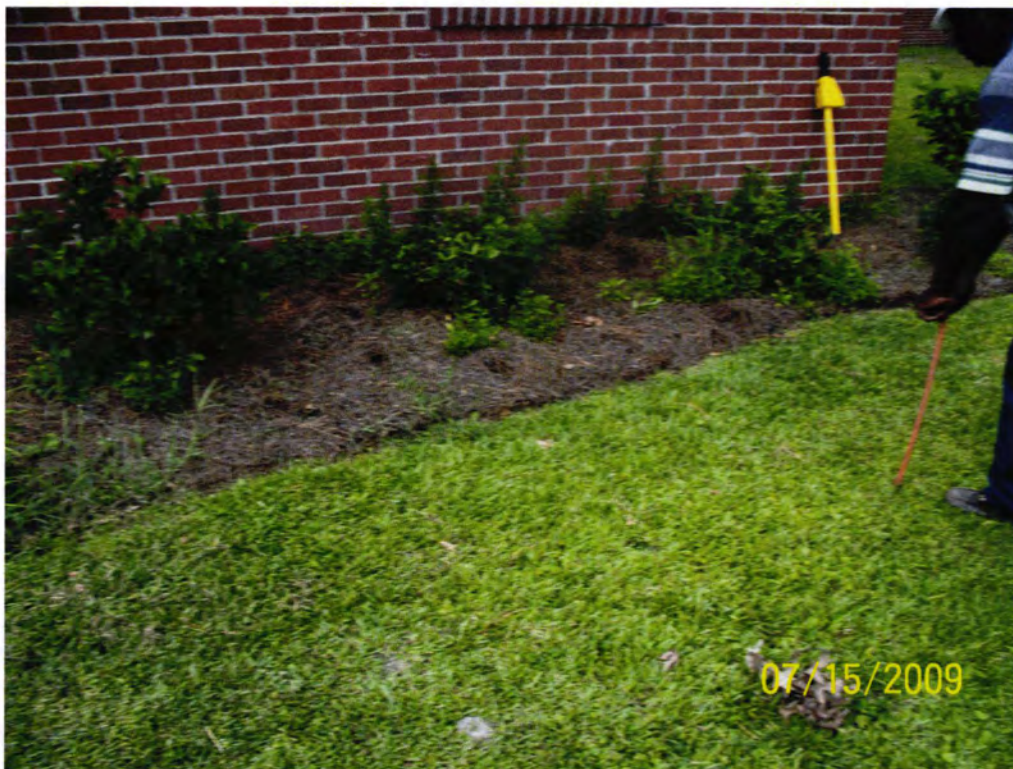
Picture 1: Location of UST 1392Dove prior to removal.
