SUMMARY REPORT
478 ALBATROSS DRIVE (FORMERLY 1413 ALBATROSS DRIVE)
LAUREL BAY MILITARY HOUSING AREA
MARINE CORPS AIR STATION BEAUFORT
BEAUFORT, SC

JUNE 2021

Contract Number: N62470-14-D-9016
CTO WE52
JUNE 2021

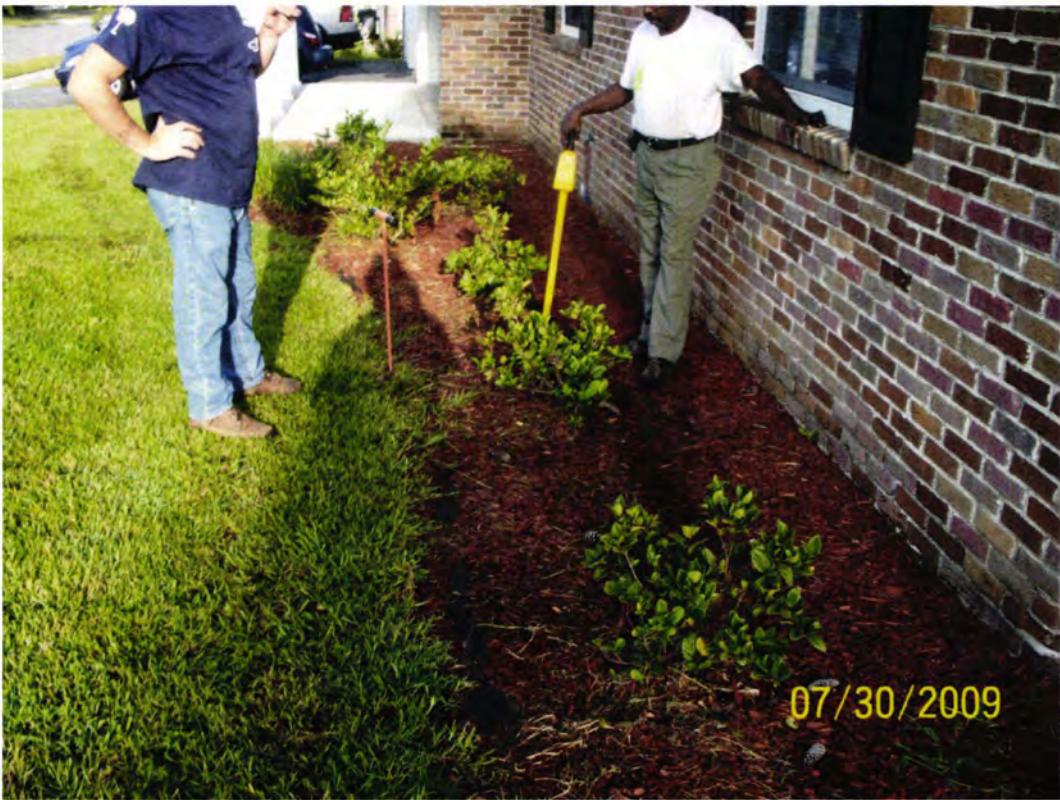
Picture 1: Location of UST 1413Albatross.
