**SUMMARY REPORT**  
**567 WEST CARDINAL LANE (FORMERLY 1452 WEST CARDINAL LANE)**  
**LAUREL BAY MILITARY HOUSING AREA**  
**MARINE CORPS AIR STATION BEAUFORT**  
**BEAUFORT, SC**

**JUNE 2021**

**Contract Number: N62470-14-D-9016**  
**CTO WE52**  
**JUNE 2021**

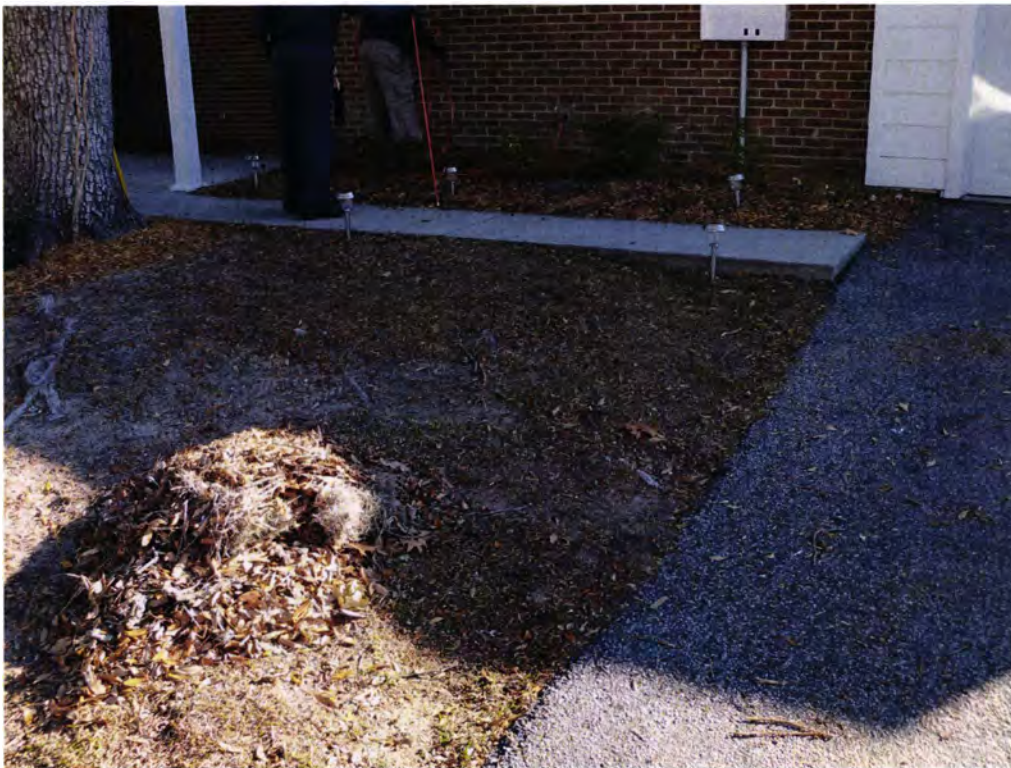
Picture 1: Location of UST 1452 Cardinal.

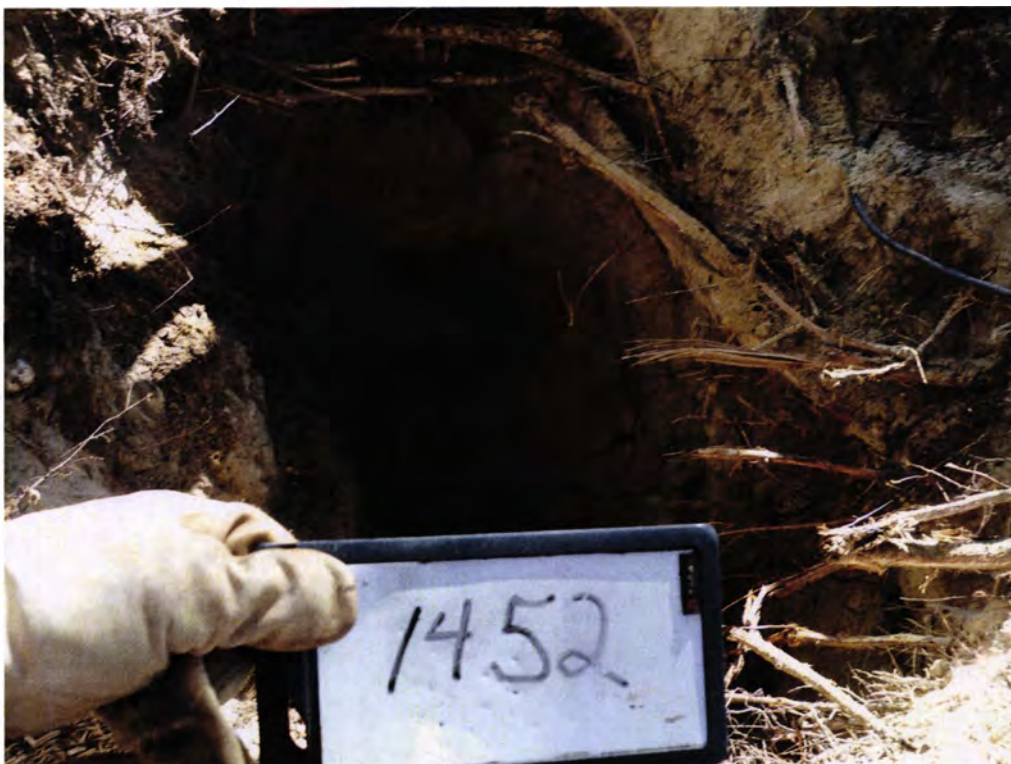
- M. Method of disposal for any USTs removed from the ground (attach disposal manifests)  
UST 1452Cardinal was removed from the ground and disposed  
at a Subtitle "D" landfill. See Attachment "A".
- N. Method of disposal for any liquid petroleum, sludges, or wastewaters removed from the USTs (attach disposal manifests)  
UST 1452Cardinal was previously filled with sand by others.
- O. If any corrosion, pitting, or holes were observed, describe the location and extent for each UST  
Corrosion, pitting and holes were found throughout the tank.

Picture 2: UST 1452 Cardinal excavation.
