**SUMMARY REPORT  
350 ASH STREET (FORMERLY 335 ASH STREET)  
LAUREL BAY MILITARY HOUSING AREA  
MARINE CORPS AIR STATION BEAUFORT  
BEAUFORT, SC**

**JUNE 2021**

**Contract Number: N62470-14-D-9016  
CTO WE52  
JUNE 2021**

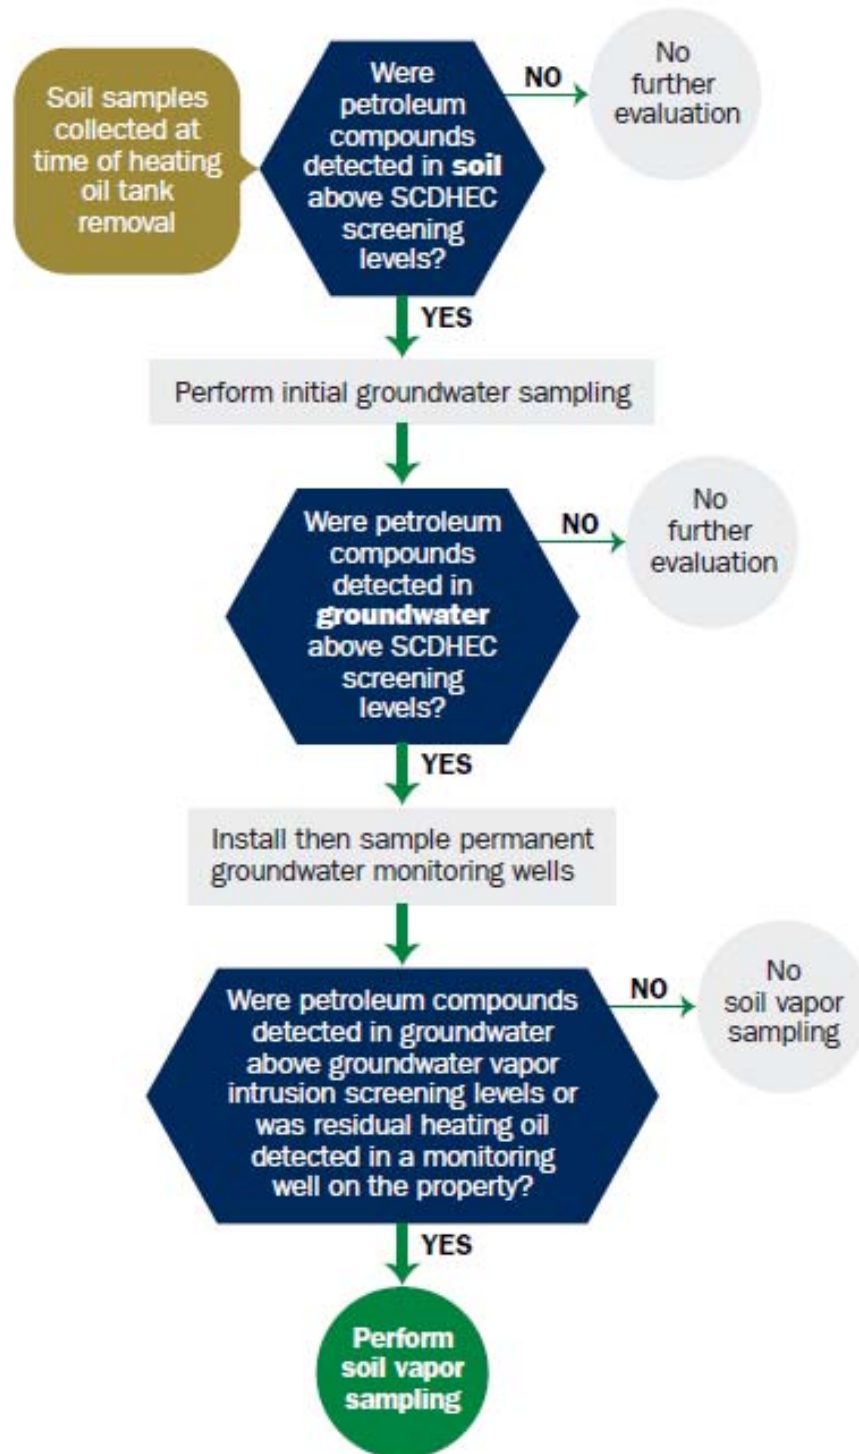
Appendix A - Multi-Media Selection Process for LBMH

The results of the soil sampling at each former UST location were used to determine if a potential for groundwater contamination exists (i.e., soil results greater than RBSLs) and subsequently to select properties for follow-up initial groundwater assessment (IGWA) sampling. The IGWA sampling process utilizes temporary groundwater sampling points that are typically installed and sampled within the same day. The intent of the sampling point is to determine the presence or absence of the aforementioned COPCs in groundwater and identify whether former UST locations may require additional delineation of COPCs in groundwater. These sampling points are not subjected to the same installation standards as permanent monitoring wells and, as such; the data obtained from the IGWA wells can sometimes be biased high and is considered preliminary data. In order to confirm the presence of any impact to groundwater, a permanent well is installed where IGWA sampling has indicated the presence of free product and/or COPCs is in excess of the SCDHEC RBSLs for groundwater. If COPCs and/or free product are found to be present in the permanent well, additional permanent wells are installed to delineate the extent of impact to groundwater and a sampling program (LTM) is established. If free product is detected in a permanent well, a groundwater sample is not collected, and monthly passive LNAPL monitoring and recovery activities are conducted. Groundwater analytical results from permanent wells are also compared to the site specific groundwater vapor intrusion screening levels (VISLs) to evaluate the potential for vapor intrusion and the necessity for an investigation associated with this media. A multi-media investigation selection process tree, applicable to the LBMH UST investigations, is presented as Appendix A.

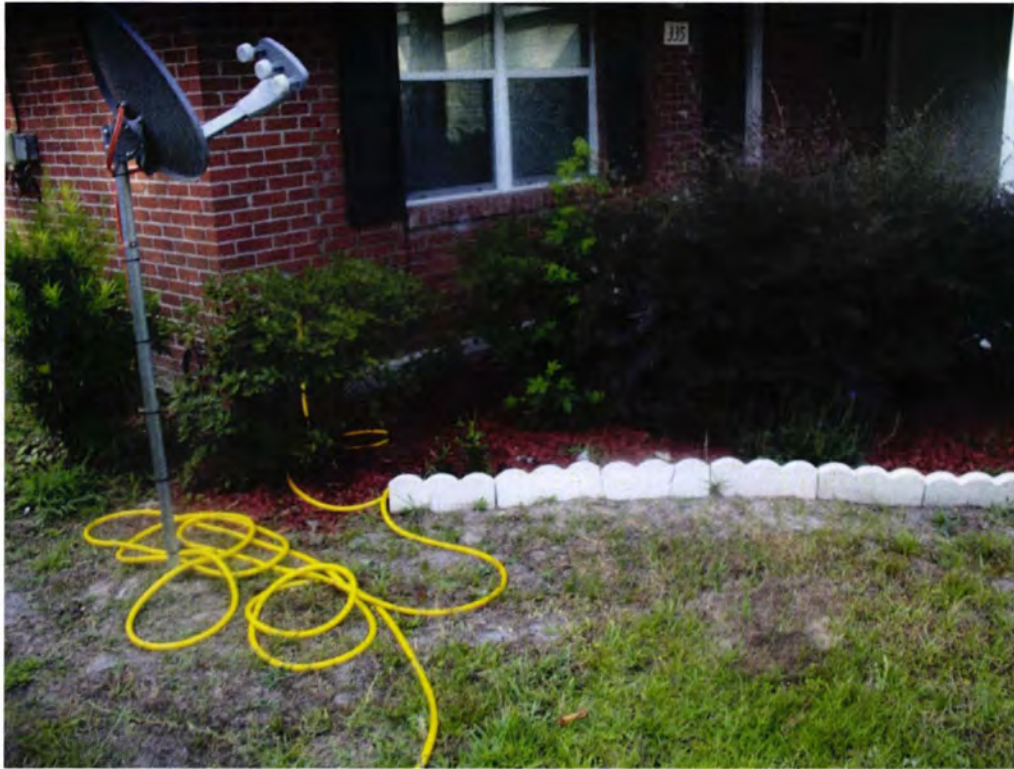
Picture 1: Location of the tanks at 335 Ash Street.

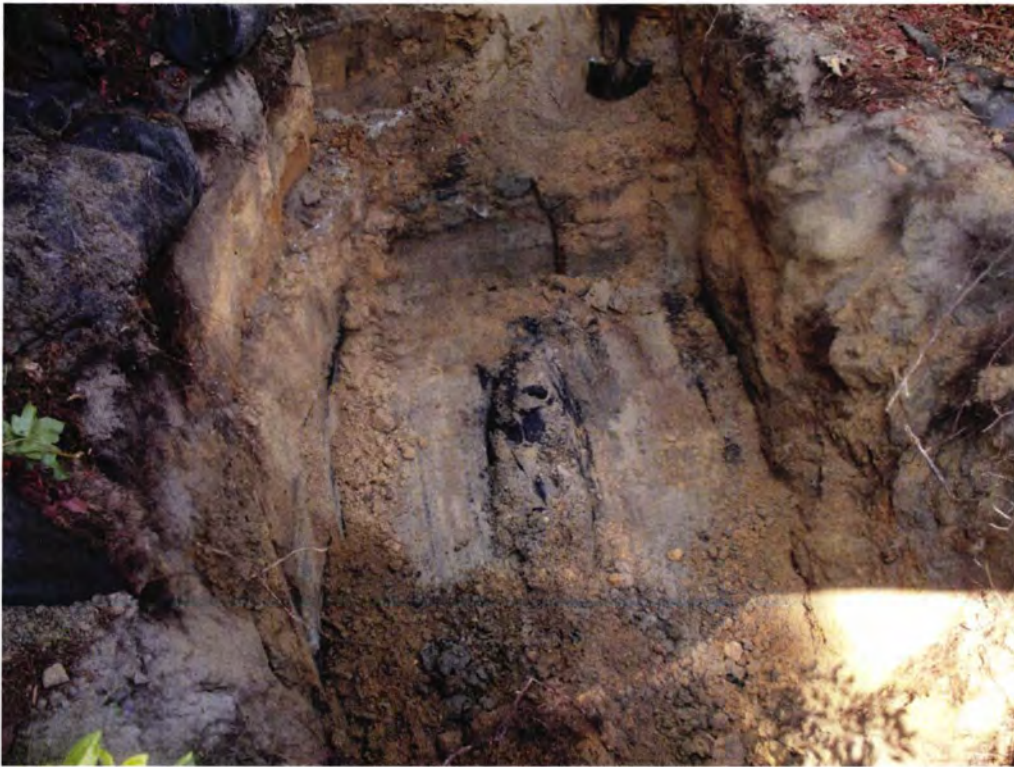
O. If any corrosion, pitting, or holes were observed, describe the location and extent for each UST  
Corrosion, pitting and holes were found in both tanks.

Picture 2: UST 335Ash-1 excavation in progress.

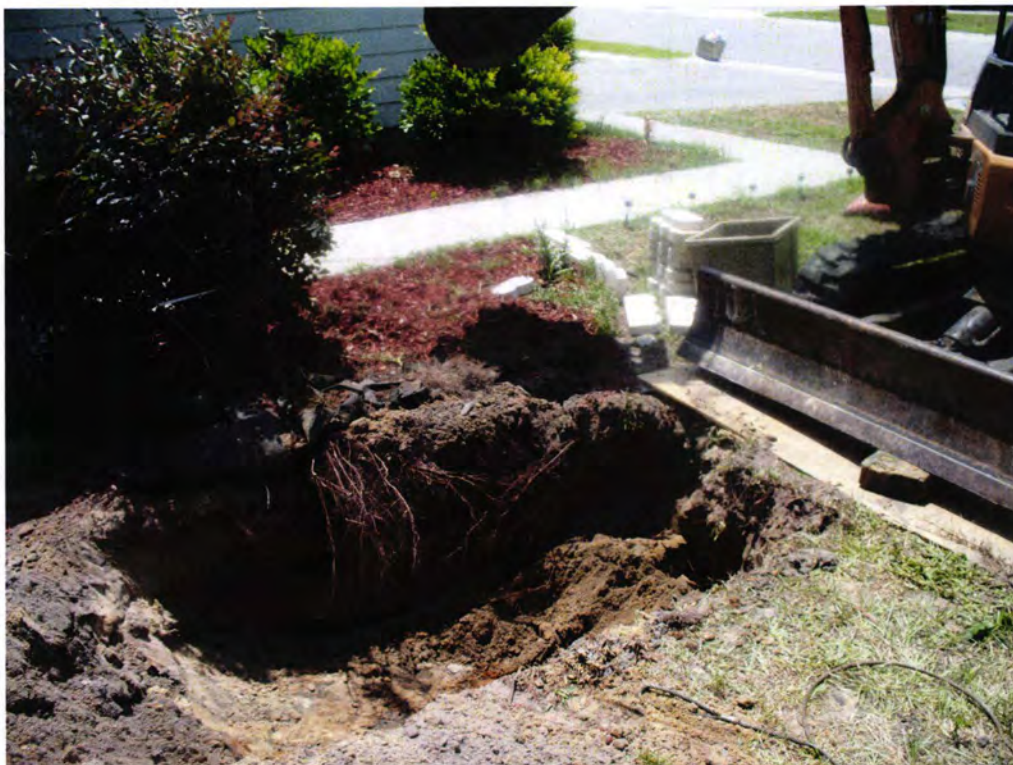
Picture 3: Excavation of UST 335Ash-2.

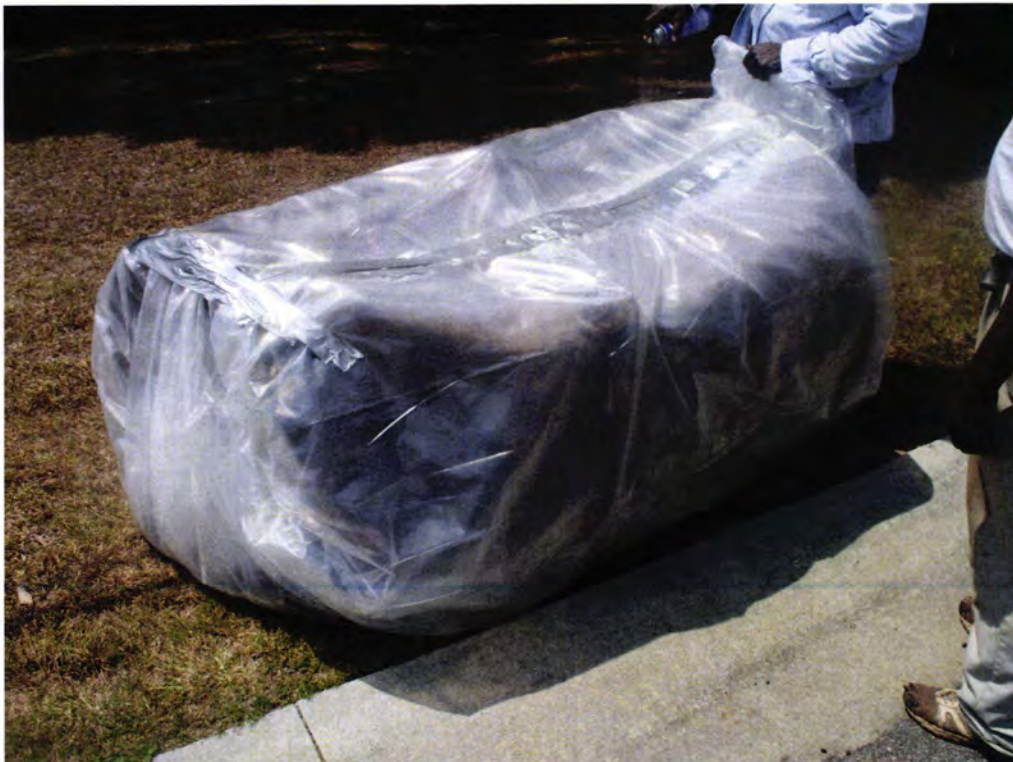
Steel vent piping for both tanks were corroded and pitted. All  
copper supply and return piping were sound.

Picture 4: UST 335Ash-2.
