**SUMMARY REPORT  
381 ASH STREET (FORMERLY 336 ASH STREET)  
LAUREL BAY MILITARY HOUSING AREA  
MARINE CORPS AIR STATION BEAUFORT  
BEAUFORT, SC**

**Contract Number: N62470-14-D-9016  
CTO WE52  
JUNE 2021**

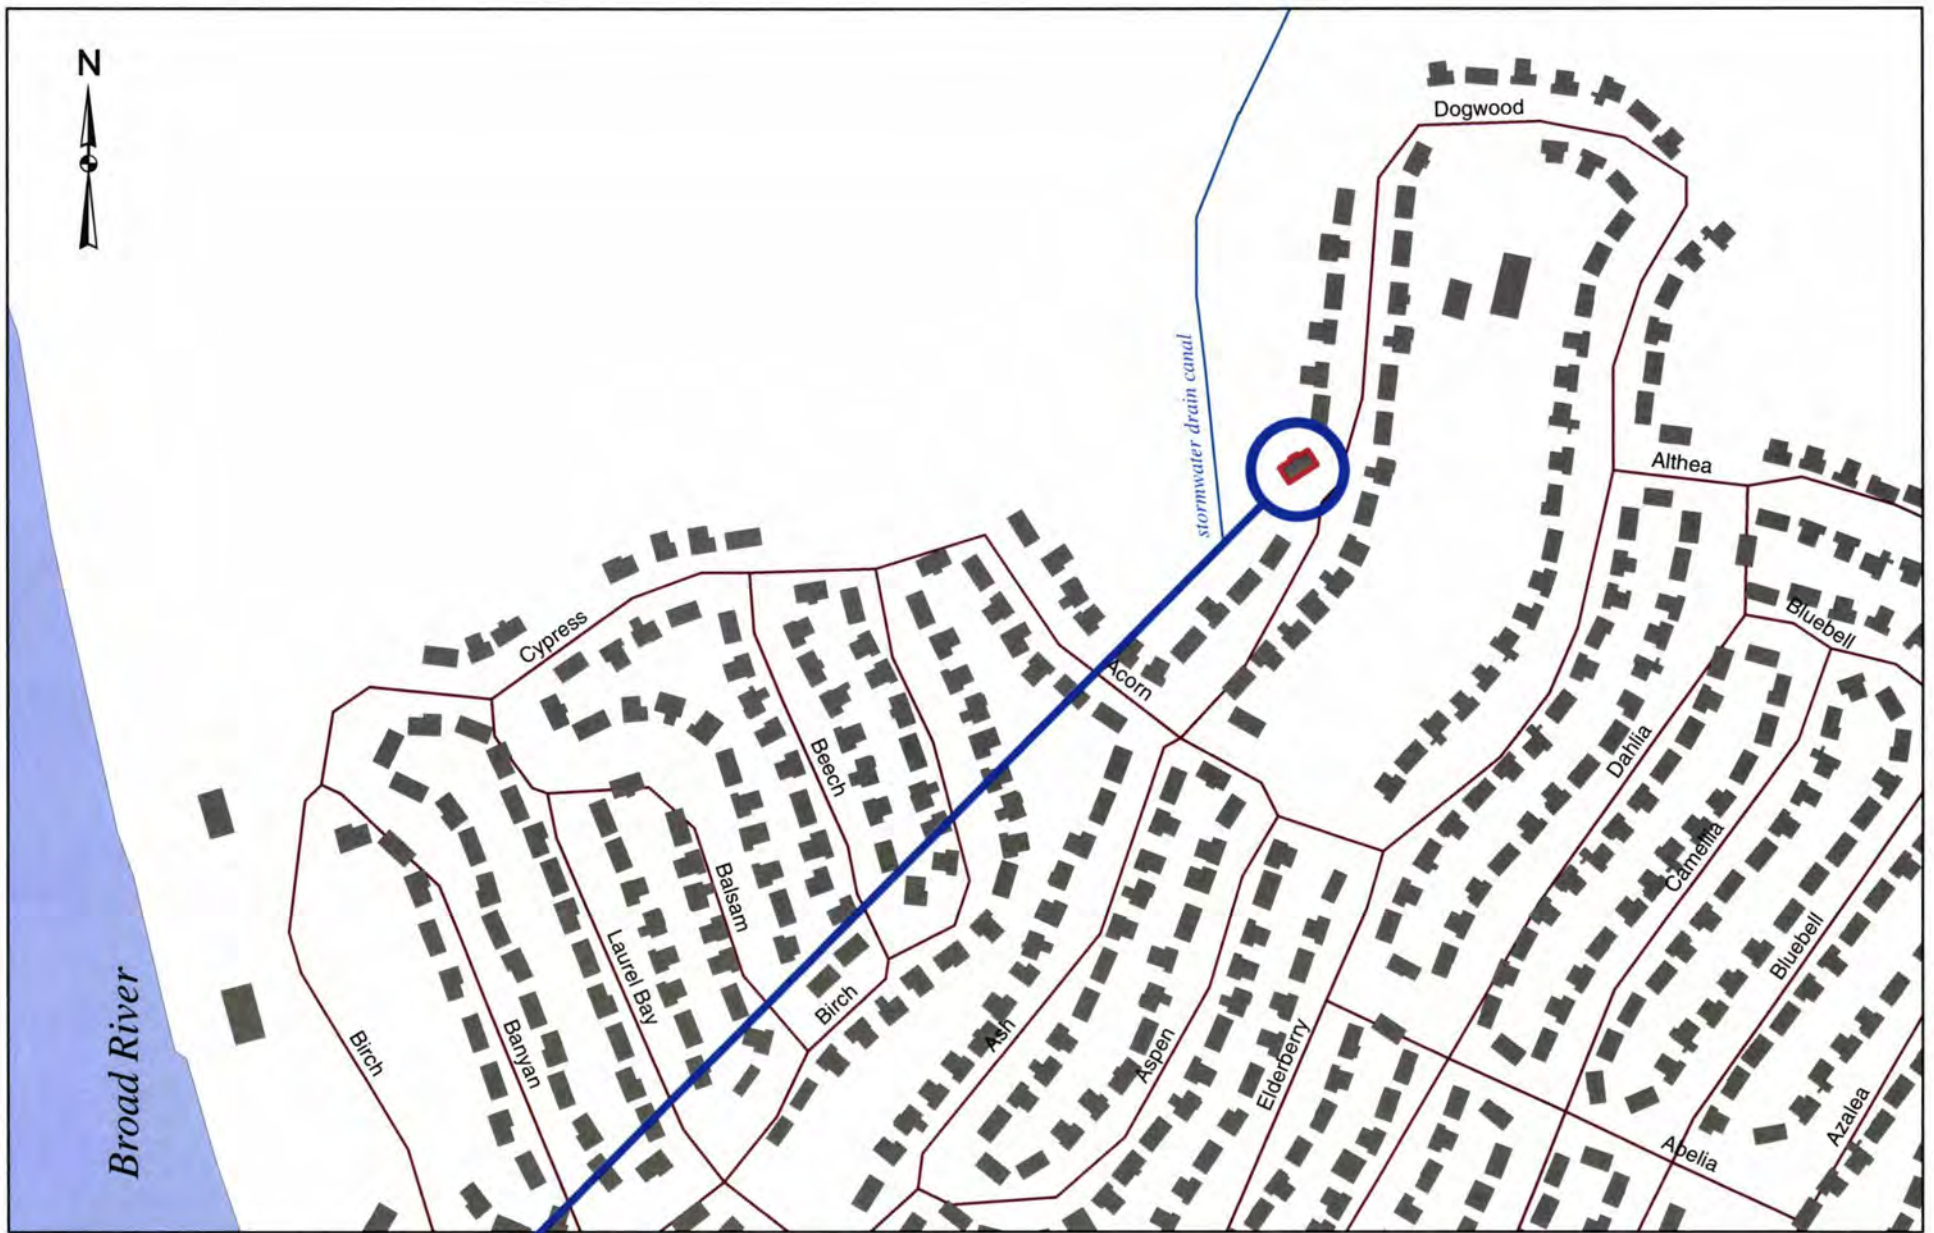
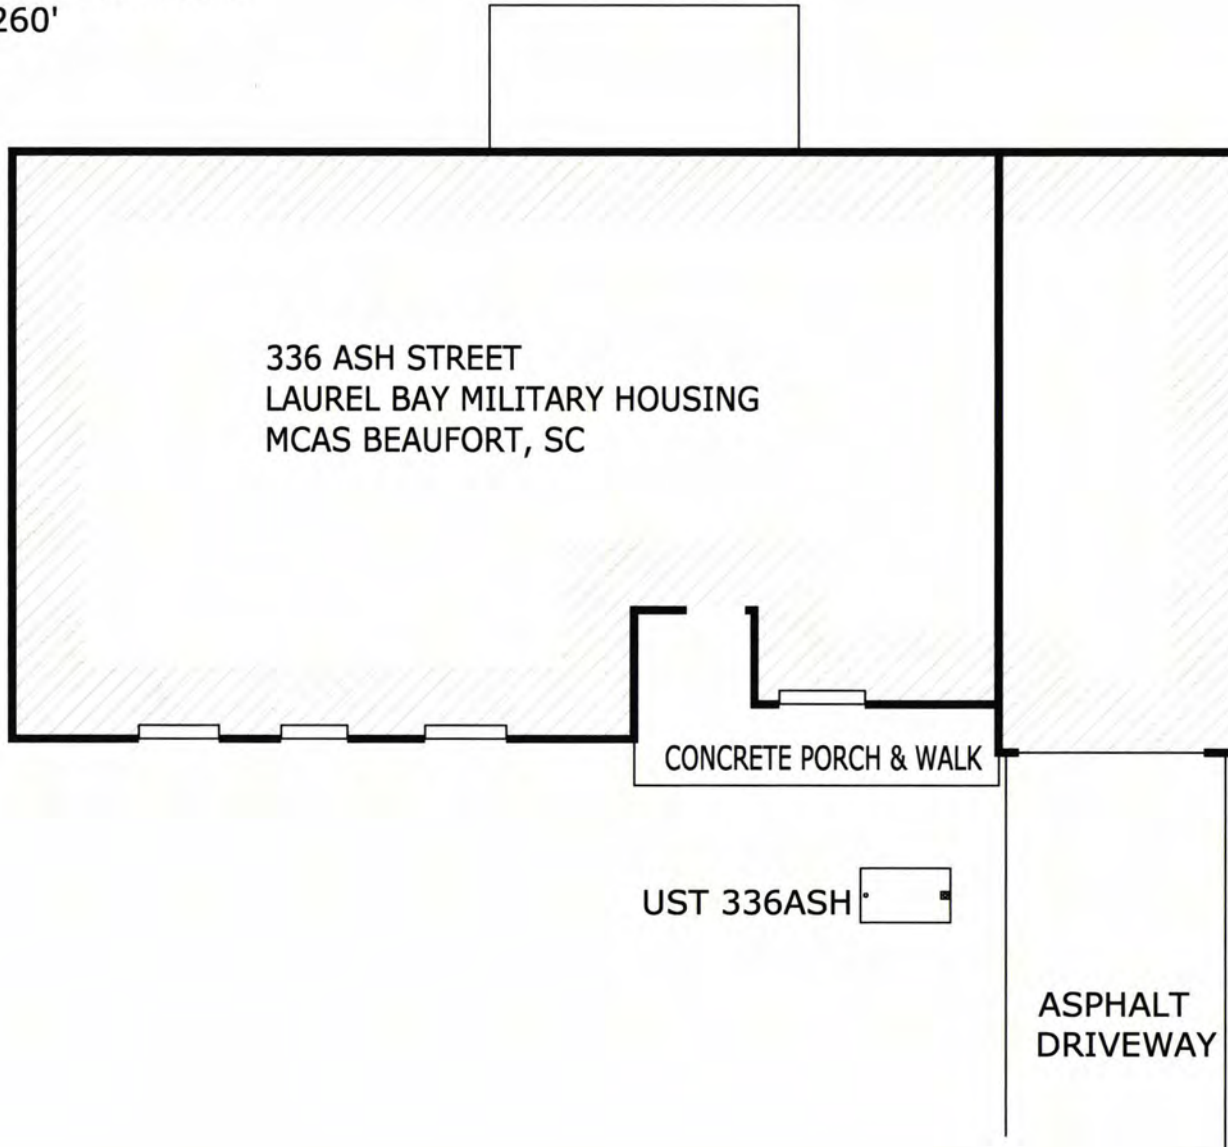
336 ASH STREET  
LAUREL BAY MILITARY HOUSING  
MCAS BEAUFORT, SC

**336 ASH ST.**

STORMWATER DRAINAGE  
CANAL  $\approx$  260'

CONCRETE PORCH & WALK

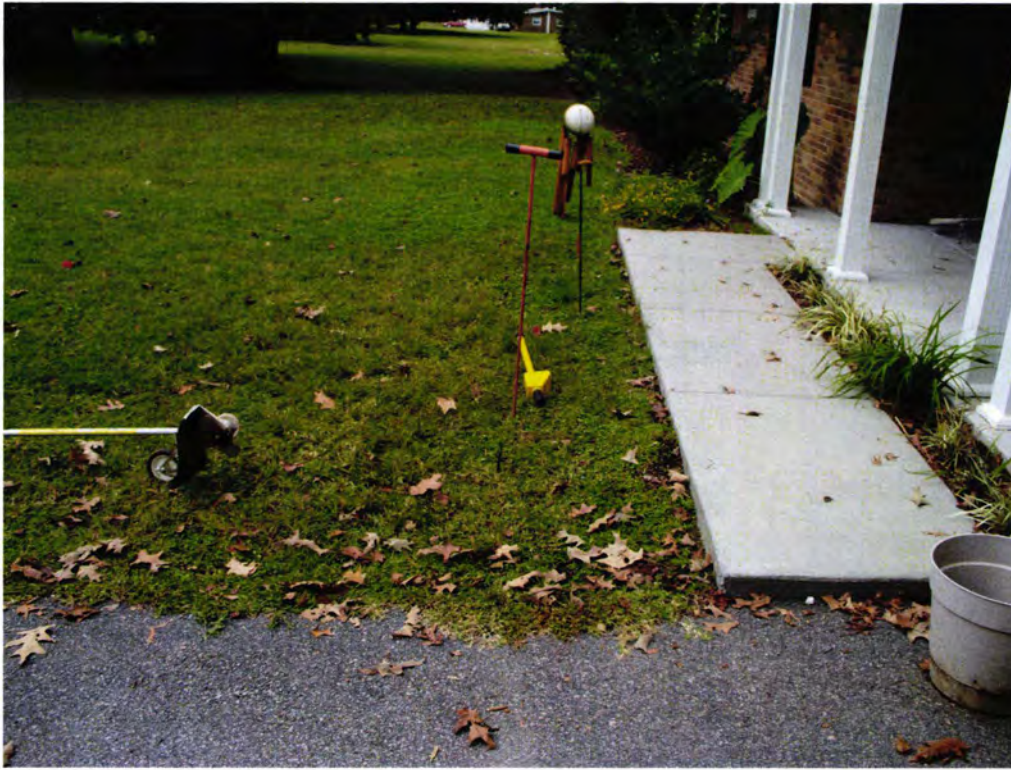
Picture 1: Location of UST 336Ash.

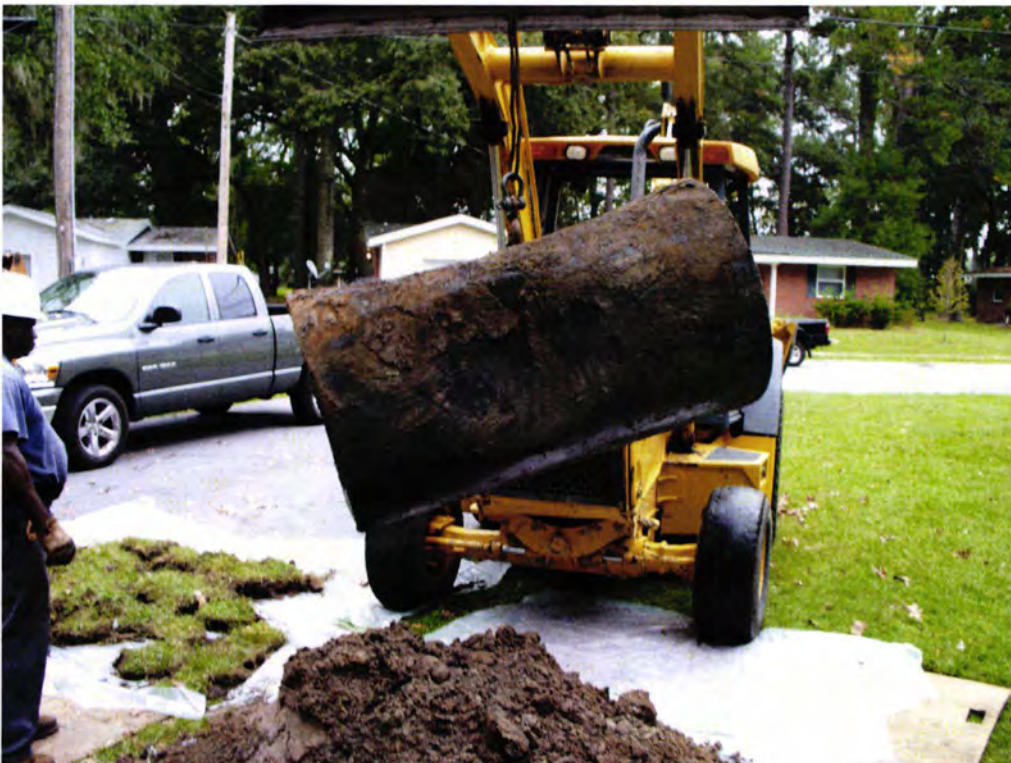
- M. Method of disposal for any USTs removed from the ground (attach disposal manifests)  
UST 336Ash was removed from the ground, cleaned, and recycled.  
See Attachment "A".
- 
- N. Method of disposal for any liquid petroleum, sludges, or wastewaters removed from the USTs (attach disposal manifests)  
Contaminated water was pumped from UST 336Ash and disposed of by MCAS.
- 
- O. If any corrosion, pitting, or holes were observed, describe the location and extent for each UST  
Corrosion, pitting and holes were found throughout the tank.

Picture 2: UST 336Ash.
