**SUMMARY REPORT**  
**537 ELDERBERRY DRIVE (FORMERLY 456 ELDERBERRY DRIVE)**  
**LAUREL BAY MILITARY HOUSING AREA**  
**MARINE CORPS AIR STATION BEAUFORT**  
**BEAUFORT, SC**

**JUNE 2021**

**CDM - AECOM**  
**Multimedia Joint Venture**

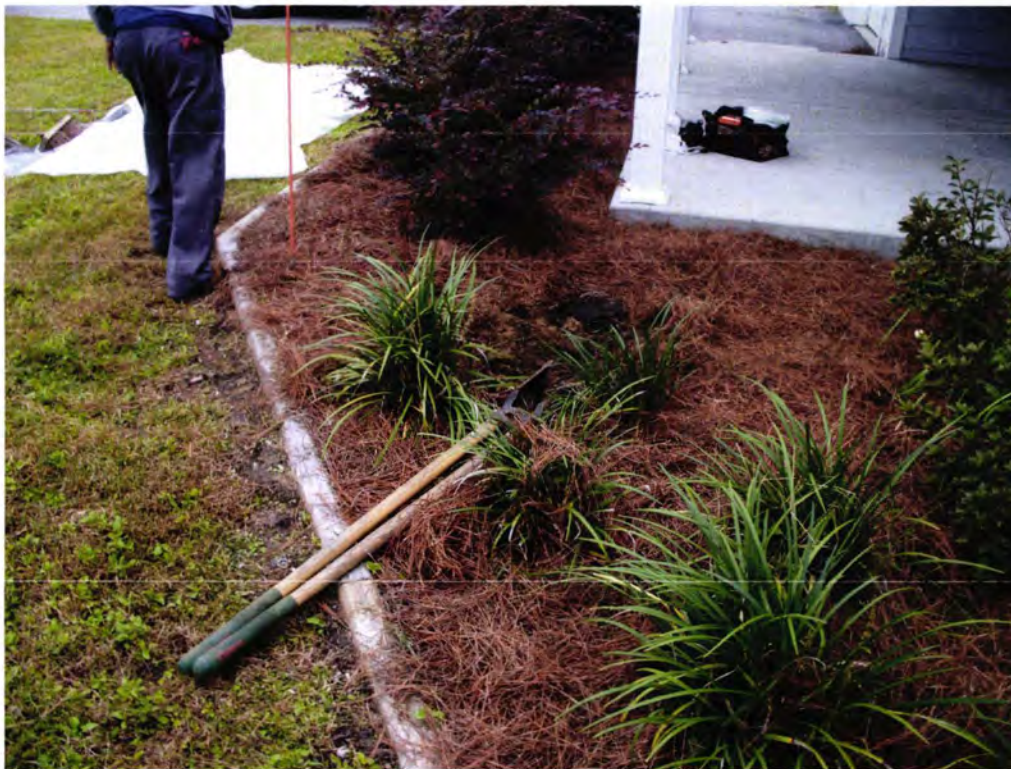
Picture 1: Location of 456 Elderberry's underground storage tanks.

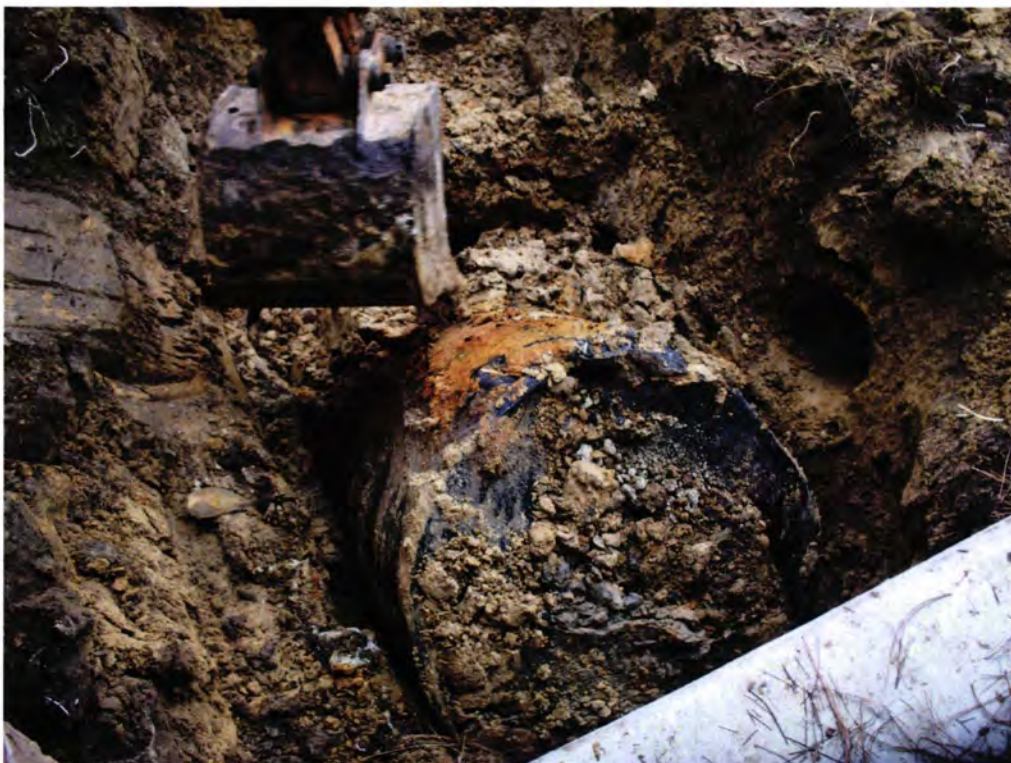
Picture 2: UST 456Elderberry-1 being removed from the excavation.

- M. Method of disposal for any USTs removed from the ground (attach disposal manifests)  
UST 456Elderberry-1 was removed from the ground, cleaned, and recycled.  
UST 456Elderberry-2 and -3 were removed from the ground and disposed of at a Subtitle "D" landfill. See Attachment "A".
- N. Method of disposal for any liquid petroleum, sludges, or wastewaters removed from the USTs (attach disposal manifests)  
Contaminated water was pumped from UST 456Elderberry-1 and disposed of by MCAS.  
UST 456Elderberry-2 and -3 were previously filled with sand by others.
- O. If any corrosion, pitting, or holes were observed, describe the location and extent for each UST  
Corrosion, pitting and holes were found throughout all tanks.

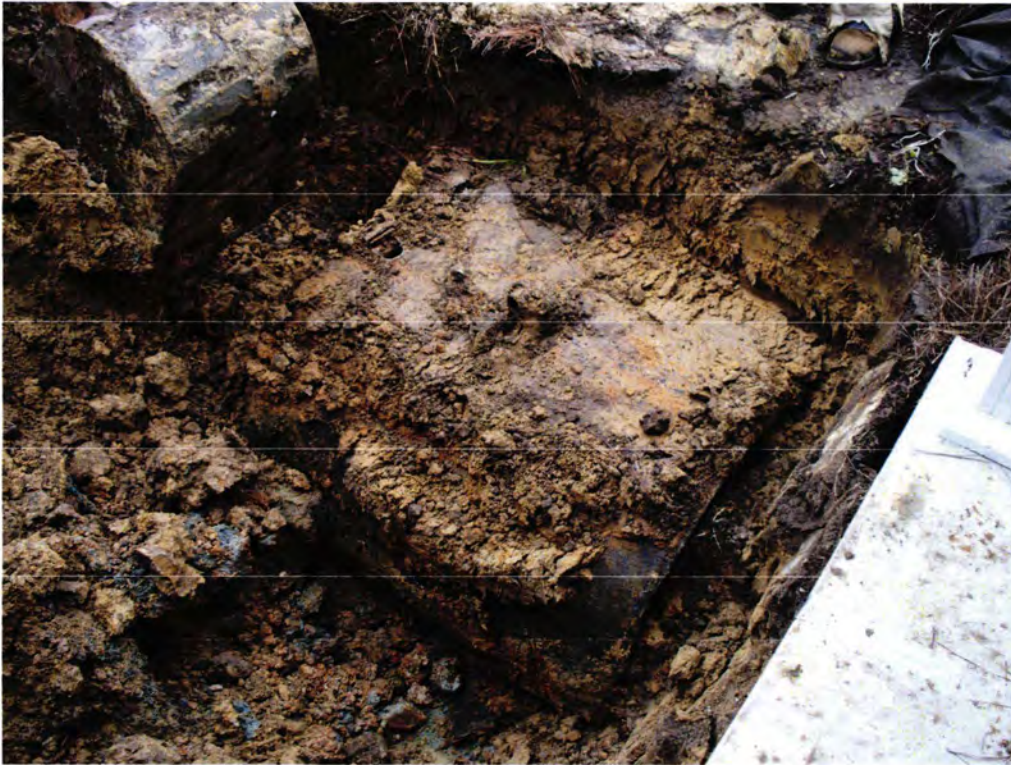
Picture 3: UST 456Elderberry-2.

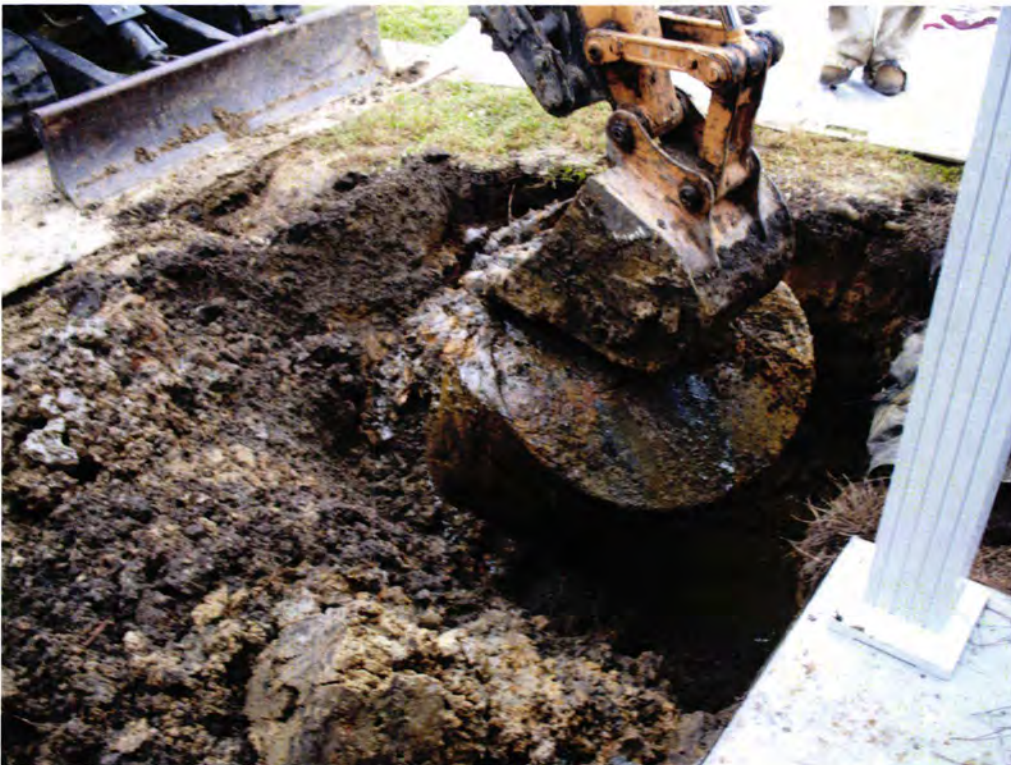
Picture 4: UST 456Elderberry-3.
